CONNECTING DATA TO DECISIONS

Linking Total Transformer Monitoring & Actionable Information
to Drive Business Value for Utilities

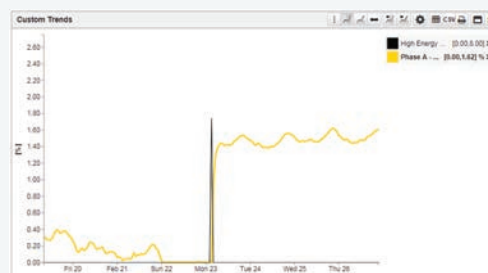
Figure 1. Capacitance increase in bushing A1 and high energy event recorded at the same time.

On February 2015, a sudden step increase of the capacitance (C1) in bushing A was detected by the monitoring system, estimating a capacitance change in the order of 1.7% which corresponds to a rough increase of 7 pF. Such a small change could have been caused by a partial short circuit between two layers in the condenser core, considering >60 control layers for 345 kV bushings. South Korean Transmission Company planned an offline test to confirm the online readings, but the results proved difficult to interpret. Indeed, the absolute value of bushing A capacitance had not changed significantly from the previous measurements, as shown in Table 1.

It was then found that at the precise moment of the bushing capacitance increase, a high energy event (partial discharge activity with significantly high magnitude, generally equal or higher than 20 V peak-peak [6]) was recorded in the same phase (from same sensor) by the online monitoring system. In this case, the recorded event had just 8 pulses per second and it happened just once. The fact that this event was recorded in conjunction with the capacitance increase was an important detail that prompted an additional offline test: oil sampling from the bushing and Dissolved Gas Analysis (DGA). Table 2 reports the results of the DGA analysis for bushings A and C. It can be clearly seen that the amount of acetylene in bushing A is well above the tolerance values, being 76 ppm; while level of acetylene in bushing C was zero, as expected.

Following the results shown in Table 2, South Korean Transmission Company promptly planned and executed the bushing replacement within a few months, thus saving the bushing from a potentially catastrophic incident. It must be noted that both the capacitance change and the repetition rate of the high energy event were quite small in terms of absolute magnitude. But being able to detect both these phenomena online and see that they occurred in the same moment provided crucial information enabling South Korean Transmission Company to take a very successful action.

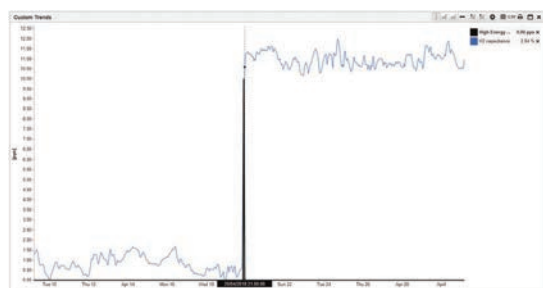
Figure 1. Capacitance increase in bushing H2 and high energy event recorded at the same time

Similarly, to Case #1, a sudden step increase of the capacitance (C1) in bushing H2 was detected by the monitoring system, estimating a capacitance change in the order of 2.9%, which can correspond to a short circuit between two layers.

By looking at the data it was observed, once again, that a high energy event was recorded in conjunction with the capacitance increase in the same phase. Figure 1 shows the recorded data (not averaged, published every hour) and the partial discharge pattern. The event was characterized by impulses with significant magnitude (60 V peak-peak) and very small repetition rate (just 6 pulses per second), almost describing a sudden arcing activity. Recognizing the same correlation pattern (capacitance change + high energy event) seen in the KEPCO case, it was then suggested to the utility to take an oil sample of the bushings.

Table 1 reports the comparison between the DGA from bushing H2 and H1, showing the acetylene concentration exceeding 20 ppm in the bushing where the capacitance change and high energy events have been detected, confirming the online analysis and enabling the utility to immediately plan the bushing replacement. The correlation of partial discharges and bushing monitoring data, along with proper offline tests, was successful in identifying the problem at a very early stage, optimizing the maintenance (in this case truly condition-based) and ultimately saving the transformer.

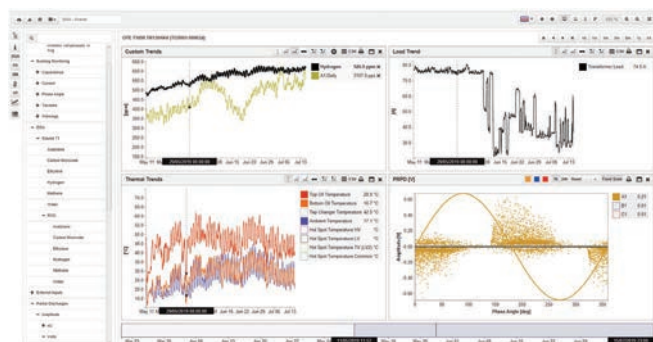
Figure 2. Online results synchronized and visualized in a way to enable further investigation on the possible correlation

- Looking at all the data collected by the holistic monitoring system, it is possible to see that there is almost no correlation to load temperature or humidity. The gas generation and partial discharge activity are not influenced by the load, nor by temperatures and humidity.

- Keep the transformer monitored and under control in order to analyse the gas and partial discharge development during the next few months.
- Plan the gasket replacements in order to perform a proper oil treatment and refilling under vacuum to remove any possible trapped bubble.
- Agree that maintenance was to be planned. However, this could be deferred to the next stop of the generator considering that:
 - the overall picture provided by the online monitor indicated that the transformer was not in a critical condition, and
 - the transformer was continuously monitored so any unexpected change in the condition would promptly notify the Subject Matter Expert.

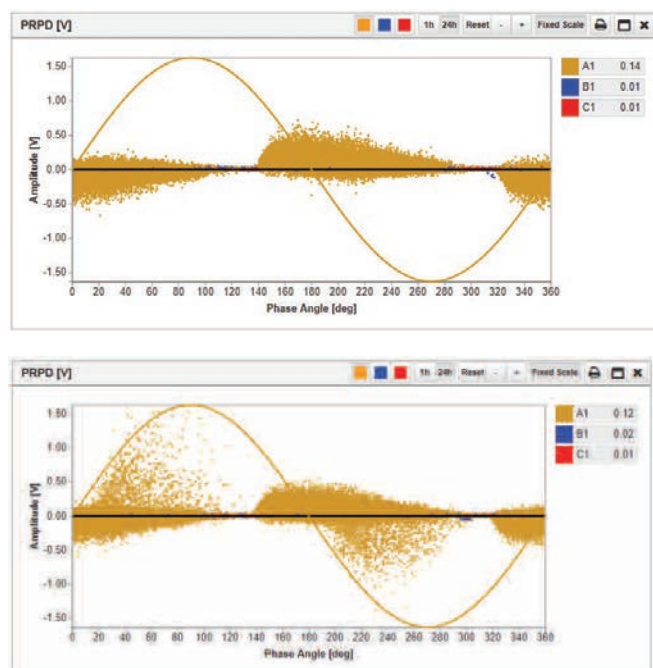
Figure 3. PRPD pattern of the stable partial discharge activity in Phase A1 (left) and the sporadic activity overlap (right)

- The first is always present and constant in amplitude and repetition rate (5000 pps) with indirect polarity and typical for defects inside the main tank (including the bushing turrets, i.e. whatever is outside the bushing core). This activity has no cross coupling with the other phases which means that the source is far from the other two phases or very close to the partial discharge sensor.

- The second is sporadic, with smaller repetition rate (in the range of 1000-2000 pps) and with direct polarity indicating that it could be inside or very close to bushing A. The overall partial discharge activity was increasing over time in terms of repetition rate, indicating that the active defect was in phase A.

- From the phase-resolved partial discharge (PRPD) pattern it was difficult to identify the partial discharge source, however similar shapes of the pattern had been recorded when the oil treatment was not conducted properly leaving small air bubbles trapped, or when small puncturing activities were present in the paper insulation on the top of the winding column (e.g. in the stress ring).

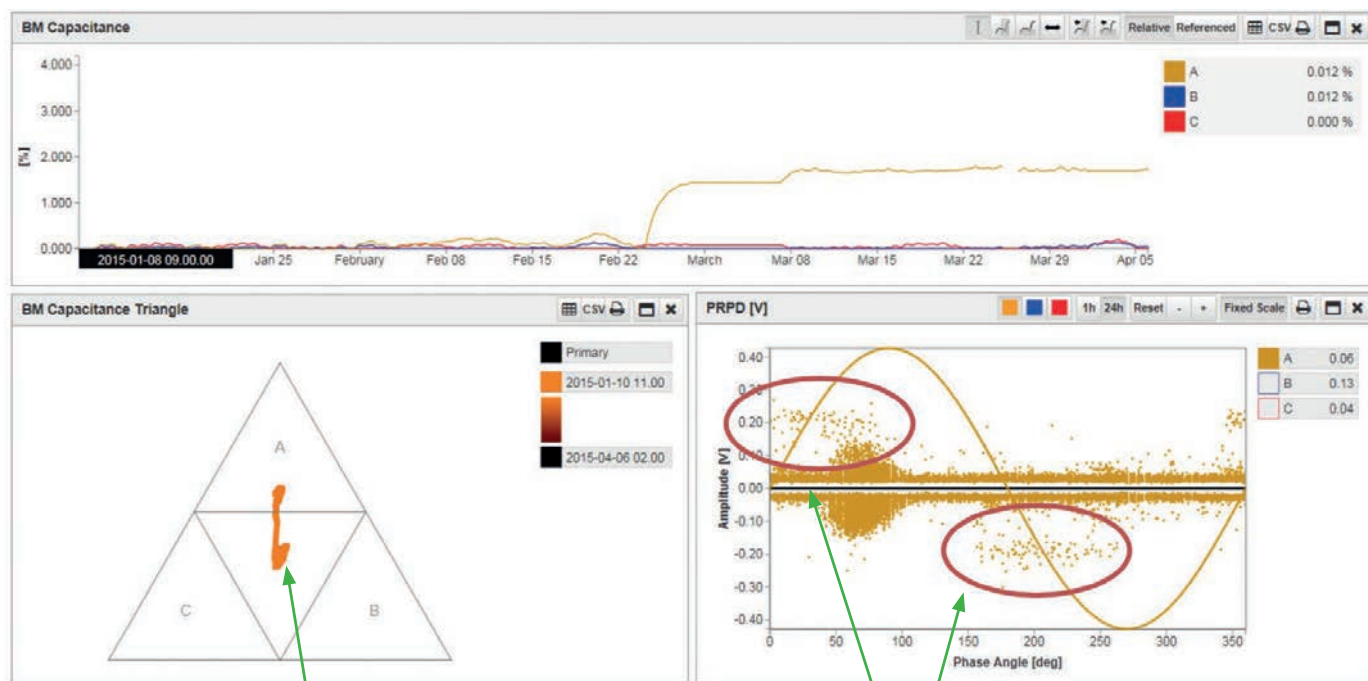
PRPD Pattern showing PD in Bushing

In depth analysis over partial discharge records revealed that High Energy Events occurred in correspondence of the sudden capacitance change.

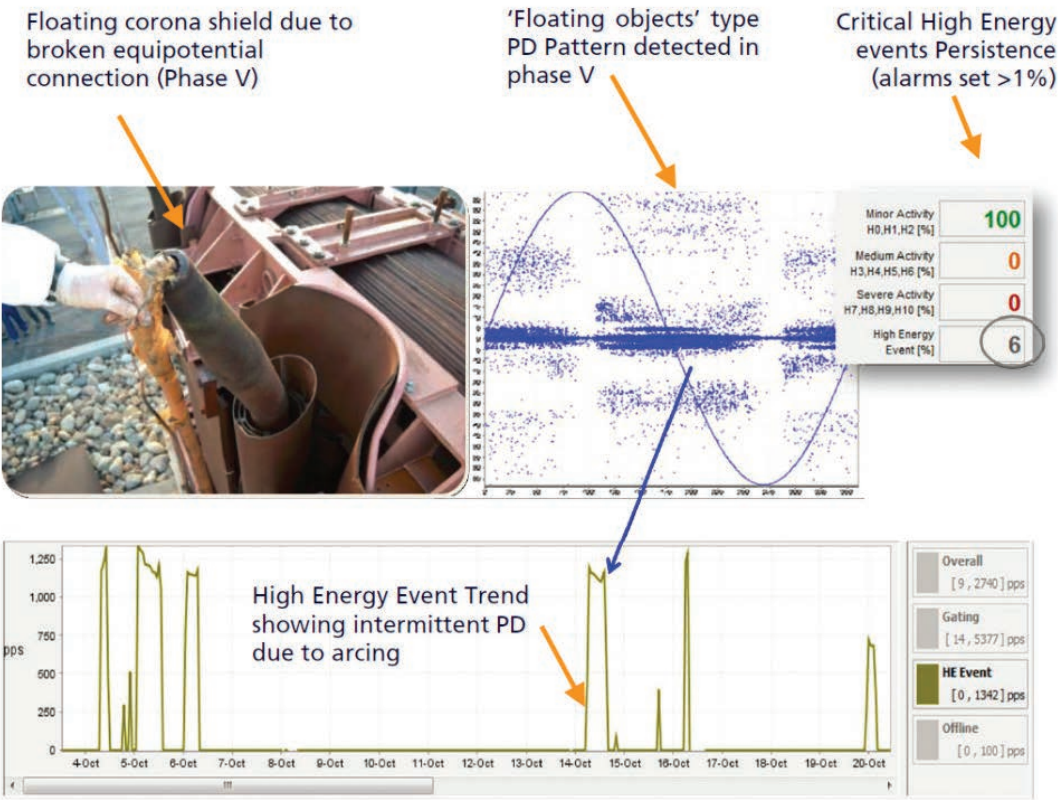
Figure 1: High Energy Event evidences, Phase V

The INTEGRO TM installed allowed for real time, continuous monitoring of the asset and detected fluctuations in PD occurring for several hours in a day and then remaining silent for weeks, showing very high energy (> 20 V, > 80nC).

This highlighted the existence of a lose/broken grounding connection in the corona shield cone immersed in the transformer tank, enabling the transmission utility to apply a proper action flow, leading to the failure prevention and optimization of the maintenance plan.

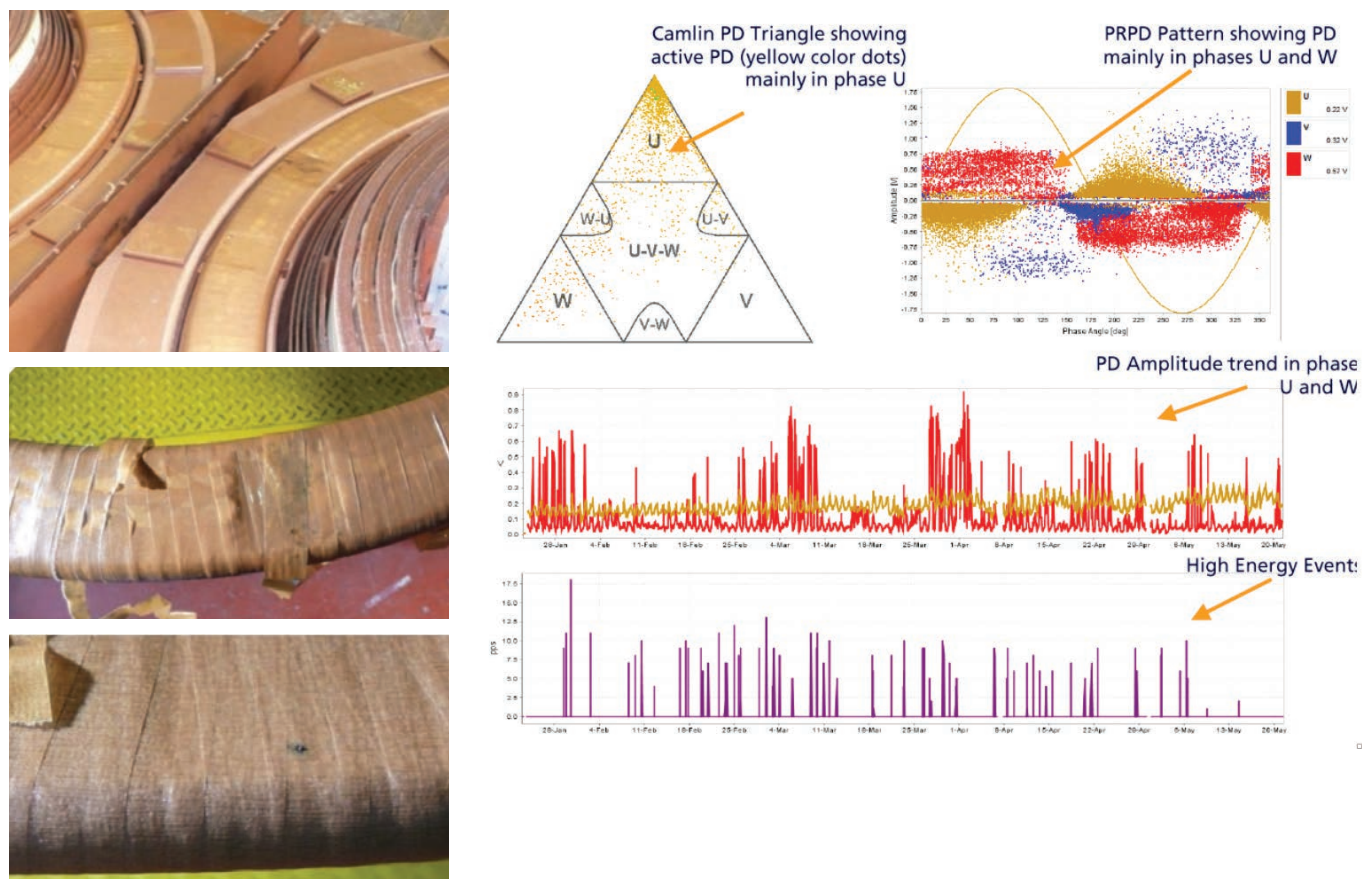
Figure 1. PD stress ring evidences, Phase U

Manufactured in 2010, a suspect Hydrogen and Acetylene concentration was noticed in the transformer after an Oil Lab evaluation in 2011. Transformer OEM supposed stray gassing phenomena. The INTEGRO TM was installed by the Utility and confirmed that cause was not stray gassing but a PD defect in one of the phases (phase U). Sporadic PD activities can where also present in phase W.

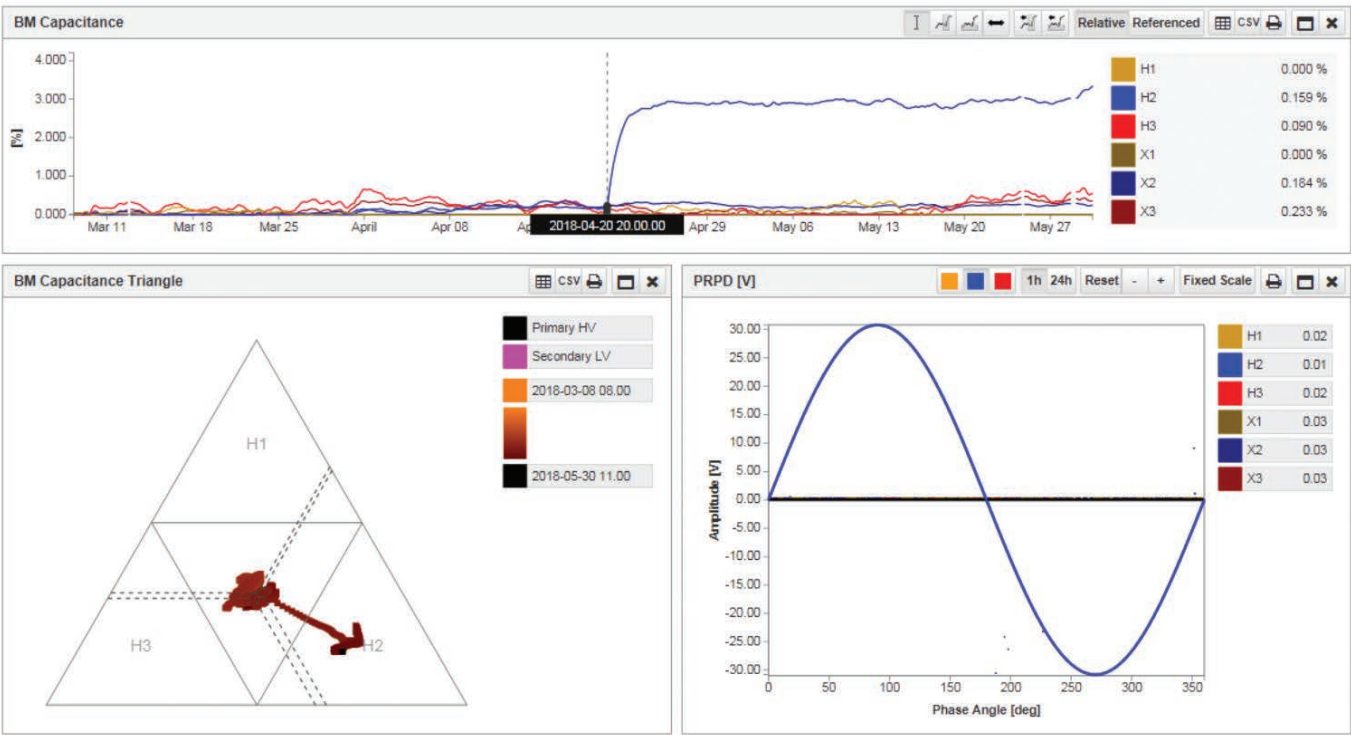
Figure 1: Sudden Capacitance increase, Phase H2

From an asset management point of view, the increasing does not represent an immediate risk factor for the Bushing provided that future records do not highlight further sudden changes in the Capacitances.

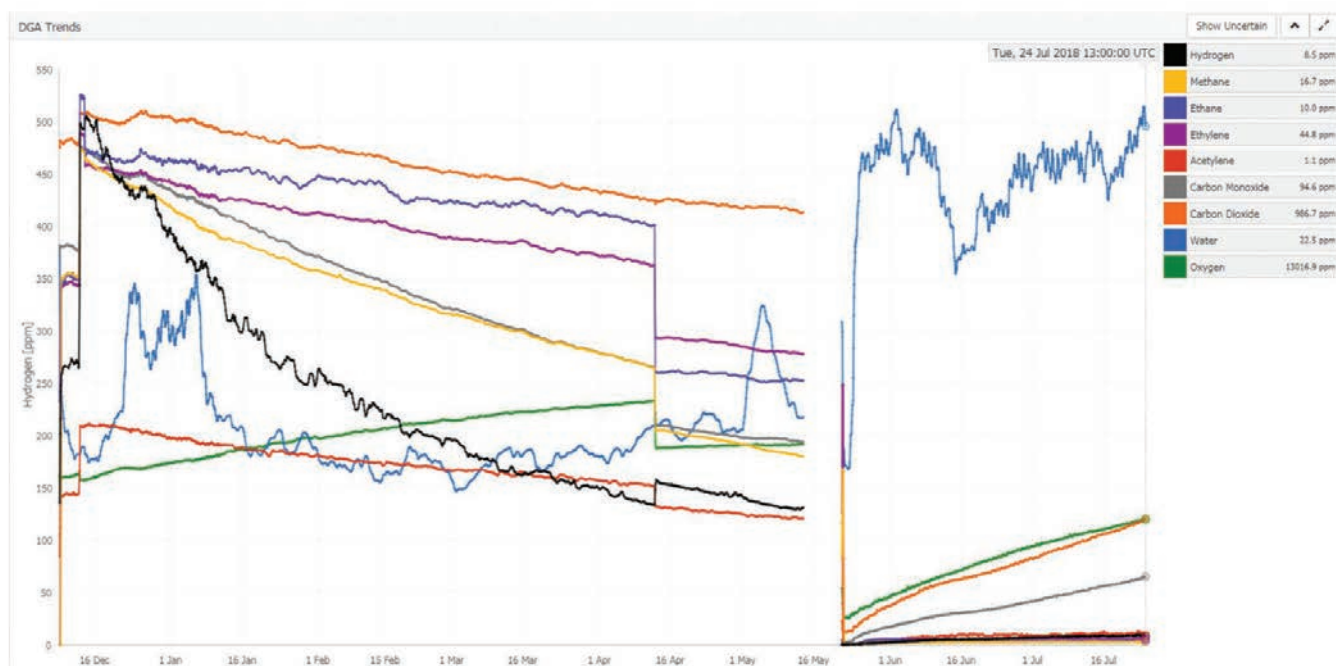
Figure 1: DGA Behavior from Installation date.

Historical DGA Lab analysis highlighted Hydrogen increasing over time and the utility, following a preliminary investigation, suspected the gassing was caused by the LTC tank which shared oil with main tank.

The TOTUS DGA tracked the readings to ensure no further gas creation. This enabled the utility to keep the Transformer in service longer, enabling an effective life extension.

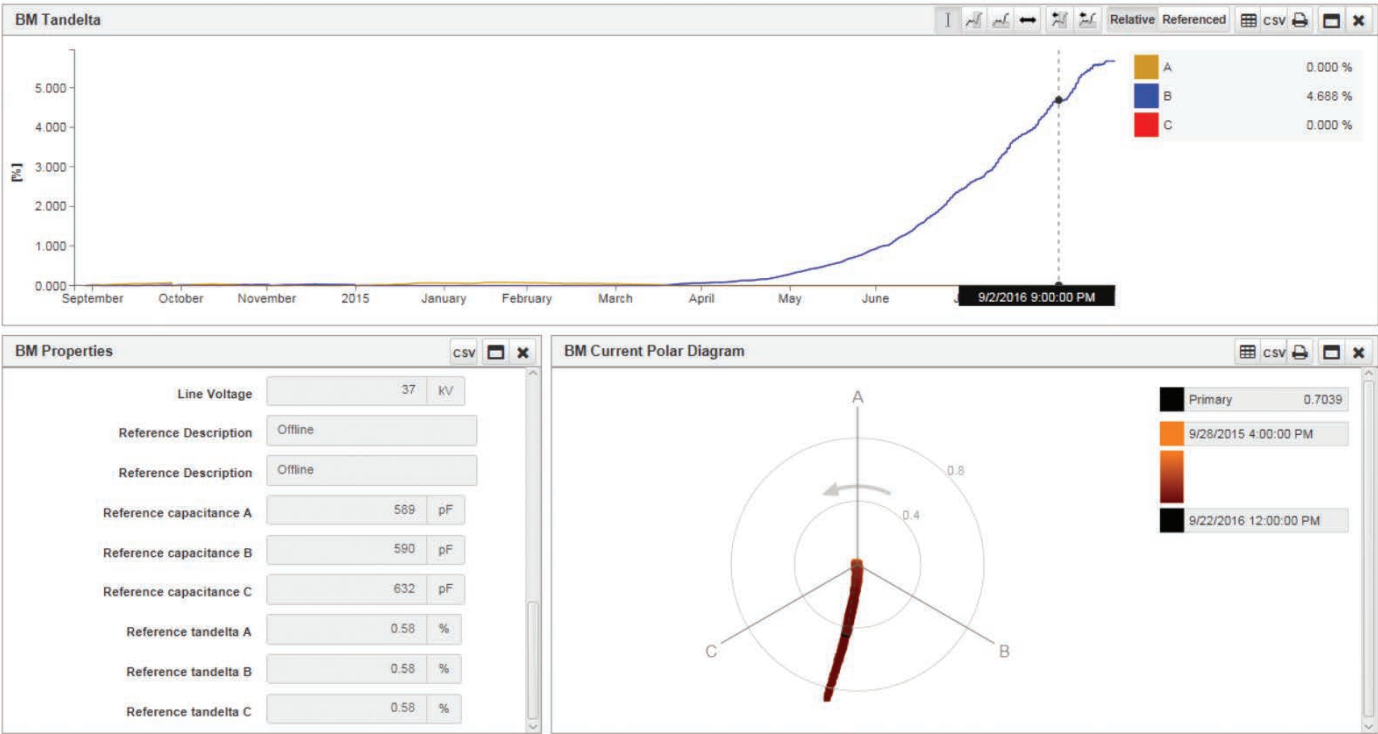
Figure 1: Bushing Monitoring Behaviour from Installation date.

Historical Bushing Monitoring data highlighted a genuine TanDelta increase on the B-phase Bushing. Considering the substantial deviation for the B-Phase Bushing, follow-up action to resolve the case was a bushing replacement.

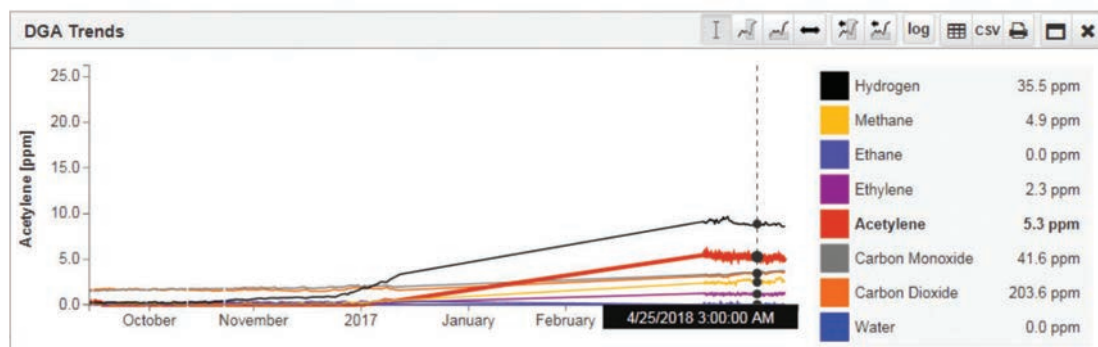
Figure 3: DGA Behavior from Installation date to April 2018

The level of Acetylene in the manual samples showed an increase over the time period. The OEM conducted an inspection and decided to replace the Transformer Tank in April 2018. Within this time frame it was possible to record a stabilization of the Acetylene from the monitoring system up to 5.2 ppm (Figure 3).

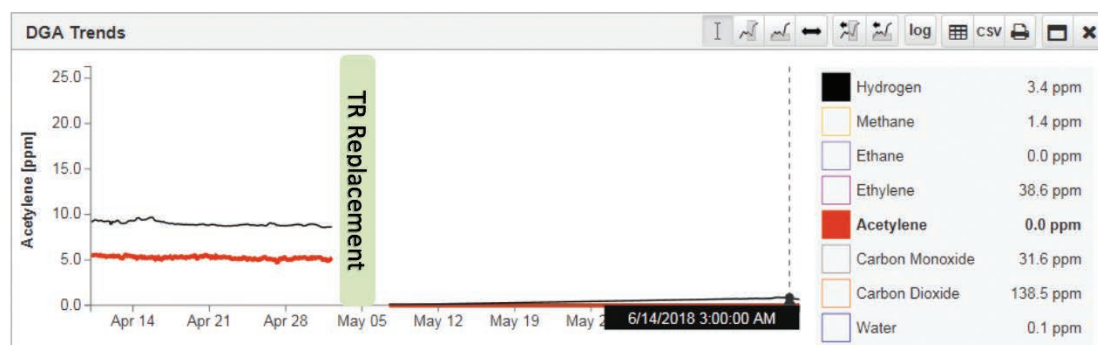
Figure 4: DGA Behavior following the OEM intervention.

After the replacement the monitoring system was recommissioned and left in operation to track future further changes. No further changes were recorded as reported in Figure 4.

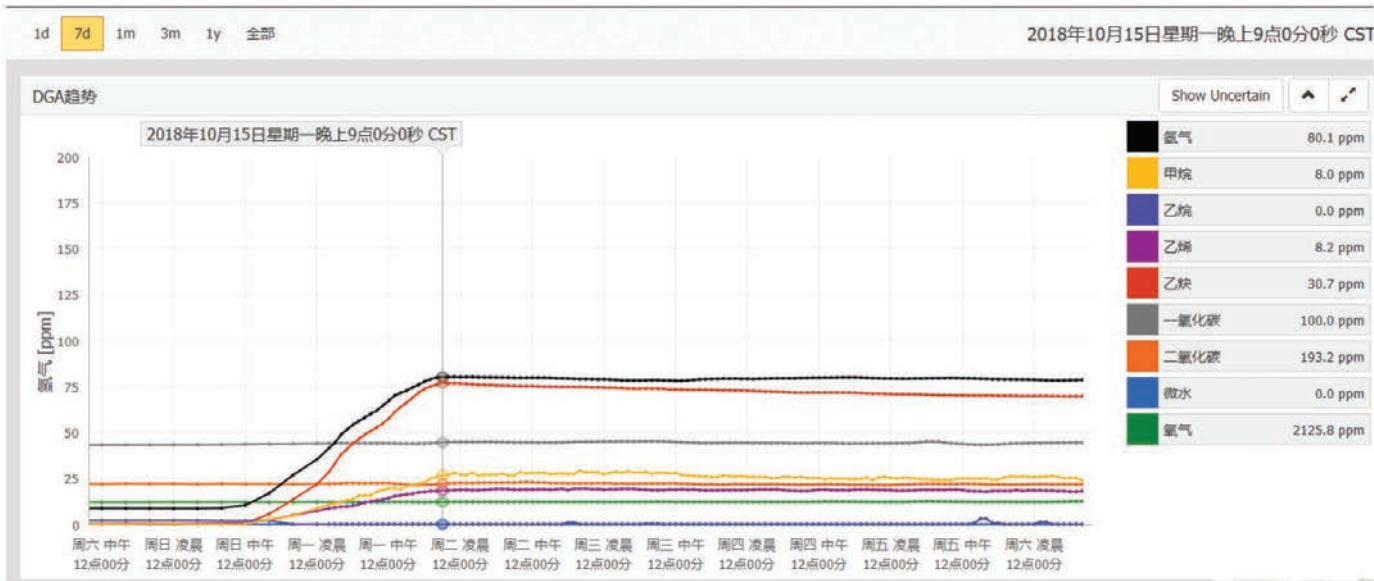
In October 2018, one of the TOTUS DGA started to record an Acetylene deviation together with increases also on other gases: methane, hydrogen and ethylene. Figure 1 shows the Camlin Web User Interface for the monitoring device.

Within Picture 1, it must be pointed out that the Acetylene concentration rose from 0 ppm (recorded at 12:00 on 14th of October) to 30.7 ppm (recorded at 21:00 on the 15th of October) within approximately 36 hours.

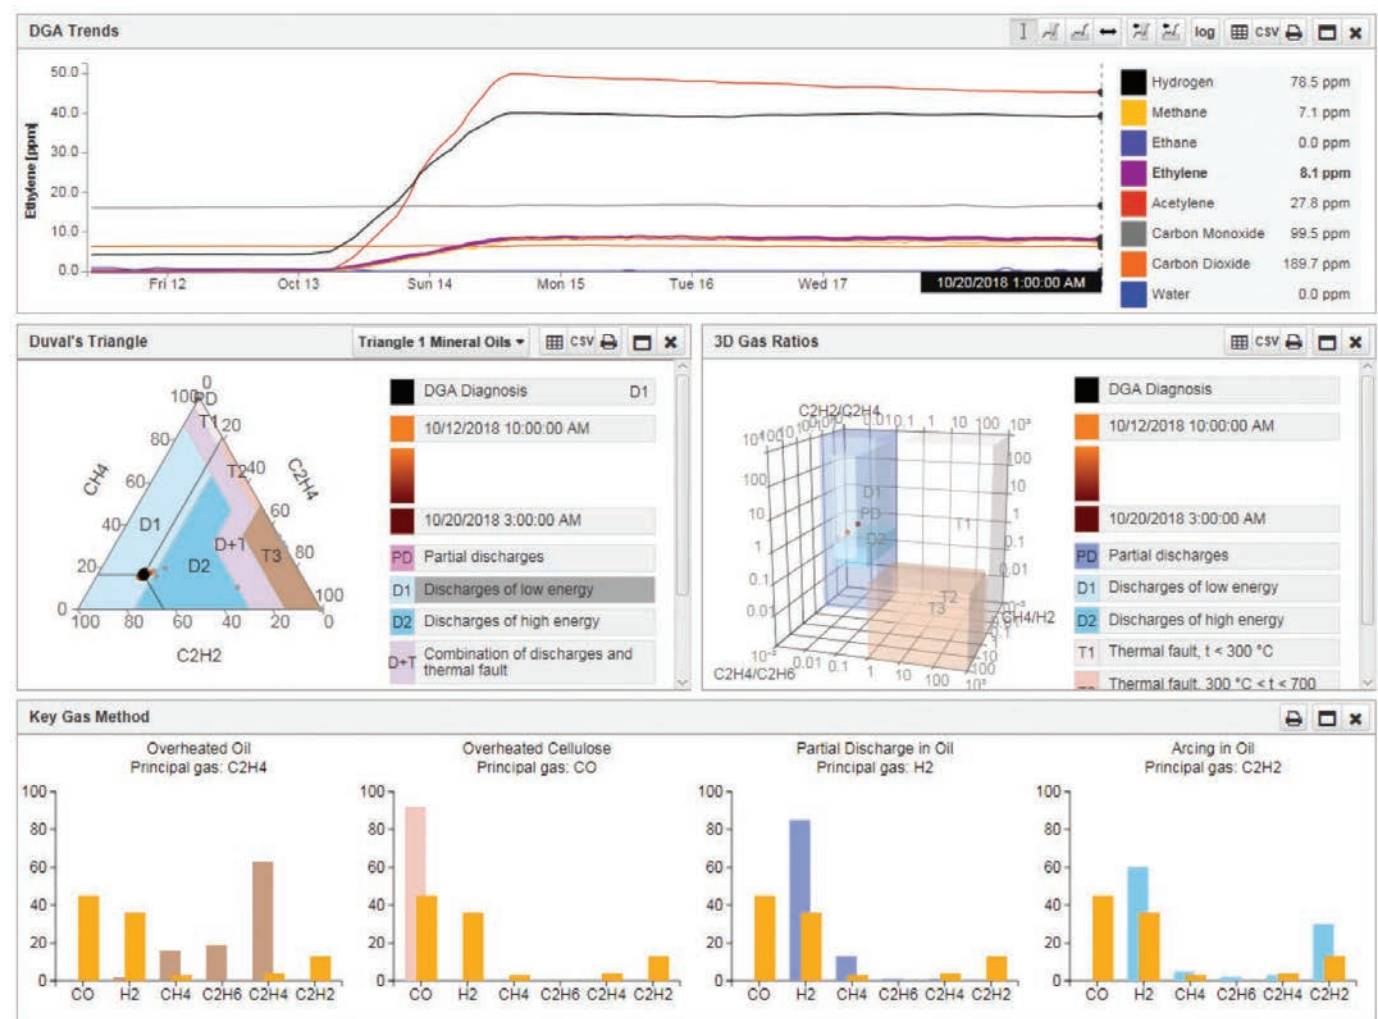
Figure 3: DGA Diagnostic results

The transformer is currently shut down and root cause analysis is still not completed. However, the decision from OEM was to replace the converter transformer.

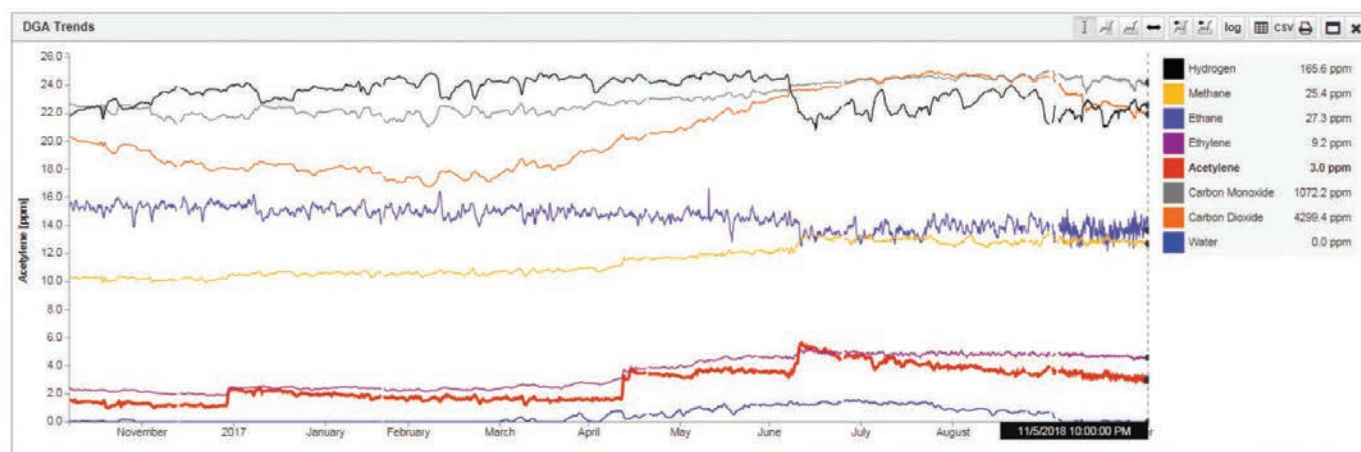
Figure 1: DGA results over the monitored period.

One of the 6 TOTUS TTM installed in the fleet recorded multiple Acetylene deviations: 3 step changes recorded over 1 year of monitoring data (Figure 1).

Figure 1 highlights Acetylene concentration increase up to a max of 5.6 ppm (July 2018). TOTUS TTM issued alarms and maintenance personnel conducted manual oil samples to be analyzed in laboratory (GC method used).

According to literature, C_2H_2 deviations occur as the consequence of arcing or discharges with high energy in the transformer tank. Although the ppm concentrations do not indicate an imminent failure, these events must not be neglected. Furthermore, it is essential to remark that several questions are un-answered in the current status:

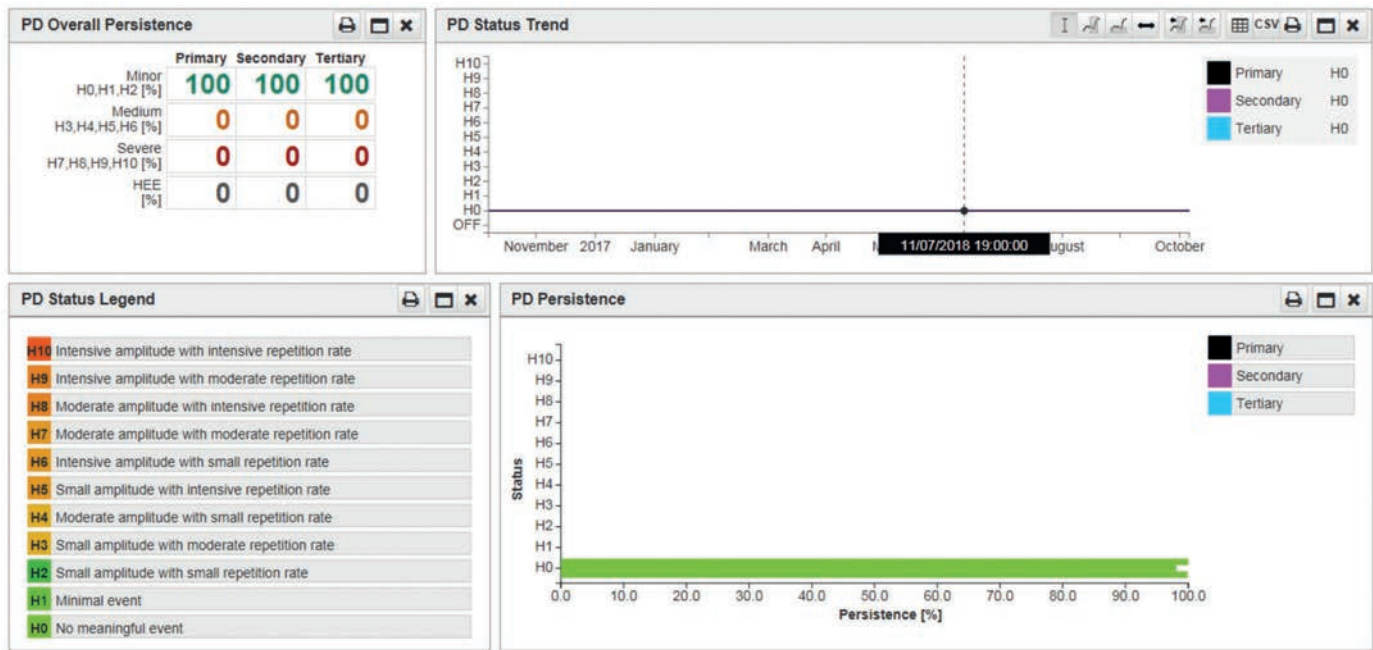
Figure 2: PD summary over the monitored period.

No persistent PD activity was been recorded within the monitored period. This means that the Acetylene increases were not the consequence of a stable and continuously active PD Phenomenon. The same conclusion can be taken for High Energy Events (in the following HEE).

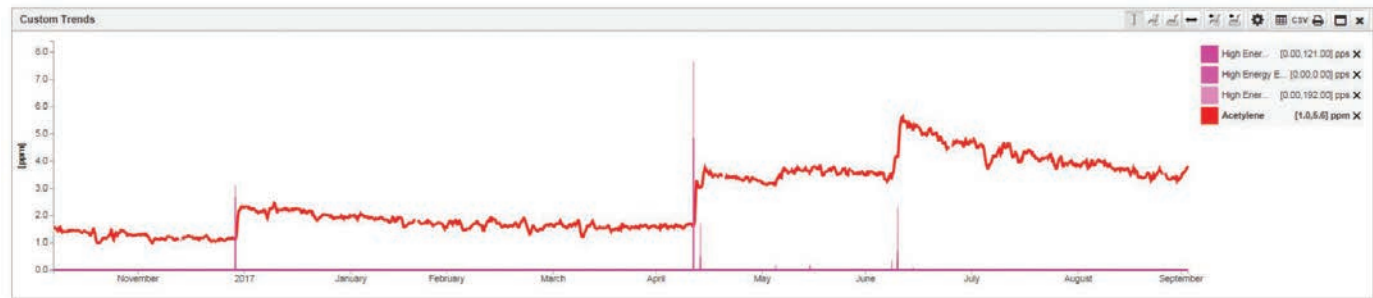
Customized trending capability enabled by the TOTUS TTM, allowed for the Acetylene ppm concentrations to be plotted together with HEE from Primary, Secondary and Tertiary windings (Figure 3) showing concurrence between HEE and C2H2 step changes.

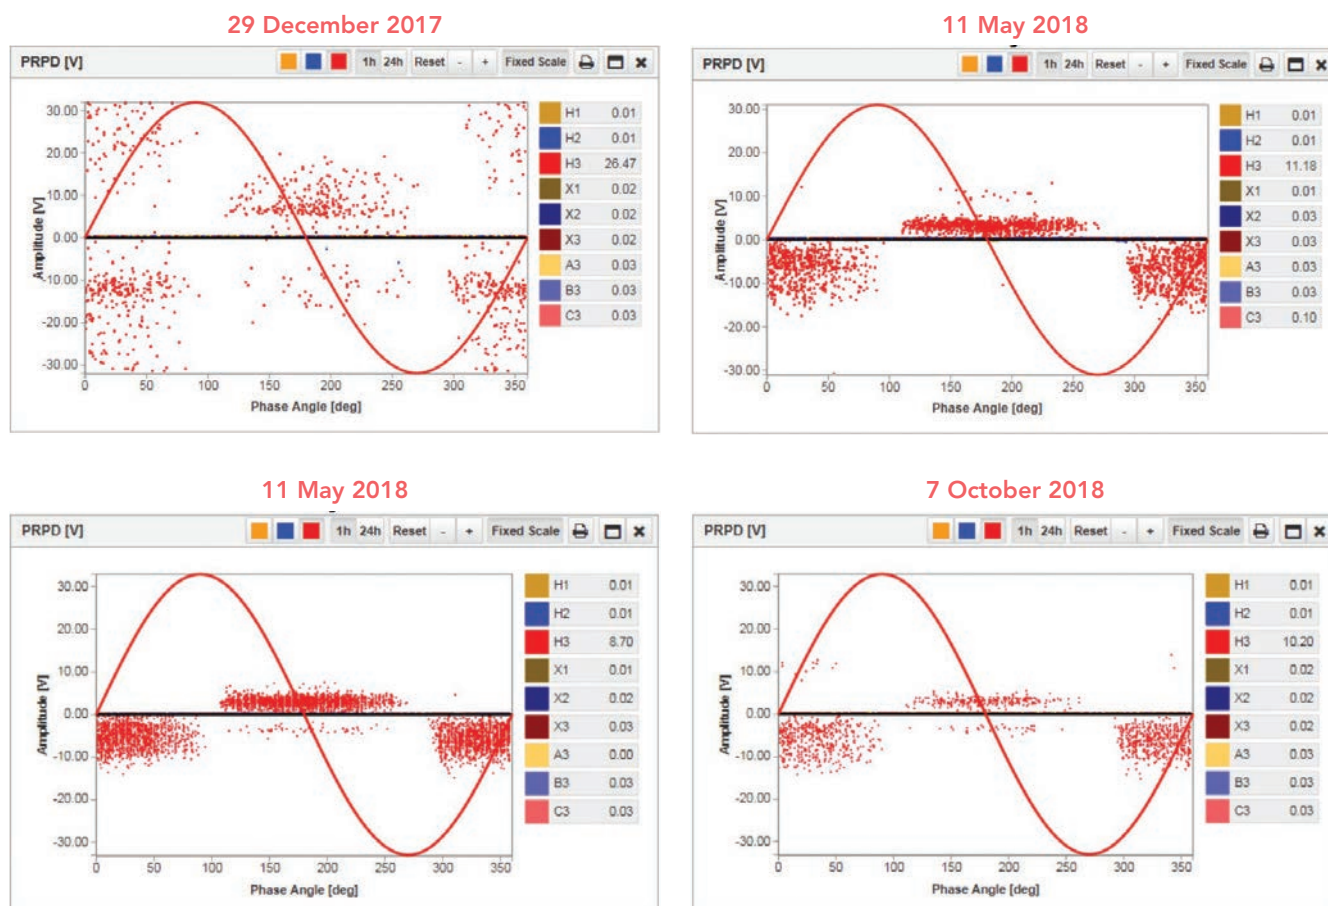
Figure 4: PRPD Patterns over the monitored period.

In this case further in-depth investigations must be addressed, Phase Resolved PD patterns can be also evaluated through TOTUS PRO Desktop in order to figure out which phase is the most affected between the three.
