Case Study 2  
345 kV Bushing Replaced in North America

# 345 KV BUSHING REPLACED IN NORTH AMERICA

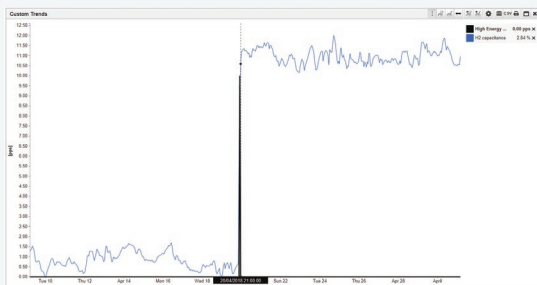
Similarly, to Case #1, a sudden step increase of the capacitance (C1) in bushing H2 was detected by the monitoring system, estimating a capacitance change in the order of 2.9%, which can correspond to a short circuit between two layers.

By looking at the data it was observed, once again, that a high energy event was recorded in conjunction with the capacitance increase in the same phase. Figure 1 shows the recorded data (not averaged, published every hour) and the partial discharge pattern. The event was characterized by impulses with significant magnitude (60 V peak-peak) and very small repetition rate (just 6 pulses per second), almost describing a sudden arcing activity. Recognizing the same correlation pattern (capacitance change + high energy event) seen in the KEPCO case, it was then suggested to the utility to take an oil sample of the bushings.

Figure 1. Capacitance increase in bushing H2 and high energy event recorded at the same time

Table 1 reports the comparison between the DGA from bushing H2 and H1, showing the acetylene concentration exceeding 20 ppm in the bushing where the capacitance change and high energy events have been detected, confirming the online analysis and enabling the utility to immediately plan the bushing replacement. The correlation of partial discharges and bushing monitoring data, along with proper offline tests, was successful in identifying the problem at a very early stage, optimizing the maintenance (in this case truly condition-based) and ultimately saving the transformer.

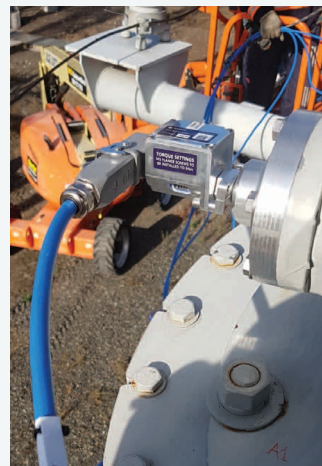
Figure 2. Bushing tap adaptor for partial discharge and bushing monitoring
