Case Study 1  
South Korean Transmission Company

# SOUTH KOREAN TRANSMISSION COMPANY REPLACES BUSHINGS DUE TO ONLINE MONITORING

South Korean Transmission Company successfully replaces 345 kV bushing.

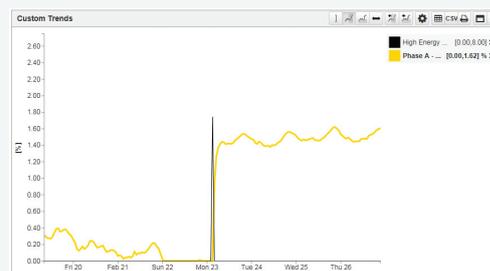
On February 2015, a sudden step increase of the capacitance (C1) in bushing A was detected by the monitoring system, estimating a capacitance change in the order of 1.7% which corresponds to a rough increase of 7 pF. Such a small change could have been caused by a partial short circuit between two layers in the condenser core, considering >60 control layers for 345 kV bushings. South Korean Transmission Company planned an offline test to confirm the online readings, but the results proved difficult to interpret. Indeed, the absolute value of bushing A capacitance had not changed significantly from the previous measurements, as shown in Table 1.

**Figure 1.** Capacitance increase in bushing A1 and high energy event recorded at the same time.

It was then found that at the precise moment of the bushing capacitance increase, a high energy event (partial discharge activity with significantly high magnitude, generally equal or higher than 20 V peak-peak [6]) was recorded in the same phase (from same sensor) by the online monitoring system. In this case, the recorded event had just 8 pulses per second and it happened just once. The fact that this event was recorded in conjunction with the capacitance increase was an important detail that prompted an additional offline test: oil sampling from the bushing and Dissolved Gas Analysis (DGA). Table 2 reports the results of the DGA analysis for bushings A and C. It can be clearly seen that the amount of acetylene in bushing A is well above the tolerance values, being 76 ppm; while level of acetylene in bushing C was zero, as expected.

Following the results shown in Table 2, South Korean Transmission Company promptly planned and executed the bushing replacement within a few months, thus saving the bushing from a potentially catastrophic incident. It must be noted that both the capacitance change and the repetition rate of the high energy event were quite small in terms of absolute magnitude. But being able to detect both these phenomena online and see that they occurred in the same moment provided crucial information enabling South Korean Transmission Company to take a very successful action.
