# TOTUS save two 130 kV bushings in Canada

**Evidence:** Increase of Power Factor and Partial Discharges in the bushing  
**Action:** Both bushings replaced after offline tests confirmed the online results

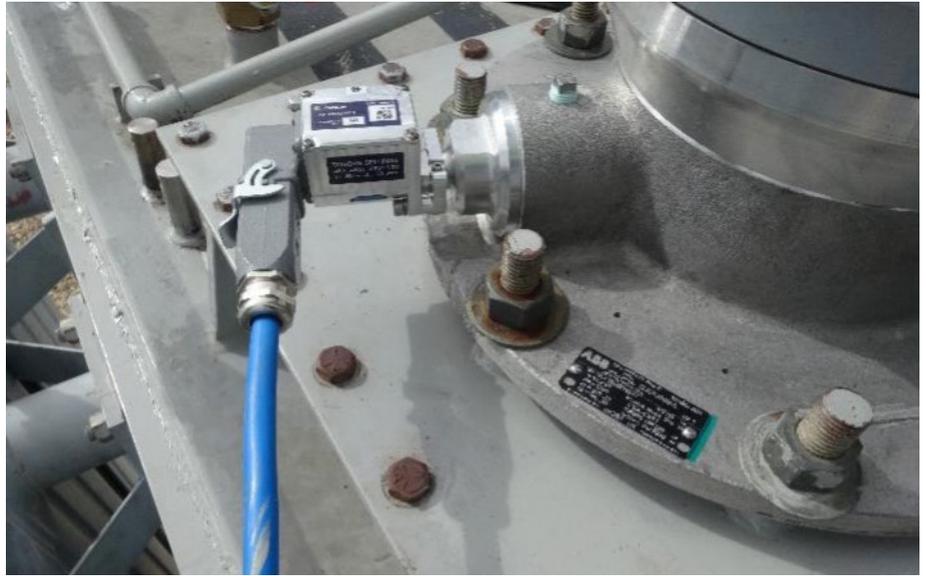
Figure 1: Kelvatek bushing sensor installed at the bushing test tap to detect both Partial Discharges and changes in Capacitance and Power Factor.

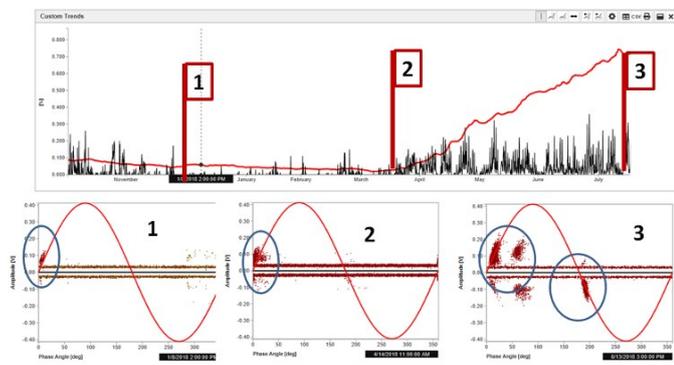
After about 2 years from the new bushing installation, an alarm was notified by the monitoring system for increased Power Factor (Tan Delta) indicating two of the three 130 kV bushings have deteriorated.

Figure 1 shows the increasing trend of the relative Power Factor, estimated from the variation of the angles of the currents (red trend line). The Power Factor started to raise in March showing an increment of around 0.7%, thus justifying further investigation. It is interesting to note the black trendline which shows the number of PD per second detected in the same bushing (X3): after some sporadic discharge between October and April, PD started to be more repetitive, correlated with a simultaneous increase of the Power Factor in the same bushing.

The TOTUS system identified the source of PD to be located in the bushing and by analysing the Phase-Resolved Partial Discharge (PRPD) pattern it was possible to speculate that the PD was likely due to the presence of particles in oil.

Figure 2: Hourly PD evolution in bushings X3 on LV 130kV side, correlated with Tandelta Increase over the time, before switching the transformer off.

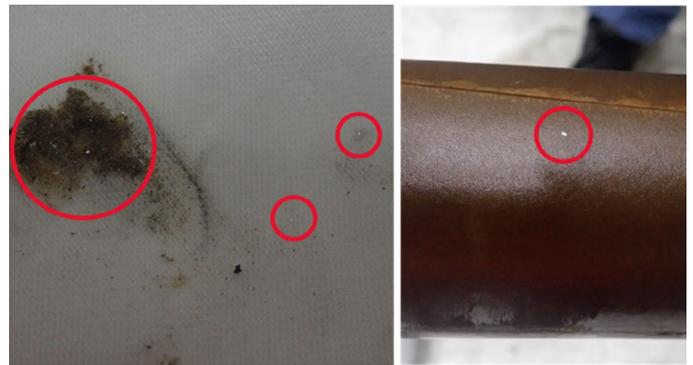
The inspection showed presence of metallic contamination. DGA was planned on all the bushings of the same batch that were not equipped with online monitoring highlighting that 3 other bushings had abnormal H2 values which led to the replacement of a total of 5 bushings.

Due to poor manufacturing, metallic particles were trapped in the bushing and free to move when, at higher temperature, the oil viscosity higher. This was generating Partial Discharges and increase of bushing losses, thus resulting in a Power Factor increase.

Figure 3: Findings of metallic particles in the bushing during visual inspection.

The utility decided to de-energise the transformer and perform the offline test including DGA and oil quality. The results confirmed the abnormal condition of the bushings, showing poor oil quality values and high DGA readings for Hydrogen, exceeding 9000 ppm. The bushings were planned for immediate replacement and visual inspection.
