KEPCO prevents in-service failure of a 345kV bushing with TOTUS online monitoring

Evidence: Online monitoring showing capacitance increase and arcing events

Action: KEPCO planned offline Capacitance and DGA test confirming online data

and issues replacement; thus, preventing an in-service failure

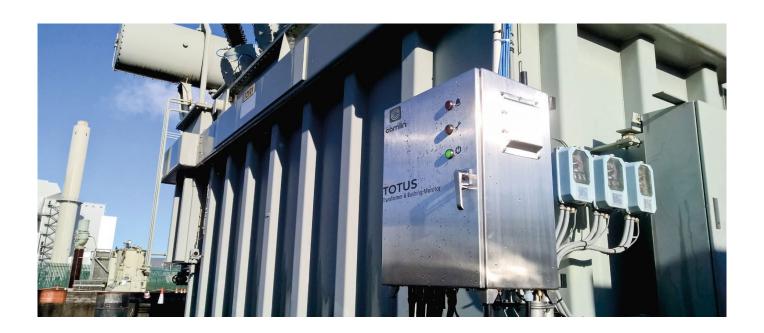
In February 2015, a sudden step increase of capacitance (C1) in the A-phase bushing was detected by the monitoring system. The recorded change in capacitance was $\sim 1.7\%$ which corresponds to an increase of roughly $\sim 7\,\mathrm{pF}$ and could be caused by a short circuit between two layers in the condenser core. Prompted by this change detected from the monitor, KEPCO planned an offline test to confirm the online readings, but the results proved inconclusive. The offline test indicated the value of the A-phase bushing capacitance had not changed significantly from the previous records, as shown in Table 1.

Still suspicious of a bushing defect, Kelvatek experts reviewed historical data from the online monitor more closely. The relative difference of capacitance between A-phase and B-phase was analysed over time. From this it was possible to spot that this difference was mostly constant in 2012 and 2014; below 2 pF variation. While in 2015, a sudden difference exceeding 12 pF was recorded; this was approximately equal to a 2.7% of capacitance increase.

Further analysis also revealed that at the precise moment of the bushing capacitance increase, a high energy discharge event had occurred. High energy events are partial discharges with significantly high magnitude, ~20V peak magnitude or more. High energy event discharges are considered similar to internal arcs that do not fault to ground, but across portions of the electrical insulation. Correlating with the capacitance increase on the A-phase bushing, a high energy discharge event was recorded that had just 8 pulses per-second and occurred just this one instance. This is believed to be the instant when internal layers of the bushing insulation faulted.

Figure 1. Capacitance increase in bushing A1 and high energy event recorded at the same time.

Following the findings shown in Table 2, KEPCO promptly planned and executed the bushing replacement within a few months, thus saving the bushing from a potentially catastrophic incident. It must be noted that both the capacitance change and the repetition rate of the high energy event were quite small in terms of absolute magnitude. But being able to detect both these phenomena online and see that they occurred in the same moment provided crucial information enabling South Korean Transmission Company to take a very successful action.
