# Works Order

**Order Number:** 23284695

125 Bliss Road

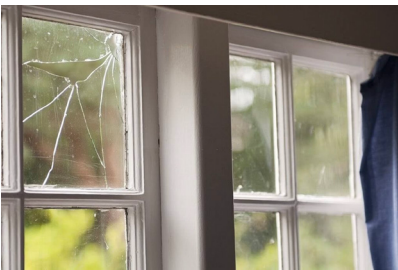
| Caption | Pre works photo |
|---|---|
| Caption | Post work photo |

| Caption | Pre works photo |
|---|---|
| Glass also broken on window | |

| Risk Assessment | Passes |
|---|---|
| Operative Comments | Window frame repaired but glass broken new unit ordered with stores |
