## Crane cab access platform collapsed

Safety Flash Published on 2 October 2025 Generated on 13 October 2025 IMCA SF 18/25

On a vessel crane, the access platform to the crane cab failed catastrophically.

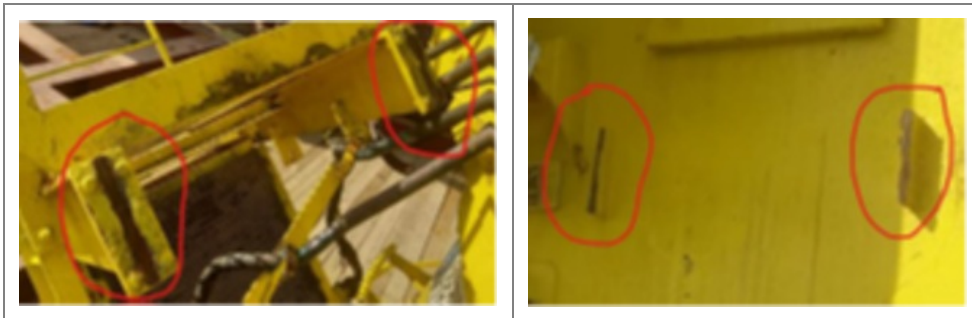
- The platform and ladder protection structure failed at the connection point to the crane base while the operator was ascending. The failure was caused by a hidden crack and corrosion at the weld seam.

- Think about inspection and verification in places that are very difficult to access – can we be sure there is no hidden corrosion?
  - Can we design or modify equipment so as to allow easy visual inspection?
  - Can we use other inspection techniques such as non-destructive testing (NDT) (e.g., ultrasonic or magnetic particle testing)?
- How do we better manage, check and verify the work of third parties, particularly when that work is done unsupervised in a dock yard or dry-dock setting?
- Be vigilant for visible signs of structural deterioration such as cracks or rust – promptly report such findings.
- During maintenance, are we cleaning and preparing surfaces properly?  
All old paint layers need to be removed, and surfaces thoroughly inspected before new coating is applied. Failure to do so may result in hidden defects, such as corrosion or cracks, being overlooked.

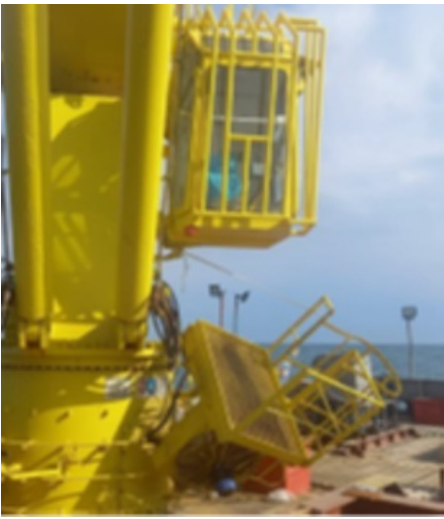
- The ladder platform was connected to the crane pedestal via a structural flange connection. Due to the narrow gap between the flange and the pedestal, visual inspection of the weld area was not feasible, which resulted in undetected deterioration over time.
- The crane structure had been recently painted by a third-party shipyard contractor. It appeared that the old paint was not fully removed during surface preparation. This likely masked existing cracks and corrosion, allowing the defects to remain unnoticed during maintenance.
