Diver sustains laceration to right hand

Safety Flash Published on 31 July 2025 Generated on 5 August 2025 IMCA SF 13/25

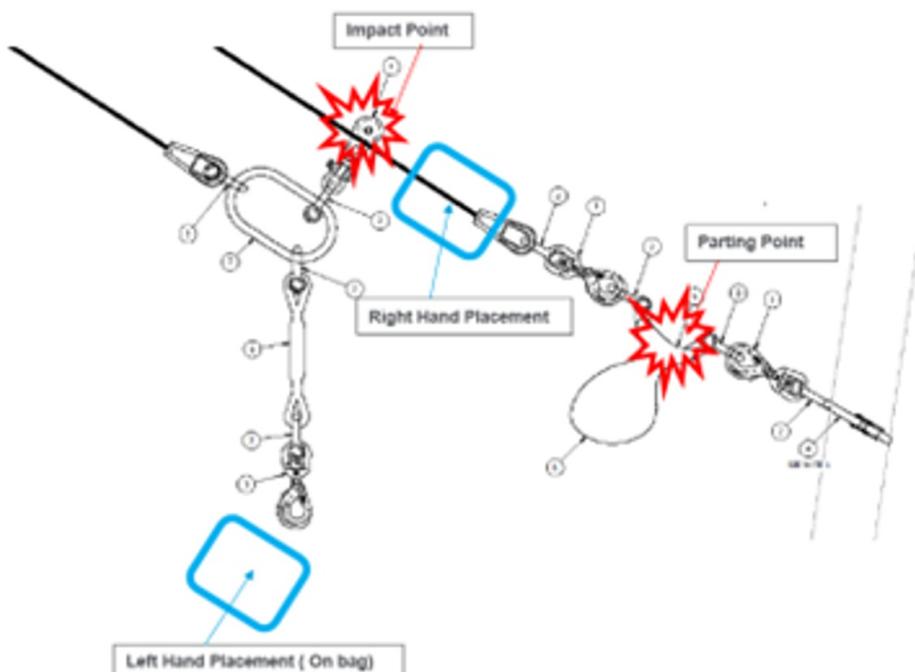
During this adjustment, the diver used his left hand to pull the tooling toward the structure while his right hand was positioned on the wire for additional leverage. However, an unexpected vessel movement caused the breaker/weak link to part, resulting in the diver's right hand being drawn toward the snatch block, and his glove becoming entrapped and torn off.

Hand Placement of injured person and rigging arrangement

Key factors contributing to this incident likely include the unpredictability of vessel movement, tension within the downline, and the closeness of the diver to high-risk equipment (line of fire) such as the snatch block.

- Engineer out the risk: configure a new engineered solution for downline arrangement / set up - reconfigure the downline to ensure diver remains out of line of fire during retrieval of work equipment.
- Amendments have been made to the divers tool bag with the addition of a lanyard to ensure diver remains out the line of fire.
- Is our communication – particularly in the context of activities such as diving – effective enough?
- Are our risk assessments stringent and detailed enough?
- Could we be more proactive with hazard mitigation strategies, including ensuring proper positioning of personnel and securing lines to withstand potential forces?
- Look out for, assess the risk of, and prepare for, unexpected vessel movements, particularly during diving and lifting operations and when winches or moving machinery may be involved.
