Divers helmet struck and damaged subsea by crane hook

Safety Flash Published on 6 March 2025 Generated on 9 April 2025 IMCA SF 04/25

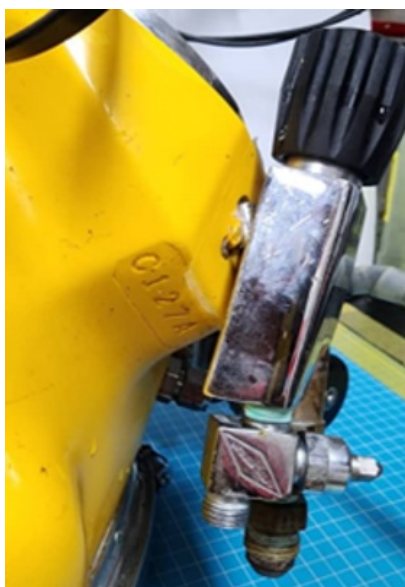
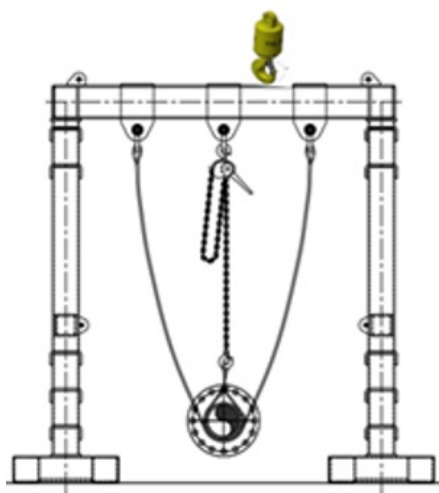
Whilst the diver was positioned beneath the PHF and moving up to disconnect the rigging, the crane hook unexpectedly struck the diver's helmet. The diver reported that they were unharmed and well, and returned immediately to the dive bell. The dive was aborted. Upon inspection, the diver's reclaim helmet was found to be damaged beyond repair, including the side block. Despite the impact, the integrity of the helmet was maintained throughout, demonstrating the high quality and durability of the diving helmets. The diver was unharmed.

When the crane hook was lowered for PHF rigging disconnection, it came to rest on the top beam of the PHF. This resulted in a 'no weight' reading, leading the crane operator to assume the hook had reached the seabed. As the diver approached the disconnection point, the hook slipped off the beam and struck the side of the diver's helmet.

- Inadequate length of crane pennant / stinger, which did not provide sufficient distance between the divers and the crane hook.
- Poor visibility, which hindered the ability to accurately observe the position of the crane hook.

- Ensure adequate distance between divers and crane hook:
 - The length of the crane pennant/stinger should be sufficient to maintain a safe distance between the divers and the crane hook during subsea operations. This will reduce the risk of accidental contact with the hook, particularly in limited visibility conditions.

- Enhanced visibility aids and monitoring:
 - In environments with poor visibility, alternative methods such as additional locating beacons, underwater cameras, or sonar should be considered to better track the position of critical equipment like the crane hook. Improved monitoring can help prevent misjudgements about the location of the crane hook.

- Reinforce communications, challenge assumptions!
 - Assumptions regarding equipment position should be minimised.
 - Clear communication and confirmation procedures between the dive supervisor, crane operator, and divers should be reinforced to ensure all parties are fully aware of the equipment's location at all times.

- Updated project procedures to specify minimum pennant lengths for different operations;
- Conducted pre-operation inspections of all rigging and lifting equipment, including crane hooks and pennants, to ensure they meet safety

- Updated the Job Hazard Analysis (JHA) to incorporate lessons learned from this incident, particularly regarding safe distances, visibility, and communication requirements for subsea lifting operations.
