# Dropped Handrail Fell 6m to Walkway Below

**SAFETY ALERT**

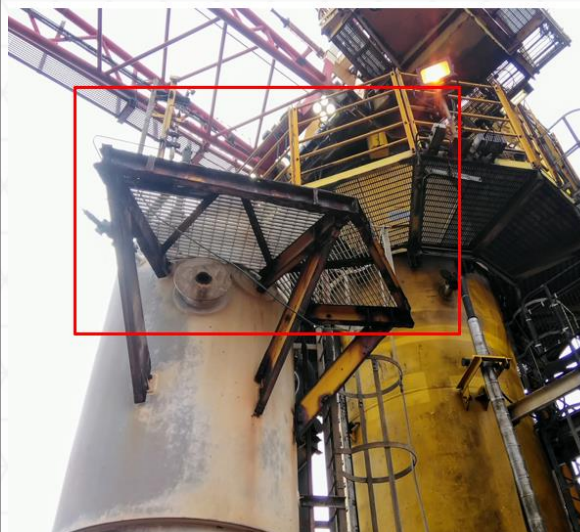
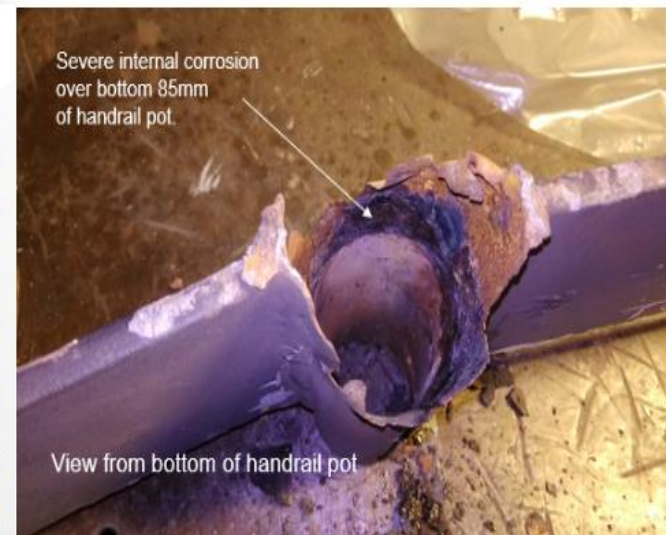
The root cause of the handrail failure was internal corrosion to the pots that connect the handrail posts to the supporting structure. This corrosion had caused significant metal loss and internal wall thinning to the inside of the pots reducing the strength of the connections.

- Unidentified Internal Corrosion and wall thinning of the pot.
- Handrail post / pot interface exposed to rainwater water and chlorides in the marine environment.
- Current Inspection Programme only calls for general visual inspection that would not have identified internal failure mechanism.
- Handrails had no cuffs attached as per original design.

Internal corrosion, consequent wall thinning resulted in a loss of strength at the interface between the handrail post and pot.

- Planned inspection was completed on the handrail posts and connecting pots. The technique used (general visual inspection) did not and could not identify internal corrosion
- The original design of the handrail specified cuffs to connect the top rail to adjacent handrail panels. These are intended to provide some additional support to the panels. If they were present the handrail panel may have been retained in position thus preventing the dropped object event.
- Review risk assessment process for non SECE's that relate to structural components, where there is a credible threat to personnel and process.
- During handrail replacement the connection between the handrail and tertiary structure was not always being removed. This needs to occur to avoid potential dropped objects.
