Head Injury in Engine Room

Safety Flash Published on 14 August 2025 Generated on 22 August 2025 IMCA SF 14/25

A Chief Engineer sustained a head laceration injury.

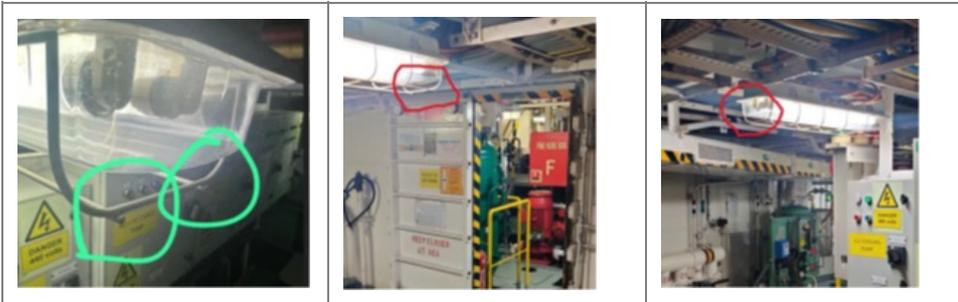
A Chief Engineer sustained a head laceration injury after accidentally striking his head on the sharp edge of a lighting protection grille rod installed at a height of 168 cm in the engine room.

Location of lighting and lighting protection grille rod hazards.

- The head-room was low, and the lighting protection grille was lower still at 168 cm above deck, posing a physical hazard at head level.
- The “protective” grille was itself harmful, with sharp, unprotected rod ends which created a risk of laceration or impact injury.
- No adequate PPE (safety helmet) was worn at the time of the impact, increasing injury severity.
- This obvious hazard was overlooked during installation and routine checks following installation.

- Consider a hazard hunt to identify all snagging points (risk to head/body)
 - Could there be some you hadn't thought of, or that were missed the first time around?
 - Reassess familiar spaces, not just obvious major equipment areas. What about the mess, the corridor in the accommodation etc etc.
- Can the hazard be engineered or designed out – that's ideal but not always practical;
- Can some form of protective pad be applied?

- Can sharp edges or low-hanging objects be appropriately marked?
- Does everyone know about the hazard? Is it worth a reminder at the tool box talk? “Watch out when you go past here, there’s a low bit where you have to duck to get through.”
- Think through hazard awareness and reiterate PPE use (such as helmets in machinery spaces).
