Hydrogen Sulphide (H₂S) detected onboard vessel

Safety Flash Published on 29 April 2025 Generated on 27 May 2025 IMCA SF 08/25

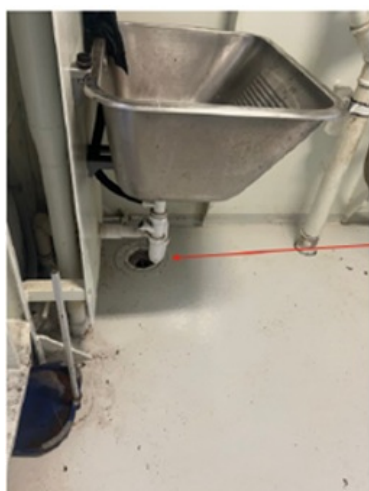
The H₂S came from the drain under sink through the dry water trap.

During investigation, a level of H₂S of 170ppm was measured in the Grease Trap room. No gas was detected by gas detector in other areas onboard, only a smell. The H₂S in the Grease Trap room came from the drain under the sink because the water trap was dry.

H₂S was detected in the ventilation from the sewage/grey water tank, in the ventilation and not the surrounding area. The smell came from the sewage/grey water tank through multiple drains where water traps were dried out onboard in different areas.

- Sewage was being re-routed due to maintenance of the sewage treatment plant.
- Residues in sewage/grey water caused a build-up of H₂S.
- Several drains where water traps were dried-out caused a "smell" detection of H₂S.

- Amended or established procedures:
 - To flush of grey water tank after maintenance of sewage plant
 - To ensure that drain water traps don't dry out
- Reviewed H2S emergency procedures.
