## LTI: Fall from height during FRC maintenance

Safety Flash Published on 20 February 2025 Generated on 3 April 2025 IMCA SF 03/25

A worker fell 2.3 m to deck from a small boat in the davit, and broke a leg as a result.

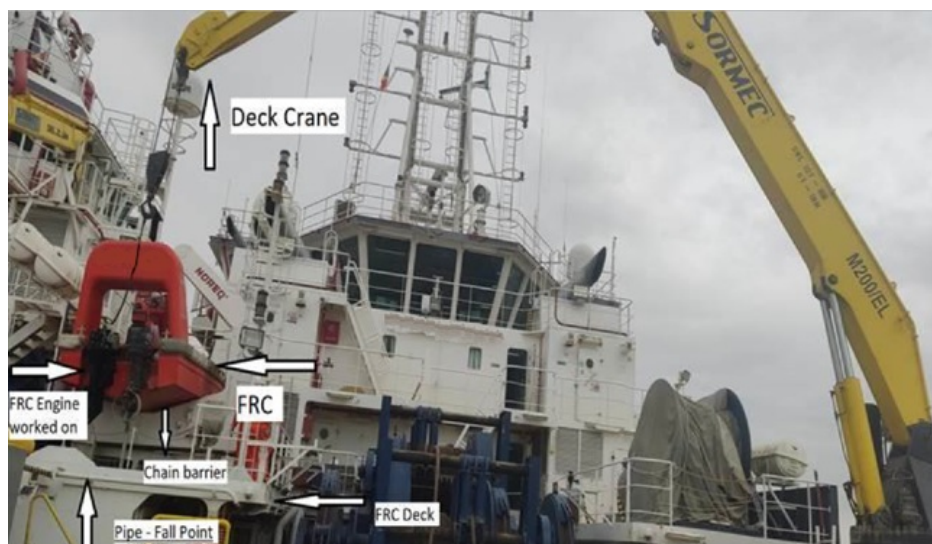
Area where incident occurred

CCTV footage from the port revealed that several times the mechanic failed to secure the engine in place from inside the FRC (aft) due to restricted access. Afterwards, he crossed the chain barriers of the FRC deck and attempted to bolt the FRC engine in place while standing on a small diameter pipe designed to cover electrical cables. There was no use of fall protection equipment.

- Ensure work is properly planned and that there is a thorough, comprehensive and detailed risk assessment.
  - In this case, the requirement for work-at-height equipment (fall arrest harnesses, etc.) for persons working in an FRC on a davit, was quite foreseeable.
- Ensure that there is a Toolbox Talk:
  - Stop and discuss the job before we begin.
  - Stop and identify hazards and controls before starting.
  - Don't just dive in.
- Ensure all crew understand that they can STOP THE JOB.

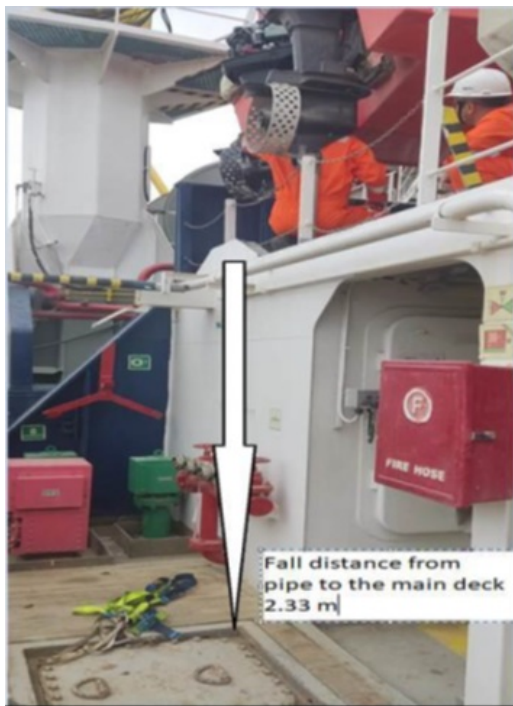
*Showing line of fall*
