LTI: fall from height during anchor chain handling operation

Safety Flash Published on 17 December 2024 Generated on 10 January 2025 IMCA SF 24/24

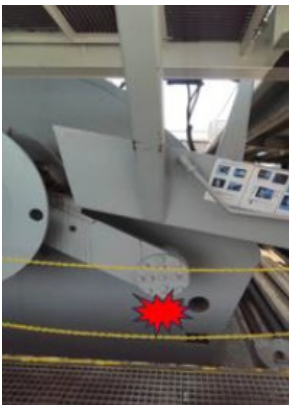
“A” deck – the place from which the bosun fell, illustrating the chain he potentially stepped on

According to the CCTV footage reviewed, the bosun put one foot on the chain barrier while passing the wire over. However, as he attempted to move his second leg, he fell through an opening between two chain barriers and landed 2.75m below on the main deck. First aid was administered onboard, and a vessel doctor called for further assessment. The bosun was subsequently transferred to shore for further medical evaluation. He suffered multiple fractures to his right leg and broke a rib.

- The injured person placed his foot on an unstable surface (the chain barrier), which led to the fall;

- Greater care when accessing locations at height – only correct, proper, secure, stable, and purpose-designed platforms and equipment should be used.
- Better identify potential fall hazards, particularly in areas with open spaces, such as around chain barriers.
- A more thorough and detailed risk assessment should be made for each step of the operation, thoroughly evaluating all associated risks. All identified hazards and corresponding control measures should be clearly communicated to the crew and verified to be in place before starting work.
- Better supervision of high risk tasks, particularly when working at height.

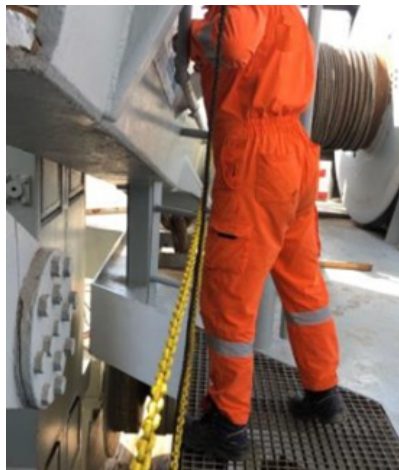
“A” deck – the place from which the bosun fell, illustrating the chain he potentially stepped on
