## Description of incident:

Incidents may occur when reeving wire rope.

There have been incidents in the past involving cable grip or “snake” equipment release during drill line reeving activities on North Sea Installations.

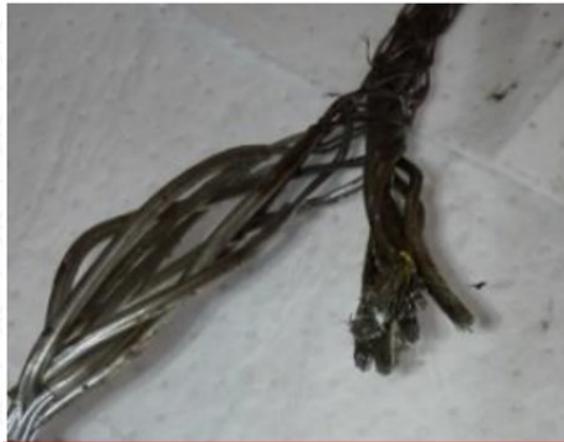
**Figure 1 – Damaged Snake Grip**

In a recent incident, a Lewis ‘snake’ assembly size had been increased to achieve a higher SWL based on previous incident learnings. The increased connector dimension exceeded the clearance between a deflector sheave and retaining bar and did not sit completely within the sheave channel. See *Figure 1 – Damaged snake Grip*

In a recent incident, the leading edge of the connector snagged on a sheave wire retaining bar. This caused compression of the connector that released the grip without any increase in line tension. The release was immediate and gave no time for the spotter to exit the red zone. The job procedure did not have hold points to allow spotter to exit the area before the connector entered the sheave. It was not appreciated how fast the release could happen.

5. **Have you identified the potential snag points for the complete path from deadline to drawworks, and that minimum pass-through dimensions accommodate the connector size?**

**Dropped drill line fell outside of the standard Red Zone (without impact to people’s safety). For any non-standard operations, designation of a total exclusion zone should consider the drop cone associated with the full path of the associated equipment**
