## MAIB: Very serious leg injury during crane operations

Safety Flash Published on 6 March 2025 Generated on 9 April 2025 IMCA SF 04/25

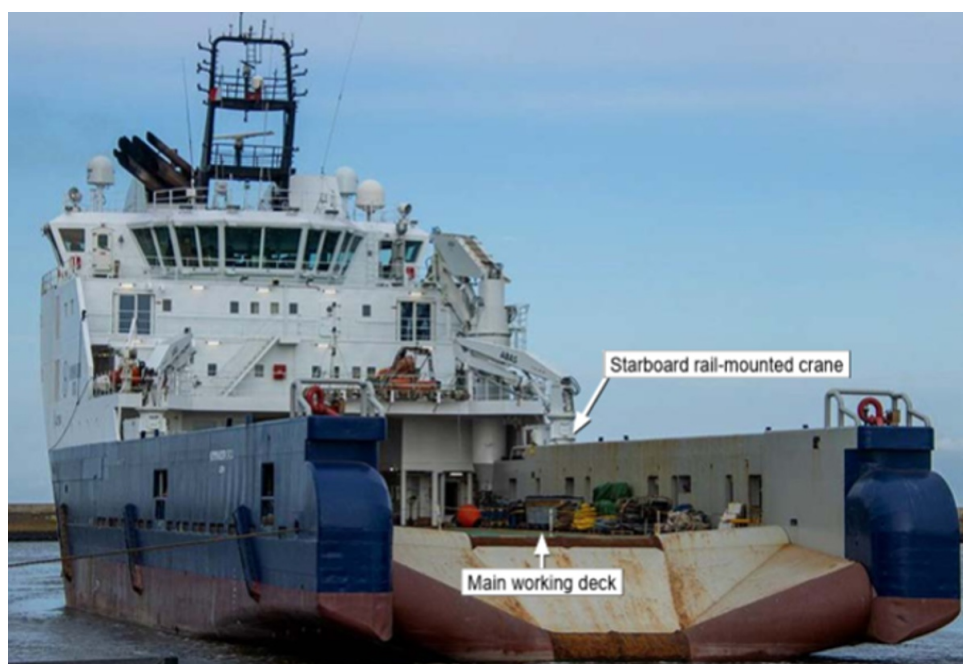
While operating the crane, the second officer stood with his left foot on the inboard bulwark and his right foot on the crane drive motor casing; this enabled him to see both the fitter and the load positioned 4m below on the main deck. Operating the crane from the local controls in the pedestal was unsafe. The 2/O's lower left leg became caught in the crane's rack and pinion traversing mechanism when he moved the crane aft for a lifting operation, and was crushed. A helicopter transferred the second officer to hospital, where his leg required amputation below the knee.

- The crane was not being operated in line with the manufacturer's instructions;
- The method of operation of the crane was unsafe;
- The permit to work did not include the hazards of working at height or working near unguarded machinery;
- There were no onboard procedures for operating the crane and the training given for its operation was consequently flawed;
- The SMS made no reference to ship-specific operating instructions – reference section 7 of the ISM Code.
