# Near Miss During Lifting Operations Air Hoist Creep – Model TCR2000/2

**SAFETY ALERT**

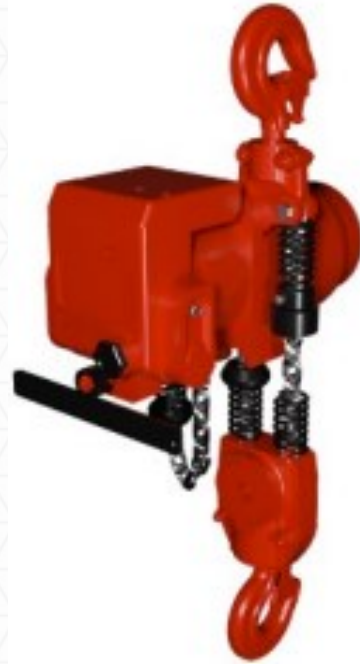
An issue was encountered offshore where the air hoist was found to be lowering by itself whilst under load.

Upon a full investigation carried out, it was found that the brake disc thickness measured was 7.1mm. The manufacturer's recommended minimum thickness is 7.3mm, and as new, these are 8.1mm.

A full strip-down and service were carried out prior to the hoist being used offshore. The engineer carrying out the service measured the thickness of the brake disc and deemed it fit for service.

If the brake disc is worn and becomes ineffective, then the hoist, when loaded, will not hold the load position. If this happens, the load will lower in a controlled manner due to the friction within the gearbox and the air motor working like a compressor when rotating in reverse under these circumstances (the load must be greater than 110 kg to overcome the friction within the hoist).

However, this is not a controlled lowering by an operator, and the load cannot be stopped by using an E-stop. This could have resulted in a fallen load that could have injured the workforce and damaged property and equipment. As the failure of the hoist brake, as described, is a mechanical breakdown during the hoist's normal operation, this became a reportable dangerous occurrence under RIDDOR.

Due to this incident, new safety measures have been implemented within the TCR-500 to TCR-2000/2 hoist models. The required thickness of brake discs throughout the fleet has been increased from 7.3mm to 7.5mm, and brake disc thickness will now be measured and recorded during every inspection. These new measures will apply to all hoists.
