Near miss: narrowly avoided fall from height due to missing deck gratings

Safety Flash Published on 20 February 2025 Generated on 3 April 2025 IMCA SF 03/25

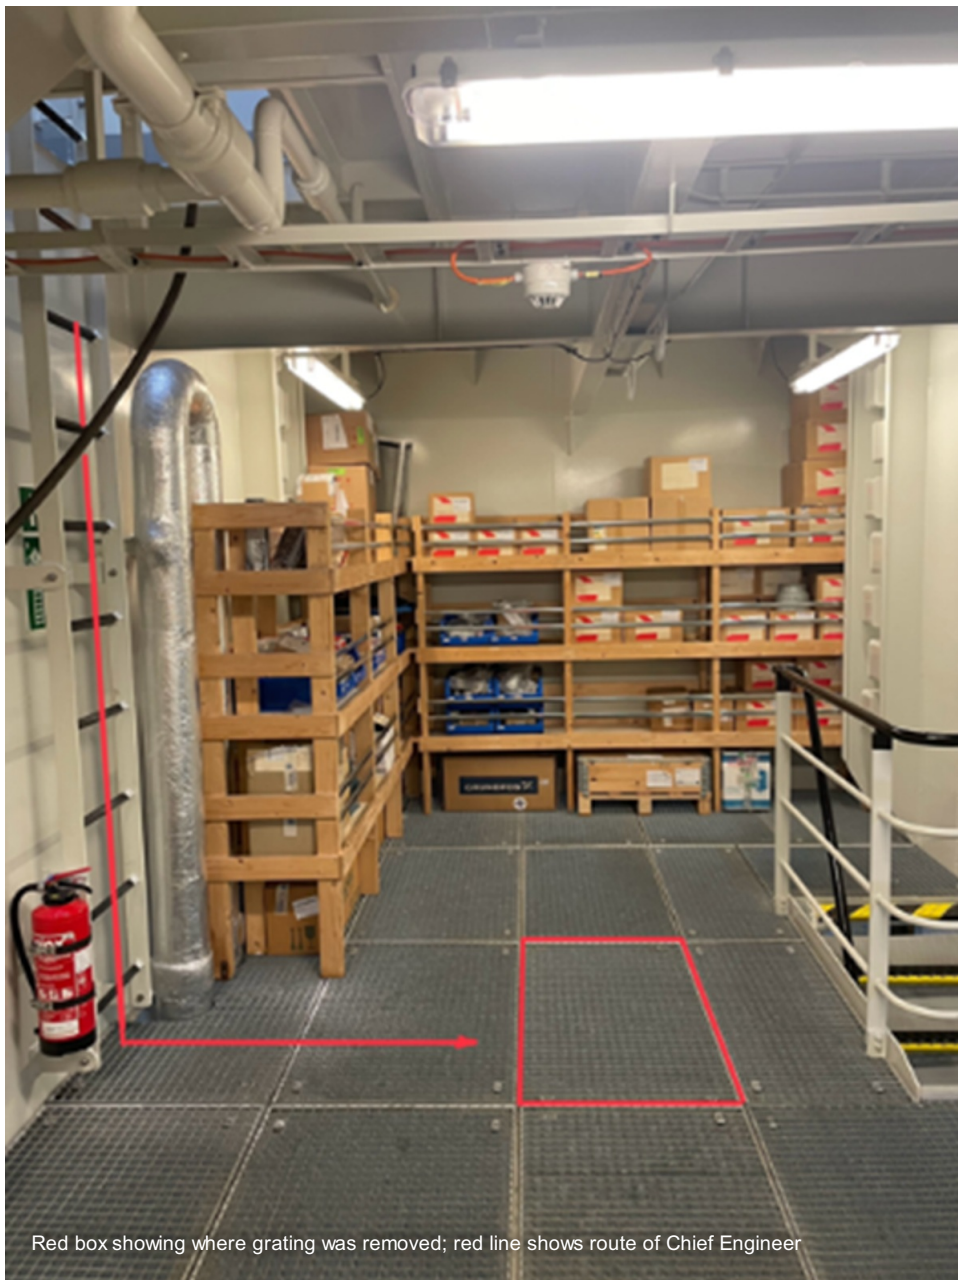
During a docking, a grating was removed from a mezzanine level in the bow thruster space to allow lifting of machinery components from the bottom plates. Signs and barriers were installed at the bottom of the companionway leading up to the mezzanine, and around the missing section of deck itself. On completion of the lifting operation, the yard contractors removed the lifting equipment, along with the barriers around the hole. The barrier across the stairs remained in place, but the grating was not replaced at this time.

Subsequently, the Chief Engineer, on the way to inspect the work, entered the mezzanine level using a vertical access ladder directly from the forecastle, which had not been signed/barriered. At the bottom of the ladder he turned, took one step, and his next step was into the hole. He only managed to prevent a fall of 4-5m by instinctively reaching out to break his fall, ending up supported by his forearms and one leg, with the other hanging through the hole.

Red box showing where grating was removed; red line shows route of Chief Engineer

- The possibility that workers would use the vertical ladder had not been considered.
- It is unclear why, after removing the lifting gear and worksite barriers, the grating had not simply been replaced immediately, there being no further work planned.

- Lack of hazard awareness in missing the possibility that a 'secondary' access route could be used.
- The hierarchy of risk controls was not applied – replacing the grating straight

away would have eliminated the hazard, as well as the need for any signs and barriers at all.

The incident was investigated by the yard, and the need for vigilance in planning tasks was stressed at inter-departmental work planning meetings. No similar events were observed during the remainder of the stay in dock.

Preventing the use of the vertical ladder (which formed part of an emergency escape route) for general access was considered, but this was deemed to be a practicable, safe means of access, with no more risk attached than several other vertical ladders around the ship.
