## High Value Learning

*Hydrocarbon Leak due to Corrosion of Incorrect Material Seal Ring*

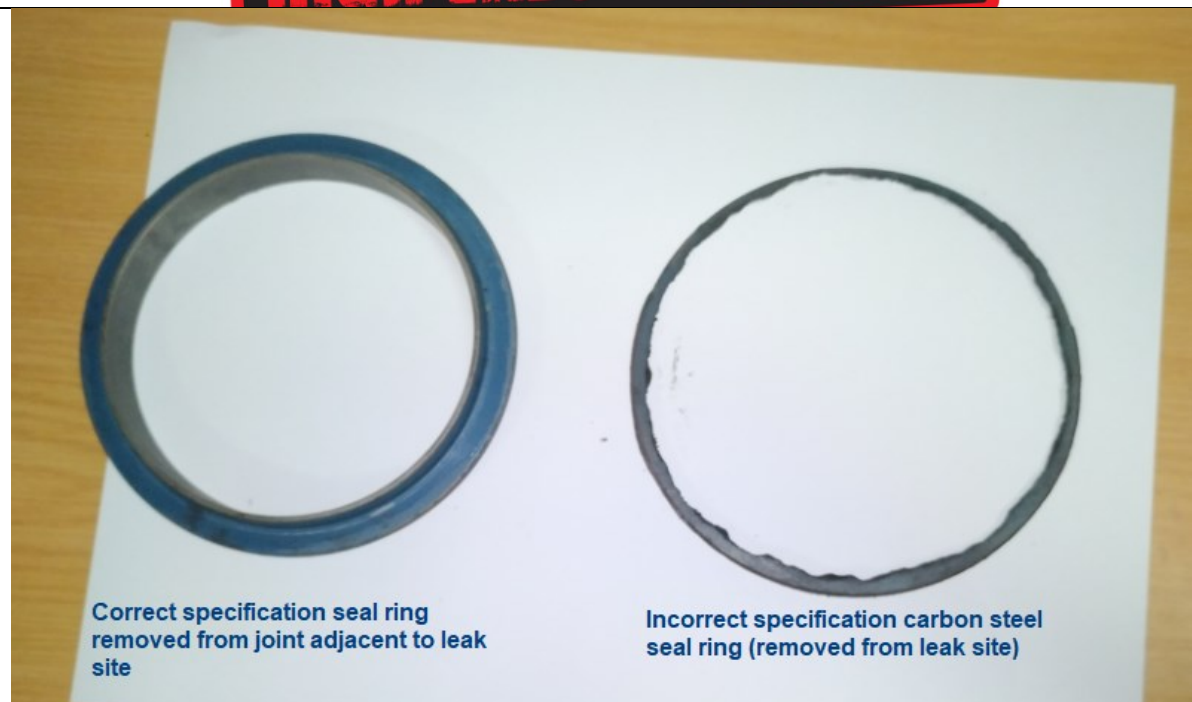
*Subsequent investigation revealed the seal ring installed at the leaking joint was the incorrect material specification for the piping class. The seal ring was confirmed by material testing as carbon steel and was significantly corroded (see supplied photograph). No corrosion or damage was present on the connector hubs, clamps or bolts. By investigation of the seal ring installed and plant records, it was determined that the seal ring was installed during the original plant construction (and had been in service for approximately 30 years).*

*NOTES: The supplied photograph shows the corroded seal ring (and cause of leak). The second seal ring shown was removed from an adjacent hub connection to the leaking joint. The second seal ring is the correct material specification and same size specification as the corroded seal ring. The second seal ring was also determined to have been installed during original plant construction and in service for approximately 30 years.*

*Risks associated with possible historic installation of incorrect specification seal rings and how these are addressed through any asset integrity management strategy*

*Any prior response to industry alerts reporting historic installation of incorrect specification seal rings / gaskets.*

*Quality control and competence arrangements to ensure correct material identification and use.*
