IMCA Safety Flashes summarise key safety matters and incidents, allowing lessons to be more easily learnt for the benefit of all. The effectiveness of the IMCA Safety Flash system depends on members sharing information and so avoiding repeat incidents. Please consider adding safetyreports@imca-int.com to your internal distribution list for safety alerts or manually submitting information on incidents you consider may be relevant. All information is anonymised or sanitised, as appropriate.

1 Hand and finger injuries

2 Crewmember suspended above deck by lifting equipment

4 Engine failure and subsequent engine room fire

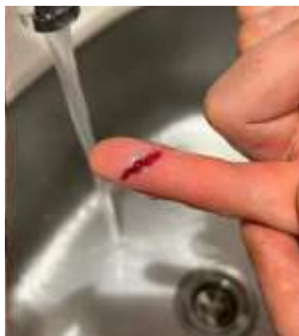
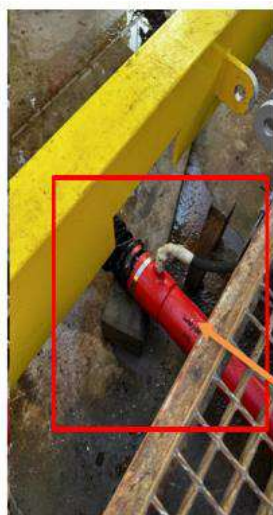
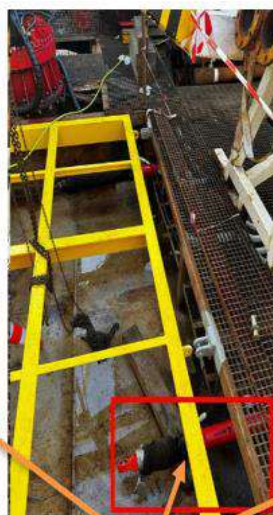
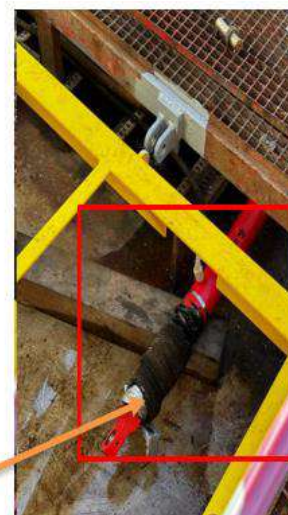
A worker suffered a crushed right little finger whilst moving the moonpool door ram. The ram was placed on a flat pallet at the time, so the potential for movement was high. The movement of the ram crushed the worker's finger causing a split in the skin and a fracture.

- Although a toolbox talk had been conducted, including a basic risk assessment for manual handling activities, the full scope of the work had not been adequately assessed;
- No-one stopped to think and reassess the additional hazard: that the ram would move, was not foreseen.

Moonpool door opening ram post incident

- Look at the ENTIRE situation – consider the use of ABBIE (Above, Behind, Below, Inside and Environment);
- Ensure task-specific risk assessment is sufficiently thorough;
- If the job changes – **STOP**, re-assess, if necessary, activate a “Management of Change” process;
- Remember you can and should **STOP THE JOB** if you think it is unsafe – don’t just carry on!

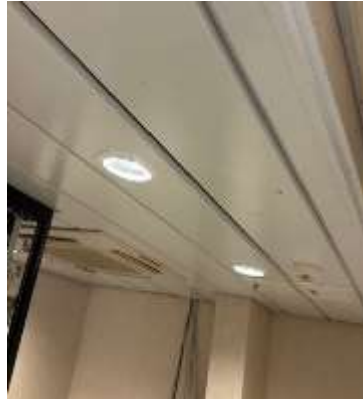
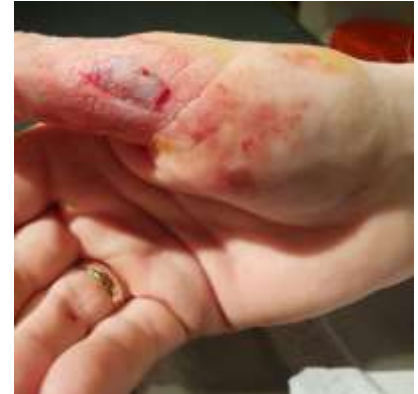
When removing the ceiling plates in the main deck instrument room, a worker cut his hand on a ceiling plate, which had sharp edges. The worker was not wearing gloves – as should have been the case. Wearing gloves would have prevented the injury.

- Watch where you put your hands! It's so easy just to do it – **DON'T! STOP and THINK;**
- PPE is there for a reason – **use it.** Gloves you can replace: fingers and hands, you can't.

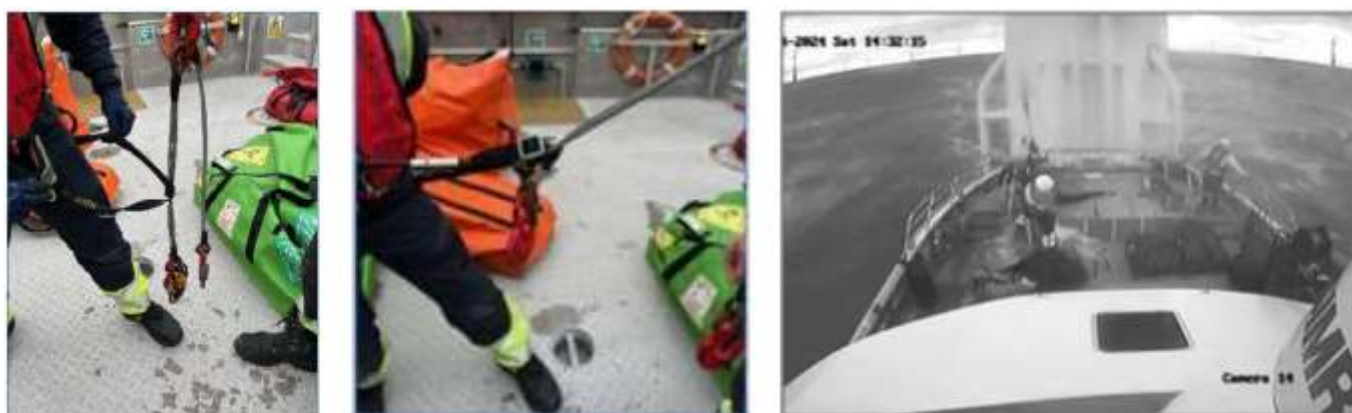
On a CTV (Crew Transfer Vessel), a crew member’s work restraint lanyard became entangled in a hook and wire sling, and the crew member was lifted off the deck. The incident happened during lifting operations offshore at a wind turbine. A deckhand and trainee deckhand were both on deck receiving a load of four lifting bags, attached by a three-leg wire sling. The trainee landed the load, detached the load from the slings, and signalled the crane operator to raise the lifting equipment. As the hook and wire sling raised, it became entangled within the trainee’s work restraint lanyard, and he immediately gave the signal to emergency stop. The crane operator neither saw nor heard the signal, so the trainee was lifted from the deck. The trainee’s weight freed the entanglement, and the crew member fell unharmed between 1 to 2 metres onto a group of lifting bags on deck.

- The crew member’s lanyard was worn in a loose position where it could become easily snagged;
- The crew member was too close to the lifting equipment when it was raised, without a tag-line or holding onto the equipment to guide it free of entanglement;
- The crane operator neither saw nor responded to the emergency stop signal.

The potential consequences of a major injury or worse were present had the crew member been lifted higher, outboard of the vessel, or without a cushioned landing.

- Ensure that lanyards are properly secured and are kept away from entanglement / entrapment hazards, such as lifting accessories, moving parts, etc.;
- Ensure that all lifting accessories are fully clear of any potential snagging points, including the path of any lifting accessories, before instructing the crane operator to raise the equipment;
- Step away from any lifting accessories or manually guide any lifting accessories away from you before signalling a lift, to prevent any snagging;
- Never assume that someone will be aware of a hazard, especially less experienced colleagues – always speak up and be prepared to **STOP THE JOB**;
- Always ensure that clear lines of communication are open during the lift and during the recovery of rigging equipment;

- Always pay attention during a lifting operation, even where there is no load or the lift is underway, and the lifting accessories are believed to be clear of obstructions.

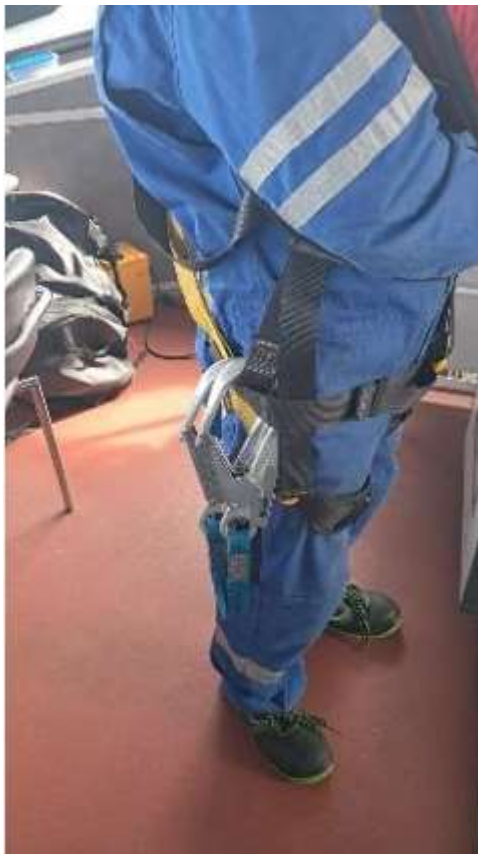
After a routine lift had been landed over the stern to a CTV foredeck, the CTV crew member gave the signal to raise the crane hook. While the hook was being raised, he stepped forward to guide the slings clear of snagging points on the CTV. A tag line attached to the slings snagged or became entangled on carabiners connected to his harness, and he was lifted about 0.5m clear of the deck. The lift was quickly stopped by the banksman, and the crewman lowered back to the deck unharmed within a few seconds.

Hook position on the worker's harness before entanglement with tag line

- Think about where you're standing on deck, particularly during mooring or lifting operations.
- The CTV operator is reviewing procedures and discussing the incident with crews.

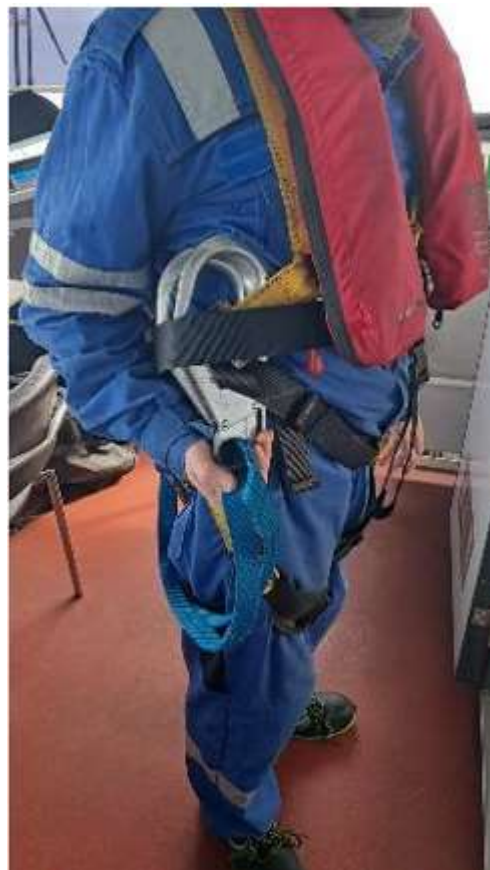
Hook position on worker's harness once the tag line got tangled

- Right? There was a quick response by the banksman and the crane operator;
- Wrong? The crew member was in a hazardous place or position without appreciating the fact.

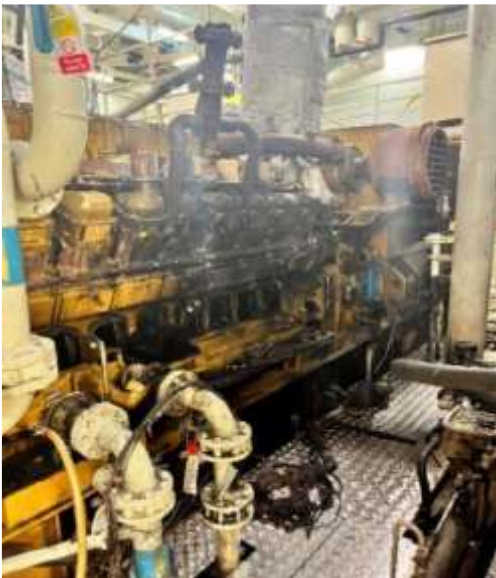
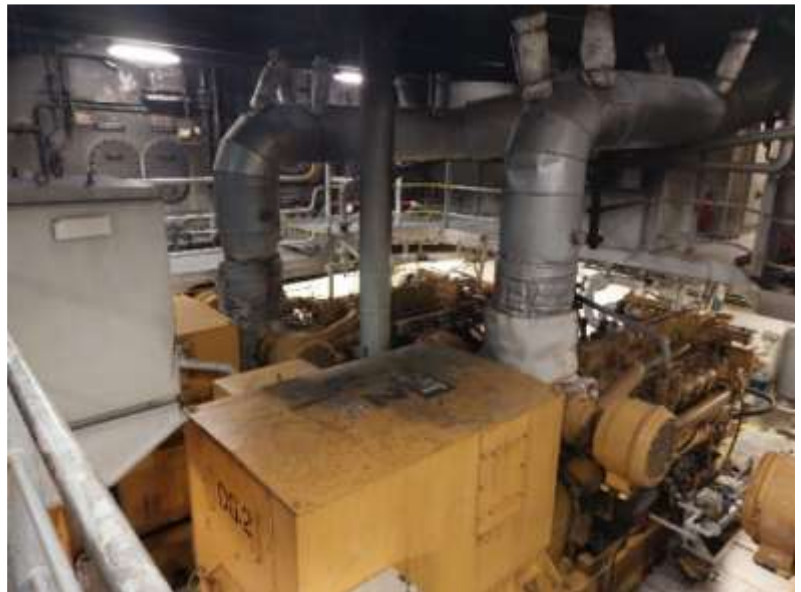
There was a catastrophic failure of a diesel generator on a vessel working offshore. The failure of the generator led to engine components being ejected by force, which in turn started an engine room fire. The Hi-Fog fixed firefighting system was activated, non-essential personnel were mustered, and onshore emergency response teams were assembled. Additional emergency procedures were deployed with fire teams instructed to assess the engine room conditions. Onshore emergency response teams stood by to support the vessel in case of need. The fire was extinguished with limited damage to any further machinery.

- Catastrophic failure within one diesel generator caused the engine room fire;
- Another diesel generator was damaged as a consequence of the force of ejected materials/components;
- The Hi-Fog fixed firefighting system worked and provided good extinguishing capabilities and allowed emergency teams early access to affected areas;
- Fire-suits and associated equipment provided good protection from heat and fire and communication and firefighting personal protective equipment (PPE) proved very effective;
- The offshore vessel management team and the emergency teams onboard demonstrated highly effective leadership in managing their response, addressing problem solving during the emergency as well as acting in a quick, decisive and effective way.

- A Thermal Imaging Camera could be useful in support of firefighting teams;
- Ensure that persons on emergency response teams ARE familiar with all applicable emergency procedures;

- Introduce fire booklets at each fire station. These should give details on the general layout, equipment, search routes, isolations, length of hose runs of each major area or compartment of concern;
- Review and revise emergency response plans to determine if the chosen communications are correct and ensure that shore-based management are informed at the earliest opportunity.

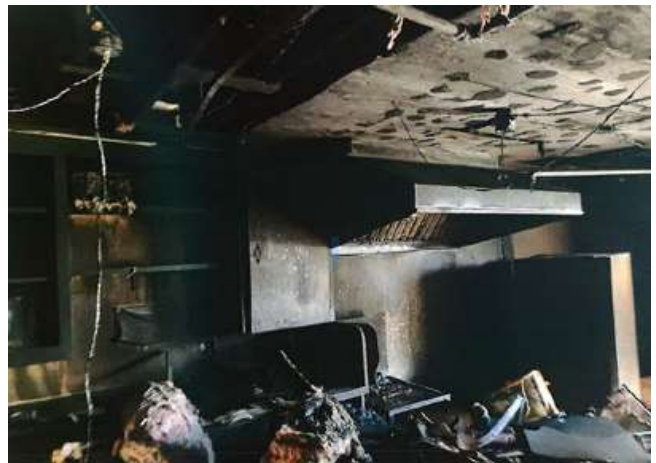
Following inspections on production and well operation sites in the Gulf of Mexico and an analysis of compliance and incident data since 2022, BSSE discovered multiple high potential fires associated with welding and burning operations. Several critical issues were identified requiring attention to ensure the safety and integrity of ongoing operations. In one incident, evidence suggests hot slag from a cutting torch pierced the underside blanket barrier of the living quarters building. The residual heat likely caused the wood subfloor to ignite.

- Hot work being conducted close (less than 10m) from equipment containing hydrocarbons;
- Inadequate housekeeping practices, with material like cardboard boxes found within 10m of hot work areas;
- Tools for fire prevention, such as fire extinguishers and portable gas detectors, not properly identified as necessary;
- Offshore personnel not following safe welding and hot work procedures;
- Inconsistent and infrequent training for personnel engaged in hot work and/or welding – that is persons without training or coding to the appropriate industry standard, were engaging in hot work;
- Hot work permits and Job Safety Analyses (JSAs) listing the same person to perform fire watch **and** perform the hot work!

Fire spread to living quarters following hot work

- Ensure there are no flammable materials or hydrocarbons or other fire hazards nearby when preparing for hot work;

- Ensure the rating, current condition, and placement of fire protection barriers mitigate the potential risk caused by hot work, including personal protective equipment;
- Ensure a heightened level of planning specific to the hazards associated with welding and burning operations – **stop and think for a minute, are we doing this safely?**
- Check that training and competence requirements for persons doing hot work are in place and that they meet appropriate industry standards;
- Hot work operations should be inspected by someone in charge before starting work; adequate supervision and fire watches should be in place throughout;
- Ensure that all persons involved in hot work attend and participate in pre-job JSA meetings and toolbox talks and that they fully understand what is required of them.
