Gas turbine small bore fitting failure

SAFETY ALERT

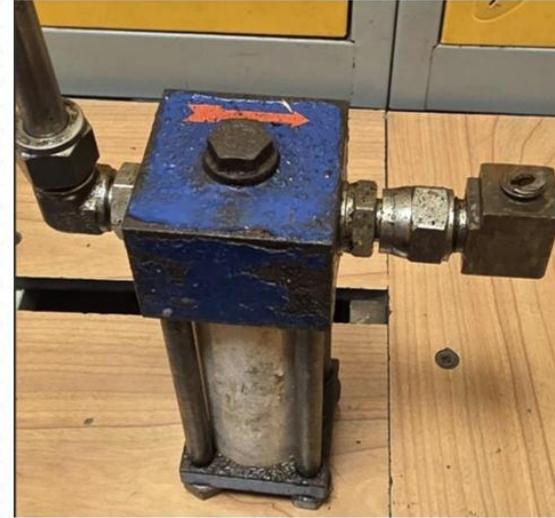
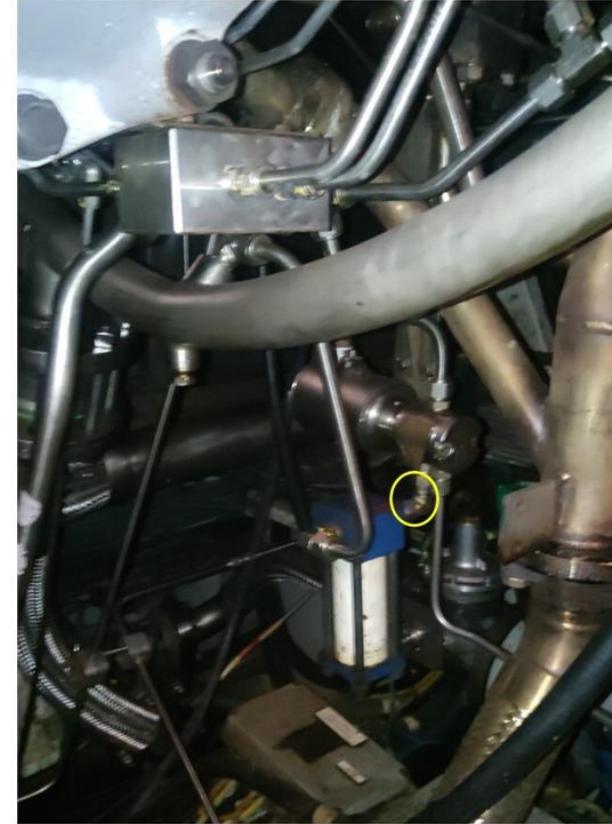
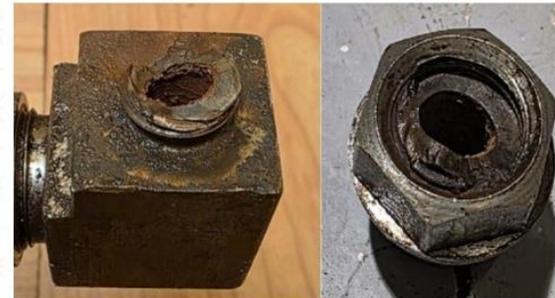
A fuel gas system leak test revealed a failed SBT fitting/ elbow connecting a purge gas filter to a purge valve.

Investigation ongoing but possible contributing factor for the failure is thought to be fatigue induced failure mode due to lack of supports on either the purge gas filter or purge valve or both.

Ensure adequate inspection of small bore connections on gas turbine fuel systems and adequate support of the small bore connections and system components. It is possible original equipment manufacturers may not have installed adequate small bore tubing/component supports and cycle fatigue may mean failure can occur within the package design life.
