# Serious foot injury on walk-to-work gangway

**SAFETY ALERT**

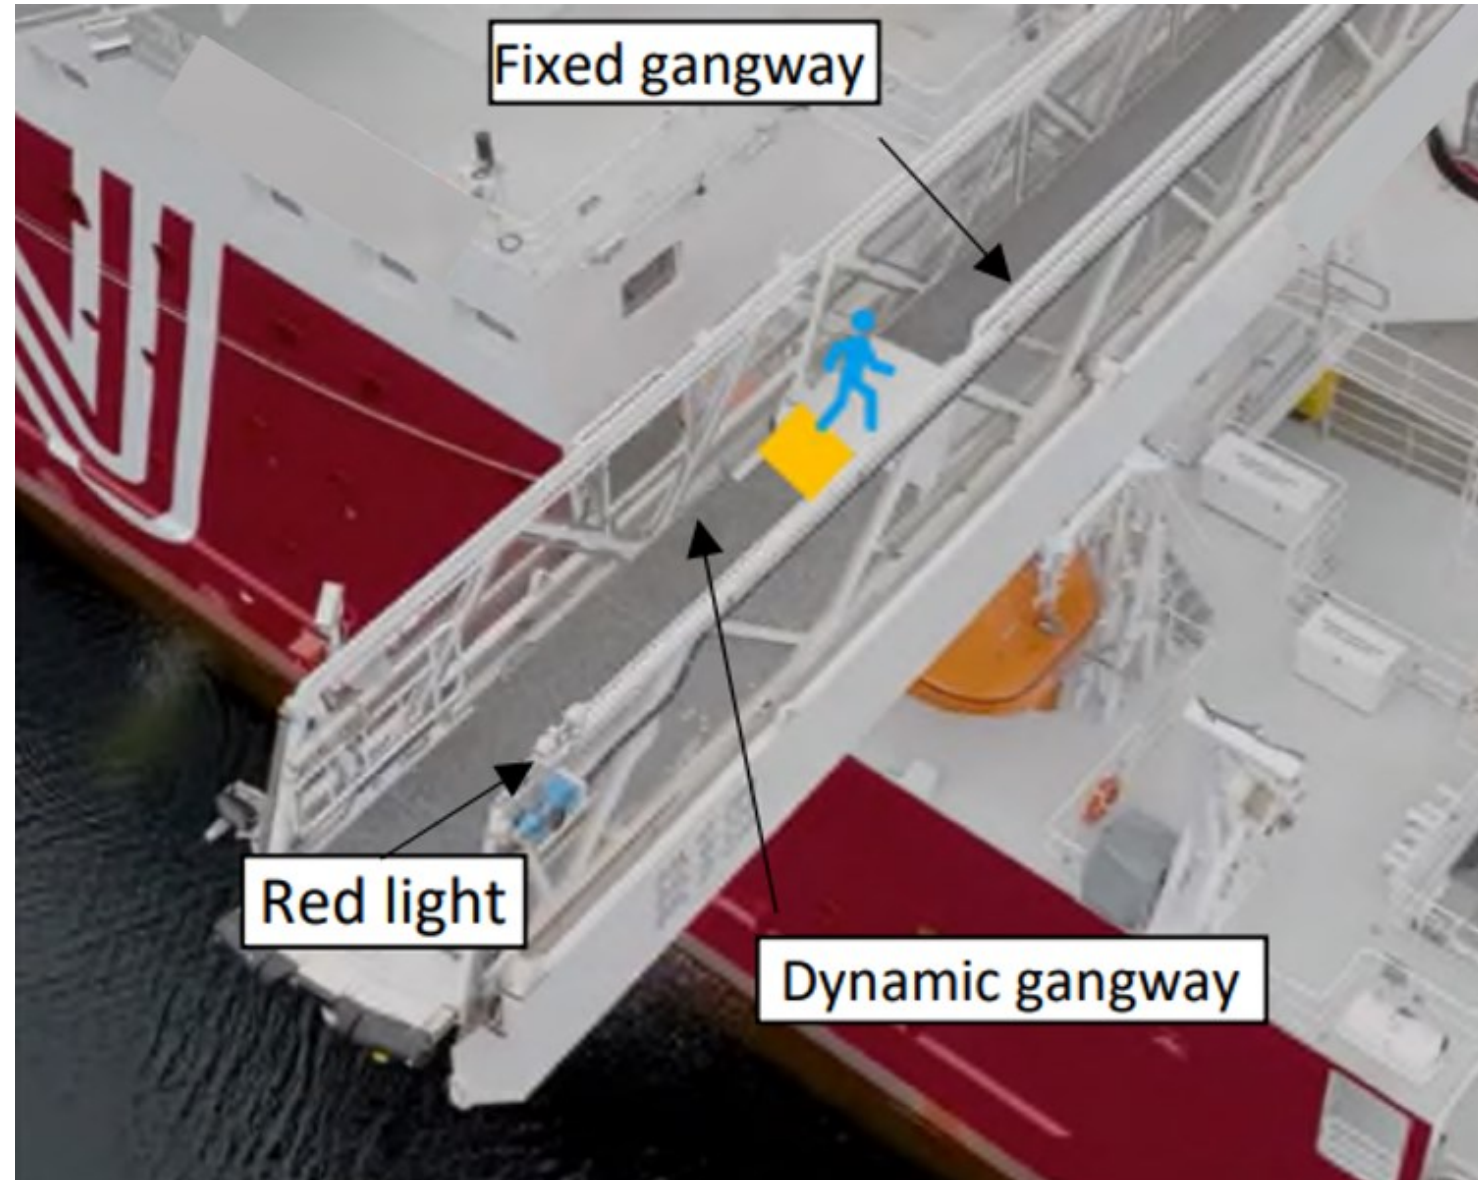
- This incident occurred when the IP entered the dynamic section of the gangway. The IP's turning motion and foot placement, while attempting to return to the vessel, combined with compensating movements within the dynamic section of the gangway towards the static section, likely resulted in the IP's boot becoming trapped between the air gap and the grating of the dynamic part. This entrapment occurred as the dynamic section was adjusting to sea conditions by moving towards the static part.
- The gangway was inspected after the incident and was found to be functioning as intended.
- No technical defects have been identified. The gap between the static and the dynamic sections of the gangway was measured to 20 mm.
- The vessels dynamic positioning system and associated gangway system were both operating within allowable parameters.

- Adjustment of the horizontal air gap between the fixed and mobile part of gangway to minimum allowable gap (performed by gangway manufacturer).
- Further strengthening of safety routines and awareness for personnel using the gangway, including:
