Description of incident:

A piece of external cladding fell from the North-West corner of the drilling derrick middle stem, weighing 2.25 Kg and measuring 1.92m by 0.11m. It landed on the drill floor, 34 meters below. No persons was on the drill floor, and no drilling or crane operations were taking place at the time.

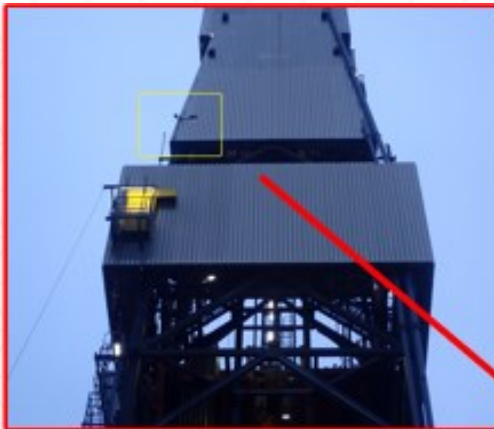
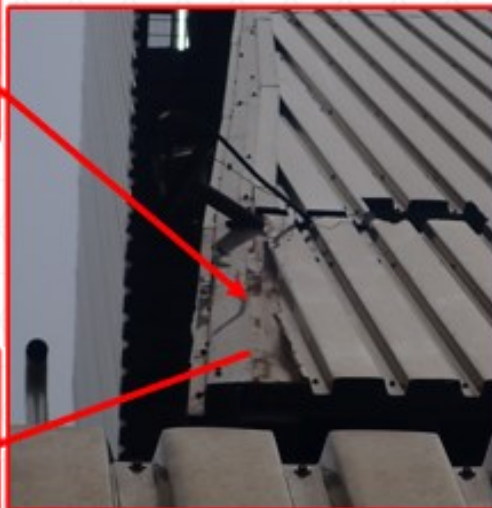
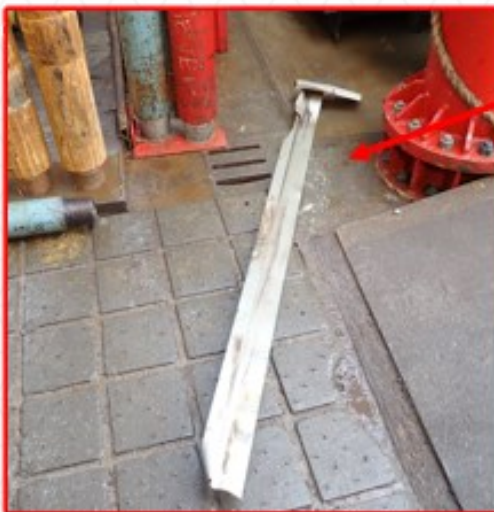
During investigation, it was discovered that the cladding was modified during installation, and no screws were used to fix it to the steel members. Instead, it was attached with pop rivets. This was different from the original design, and subsequent drawings were not updated to reflect the current build. As a result, it was difficult to detect the anomaly during inspections and maintenance.

The weather conditions and deviation from the original design caused the cladding to fall.

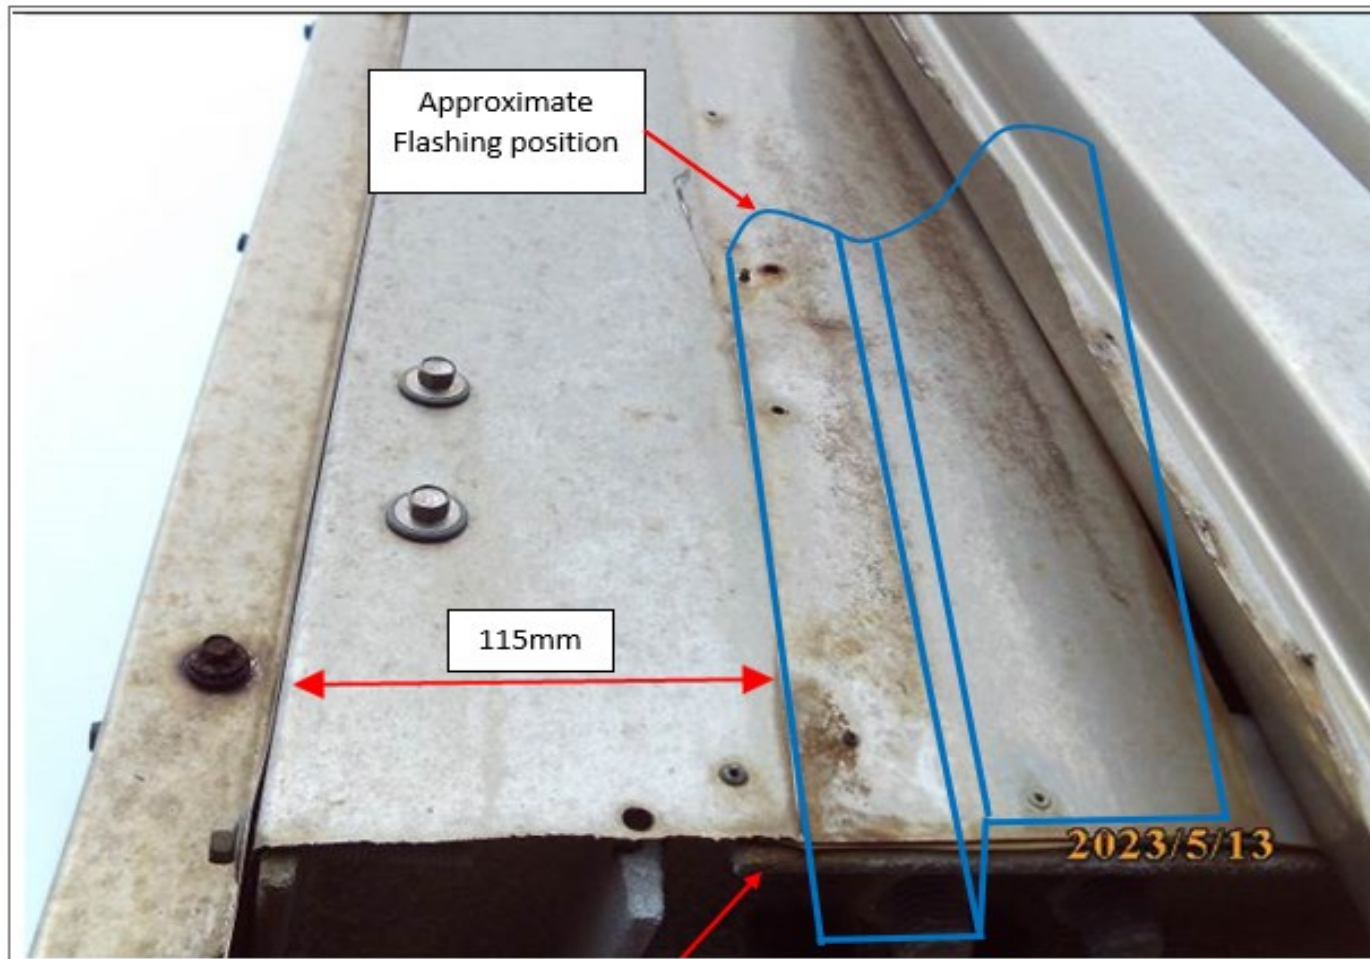
There was steelwork behind the Flashing at the bottom.

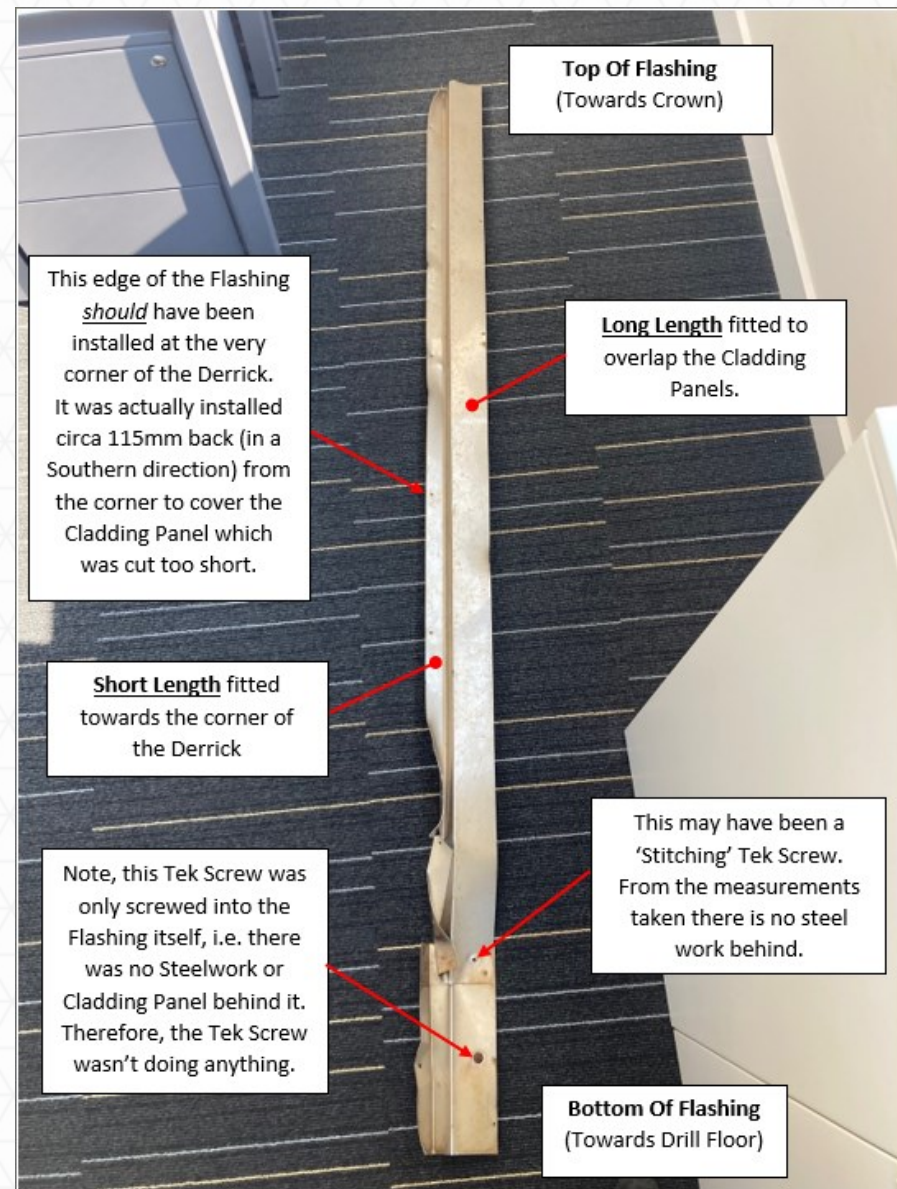
Superimposed position of cladding – indicating not in correct position at corner of derrick
