Learning from Incidents

80/90ft Wireline Mast Column Stop Plate
falls 65ft / 19.8m (HiPo)

Published by **DROPS** (Dropped Object Prevention Scheme) JUNE 2025

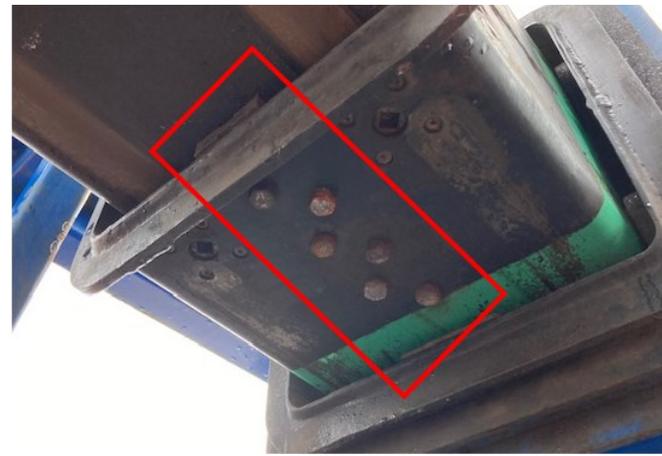
Underside stop plate correctly installed. Torque of bolts was checked at the time of visit and found to be correct

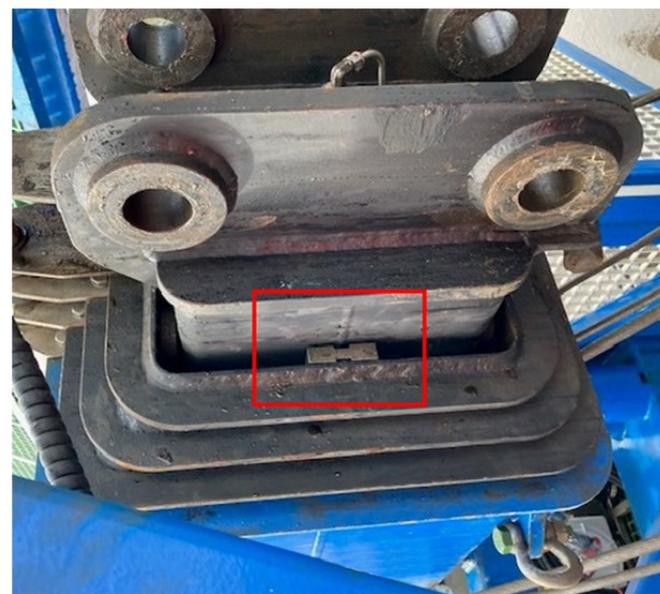
Other stop plate correctly fitted with around 2mm of clearance.

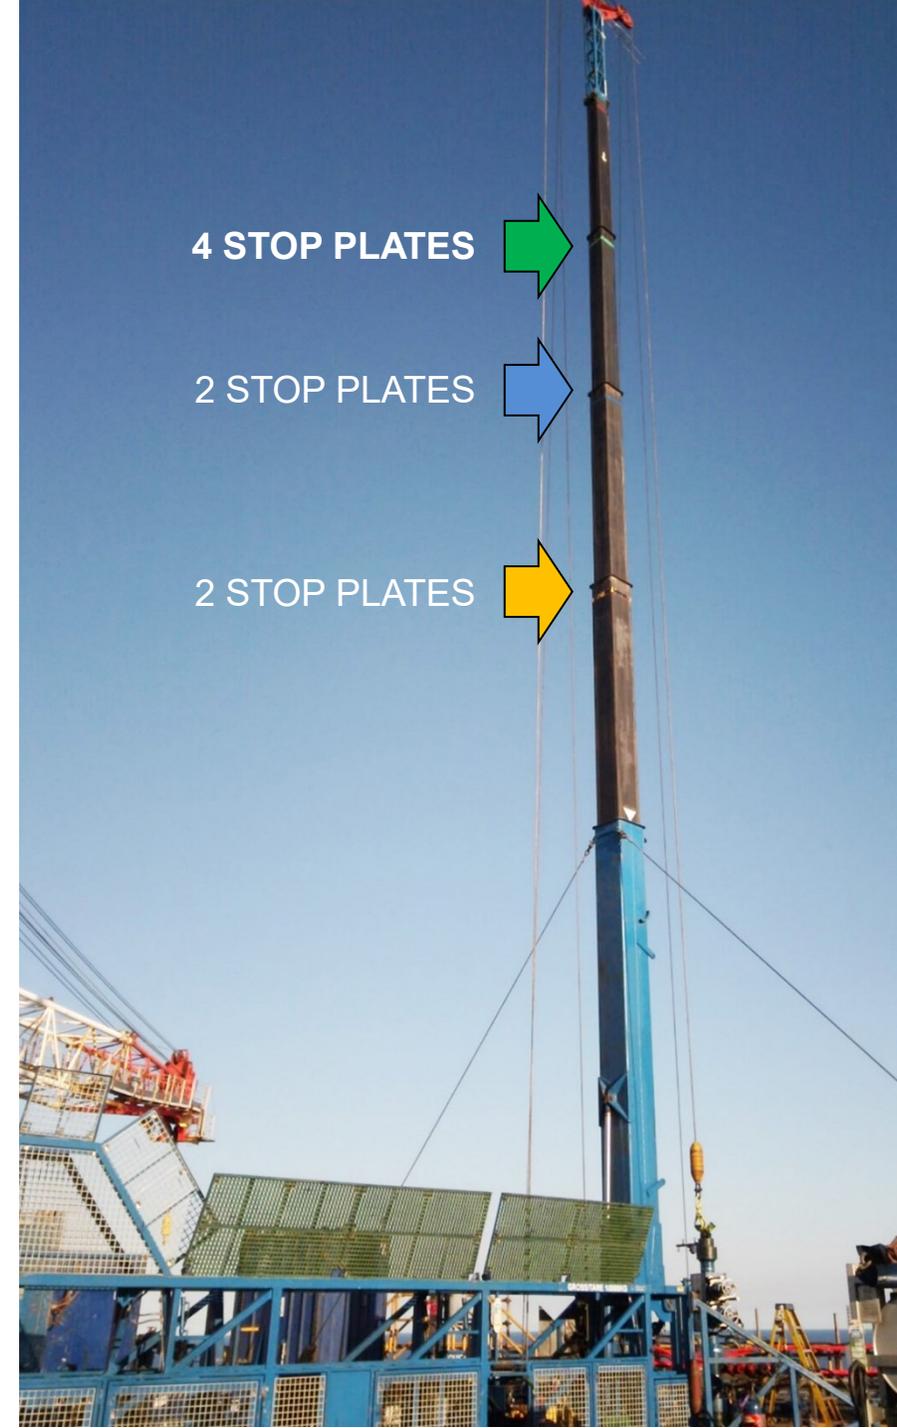
The end (green) column is the only column to have 4 stop plates in place. These are secured to the column section each with 6 x 12mm grade 12.9 Carbon Steel bolts.

The blue and yellow columns only have 2 stop plates and are of a different design and cannot be fitted in any other orientation.

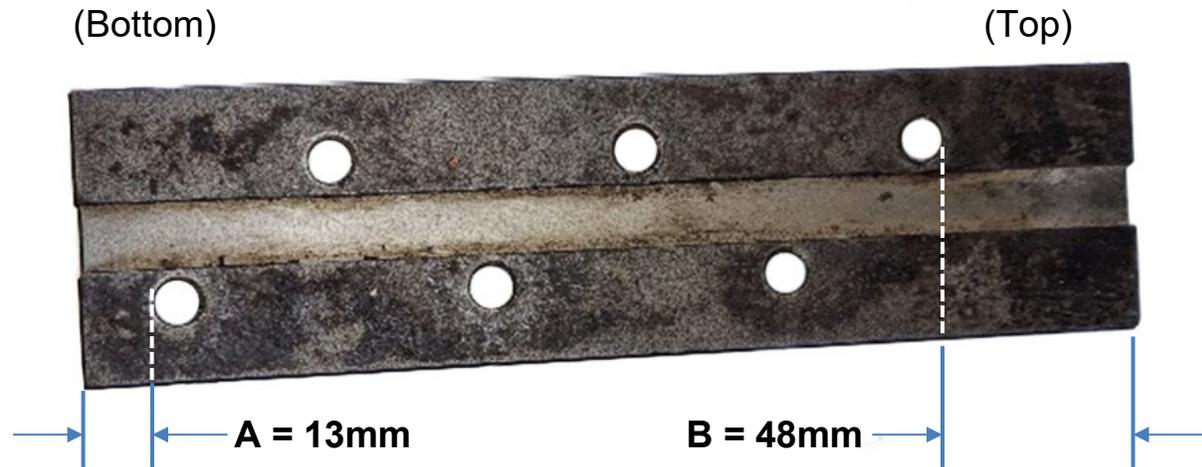
STOP PLATE

When installed correctly, distance **A** would have been at the bottom of the stop plate whilst the mast was in an upright position.

Due to the incorrect orientation, distance **B** was at the bottom of the plate, **leading to a 35mm difference between the incorrectly installed plate and the other 3 plates** (which were correctly orientated).

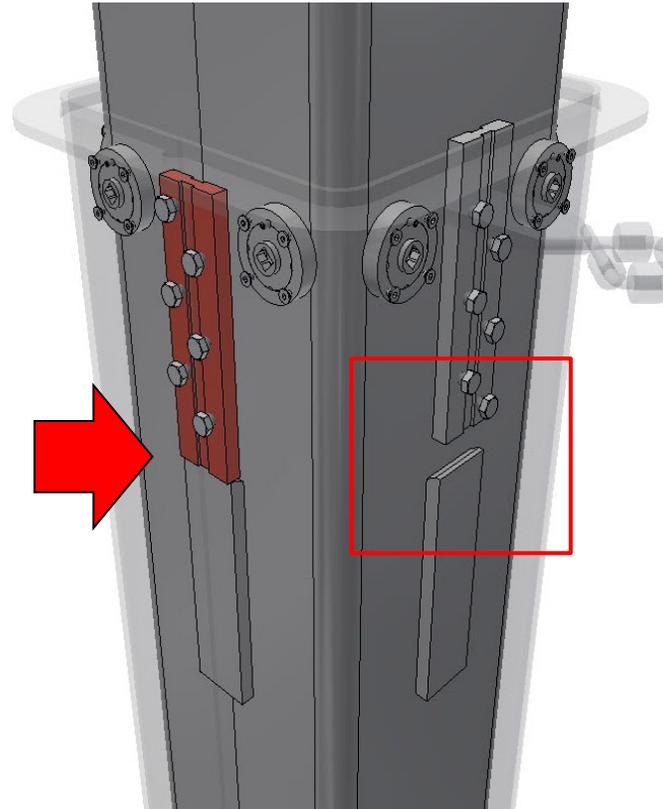
Incorrect Installation

In the incorrect orientation, the plate sits 35mm lower than the other 3 plates on this column.

Due to this, when the mast is erected this stop plate is being impacted alone, without the other 3 being in contact.

35mm was the distance that the telescopic cylinder travelled when the bolts sheared.

In the incorrect orientation it sits below the collar level (by 35mm).

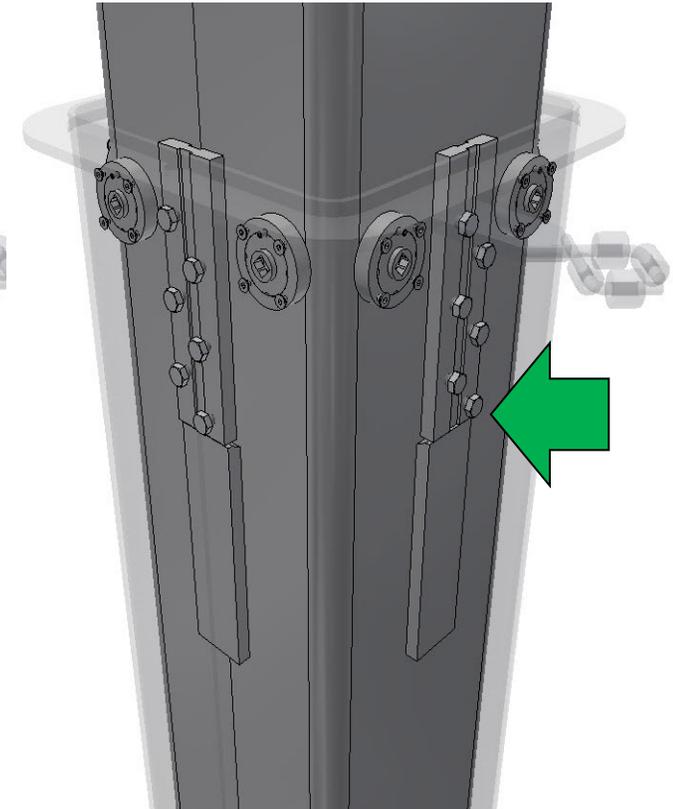
Correct Installation

In the correct orientation the plate sits flush with the section collar.
