## Description of incident:

## **Master Link Failures**

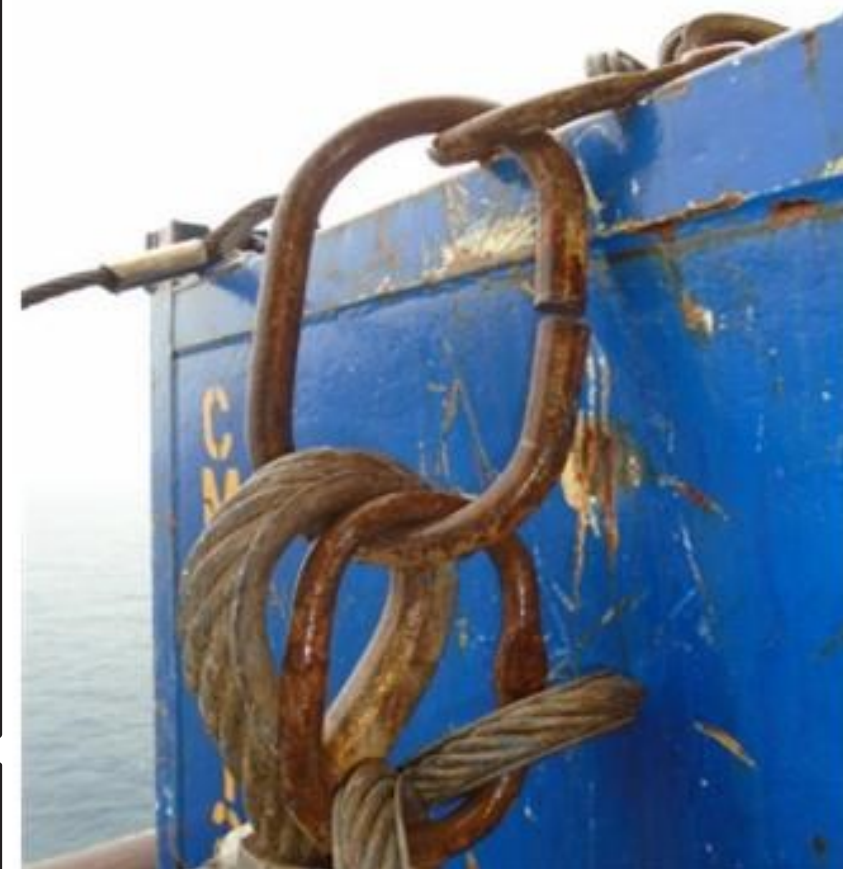
After landing a mini-container (CCU), one of the deck crew observed that the master link which attaches the lifting bridle onto the 5<sup>th</sup> leg, had parted at the welded joint.

There appeared to be no physical damage to the link or the lifting set that would have indicated the assembly had been subjected to an overload.

The master link was approximately 9 years old and the last MPI of the weld area was undertaken on the 15<sup>th</sup> November, 2023. The master link will be sent to a metallurgical laboratory for examination

Until the results of the metallurgical examination are available, emphasis should be placed on the pre-use inspection of all master links fitted into offshore container sling sets. Visual inspection in the area of the welded joint should be undertaken prior to shipment and prior to back-loading.

A further communication will be issued by Step Change in Safety, following review of the incident investigation report. In the meantime, **High Value Learning (5-July, 2024)** remains valid and particular attention should be given to a visual inspection of the master link weld.
