Safety Alert

Number: 25-01

Subject: Vessels Gangway Fell from Quay

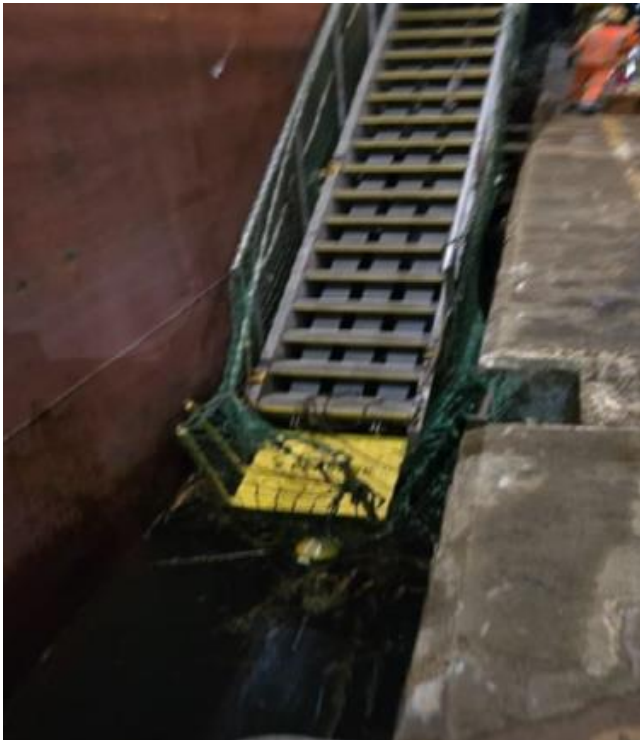
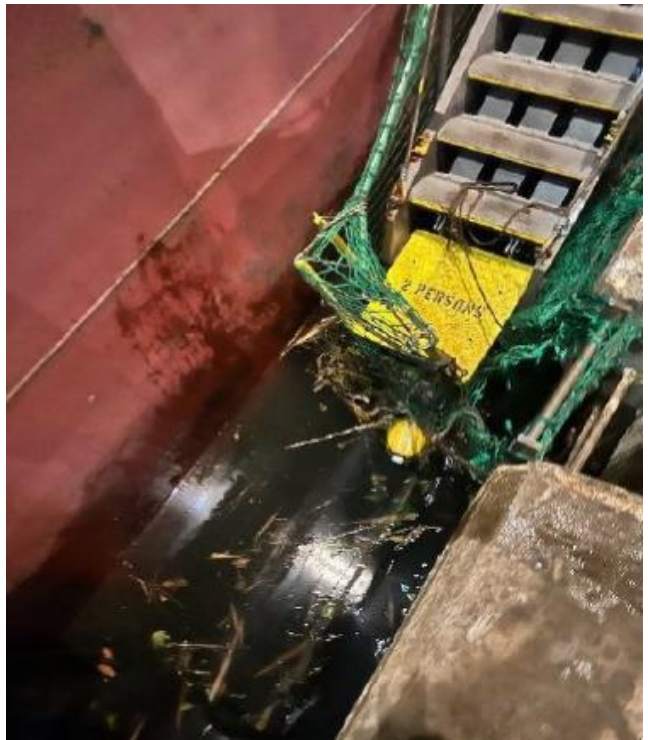
Photographs / Supporting Information

Movement of the vessel on a tidal berth resulted in the vessel's gangway resting partially over the quayside ladder void. As the five lashers were ascending the gangway, the gangway moved from the quay wall, swinging back to the side of the vessel and dropping approximately 2-3 meters below the quay wall (images below).

- Tidal movement of the vessel caused the gangway to move position, and the gangway roller encroached on the ladder void, causing it to be less stable.
- Vessel gangway procedure requiring supervision at all times, was not followed. At the time of incident, the gangway hoist wires were slack enough to for the gangway to drop approximately three meters.
- Markings on the quayside, around the ladder were faded and of insufficient colour and size to raise awareness of potential quayside hazard.
- The IP was not wearing his chinstrap when going up the gangway resulting in losing his helmet during the fall into the water, where he narrowly missed striking the quayside fender.
- A large painted sign showing the maximum load of the gangway was faded.
- There was no life buoy present at the lower part of the gangway supplied by the vessel as per HSE ACOP.

- Position vessel gangways away from ladder voids.
- Review operations to ensure that written procedures are followed in practice.
- All employees must wear PPE correctly.
- All signs on the vessel and on the gangway must be clear in providing information regarding maximum load, capacity and potential hazards.
- Carry out pre-work gangway and vessel checks before vessel operations commence and at suitable intervals throughout.
- Encourage the use of stop work authorities if unsafe situations are observed.
- Review markings for quayside hazards such as ladder voids to ensure they are suitable.
