Safety Alert

Number: 25-04

Subject: Spill During Bulk Transfer

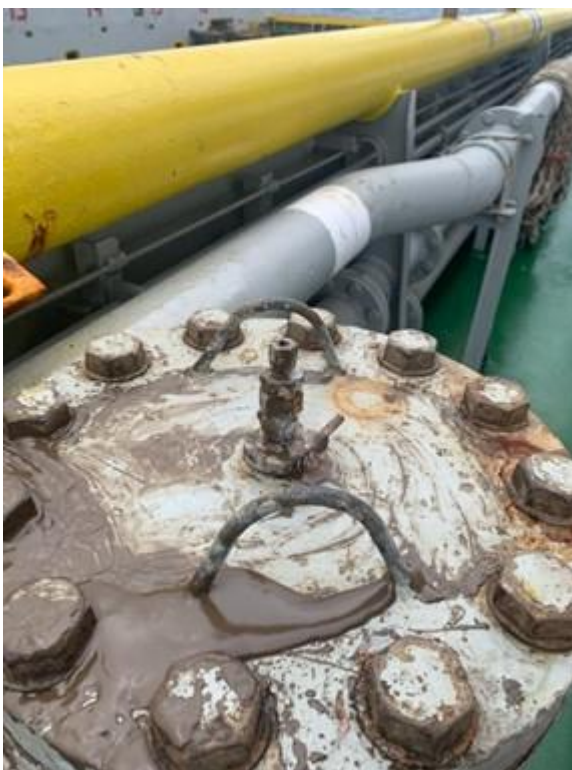
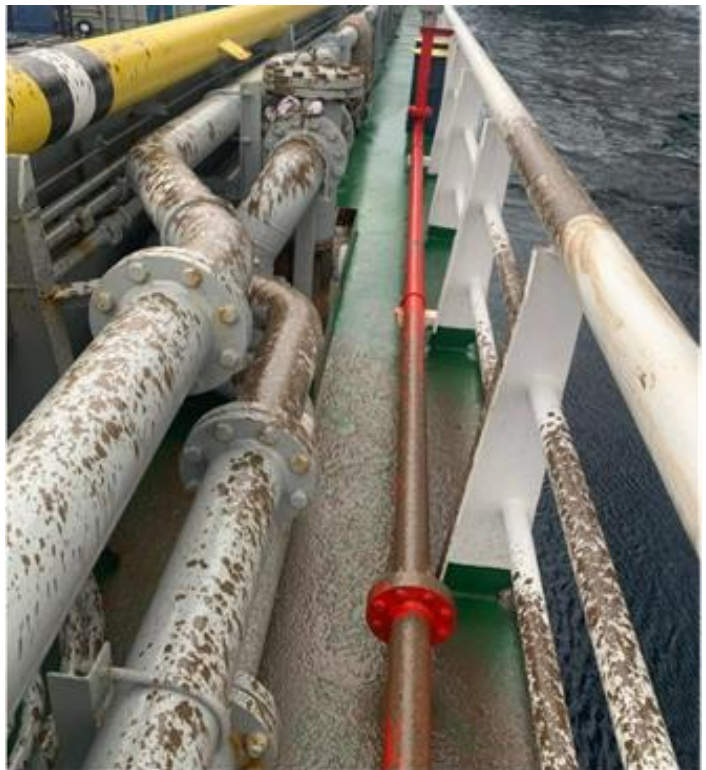
During offshore operations the vessel was lined up to receive Offshore Contaminated Bulk Liquid (Slops) from the rig. When the transfer started the bridge crew noticed a spray / mist from the strainer on the port side.

An "All stop" was called and rig quickly stopped the transfer. Approximately 4 litres were estimated to have leaked onto the vessels deck through an open strainer vent cock and 1 litre is estimated to have been sprayed onto the sea.

After recent strainer checks and maintenance the vent cock had not been closed. Pre-start checks for the bulk transfer did not capture the fact that the vent cock was open.

The wet bulk transfer risk assessment, toolbox talk and checklist have been updated to include checks of the strainer vent cocks.

Planned Maintenance System task updated to include confirming all valves are in the correct position on completion of maintenance.
