# Safety Alert

**Number: 25-06**

**Subject: Confined Space Incident**

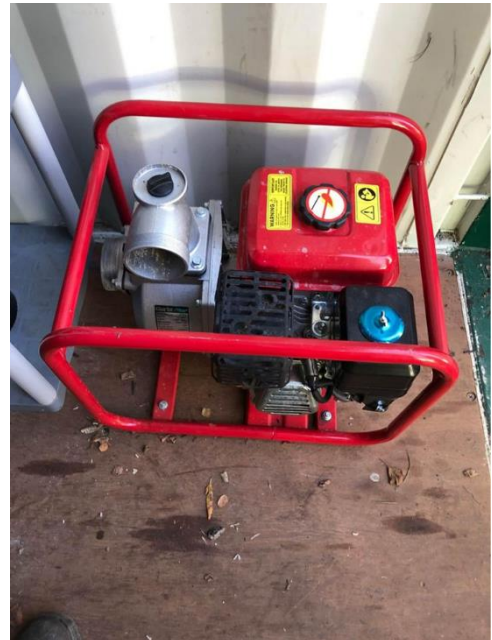
On returning to the vessel the Master discovered the engineer, and deckhand had taken the salvage pump into the hold and both were found unconscious. The Master immediately called the emergency services for assistance, while on the call unknow to the Master the cook entered the hold to help his colleagues, and he too became unconscious.

- Although instructed not to, the engineer operated the petrol driven salvage pump within the hold.
- There were no written procedures for using the salvage pump.
- Crew was unaware of danger of using a petrol driven pump in an enclosed space.
- There was no procedure for enclosed space entry / working.

- Ensure crews are aware of the dangers of confined spaces
- Enclosed space entry procedures to be implemented
- Enclosed space rescue drills to be implemented
- Hazards associated with petrol / diesel driven pumps in enclosed spaces to be shared
- Adequate and regular maintenance of bilge pumping arrangements to be in place
