# Rapid interagency shelter Assessment

## Marsh Harbour: Abaco

18/09/2018

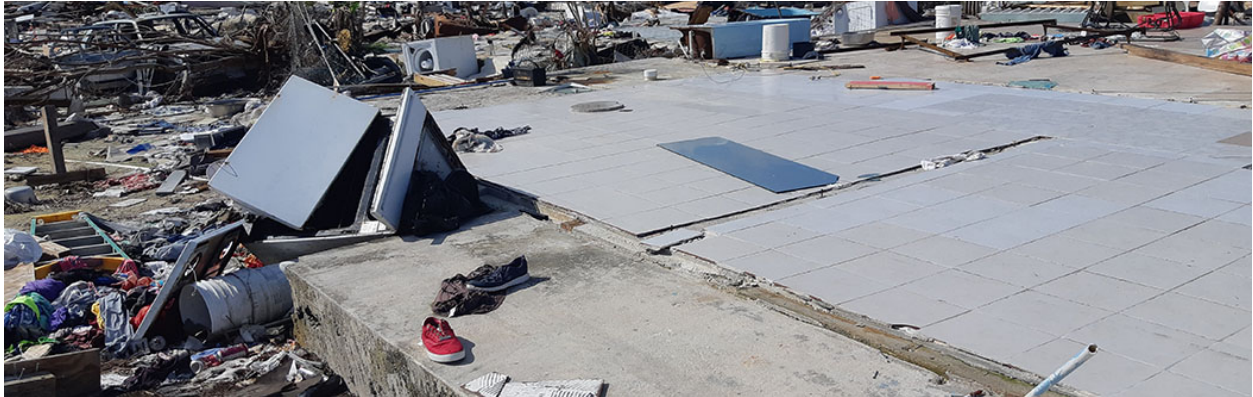
*Example of the slab remaining from a destroyed shelter in Mudd. Remains of multiple rooms can be seen.*

All shelters are built on all concrete slabs max 2 ft tall and often tiled. **Average size was 72m<sup>2</sup>**, but the observed range of shelter sizes was 30 to 156m<sup>2</sup>. It is not clear how many had a second storey.

Shelters were built incrementally, building one room as families have resources available. Several show traces of verandahs, and most show visible remains of baths latrines and ditches inside the houses.

**Shelter superstructure:** timber frame, plywood or timber paneled (light studded) walls (on wide centres with light weight timbers often 2"x3")

Shingled roofs, with no CGI visible in the debris.

Total destruction primarily due to tidal surge. Unknown damage due to wind. Debris is mixed with containers and other materials from the port.

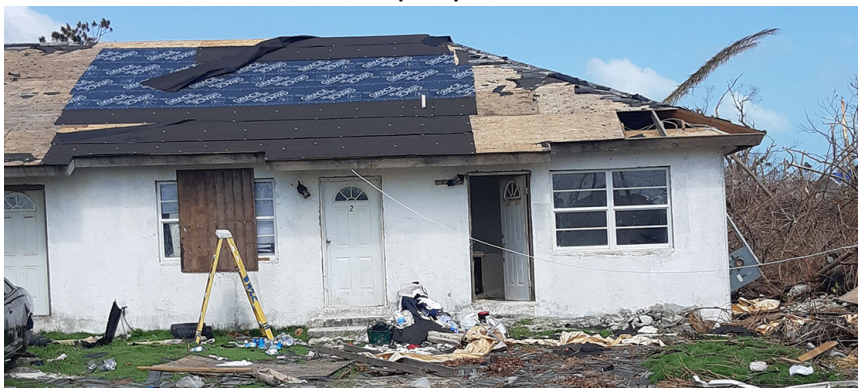
*Example of a house with roofing damage in Murphey Town. Work is underway to make repairs. Note that damage is variable.*

Every house has at minimum some roofing damage. some houses are totally destroyed. Dundas has larger houses (wealthier district) than Murphy

Walls: Mixture of stud walled and ply or timber planks as cladding and concrete hollow block construction.

Roofs: mixture gable and hipped

All roofs had missing shingles. Many had missing ply and several had failed completely. Rain coming through the roofs had caused collapse of many ceilings (in some cases made of plasterboard) leading to significant damage.

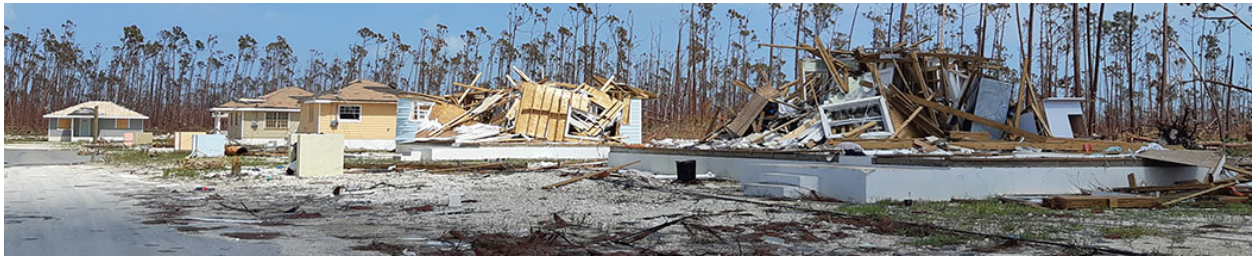
*Destruction was localized as twisters passed through the settlement*

Timber frame houses with timber cladding and ply/ shingles on roof. All o the units are damaged, some totally destroyed by the wind and localised twisters/tornadoes that passed through the settlement.
