SUMMARY OF ADVISORY BUILDING SAFETY ASSESSMENTS BY INTERNATIONAL ENGINEERS FOLLOWING THE AUG 14 M7.2 HAITI EARTHQUAKE

Report compiled by SARAID UK

25th August 2021

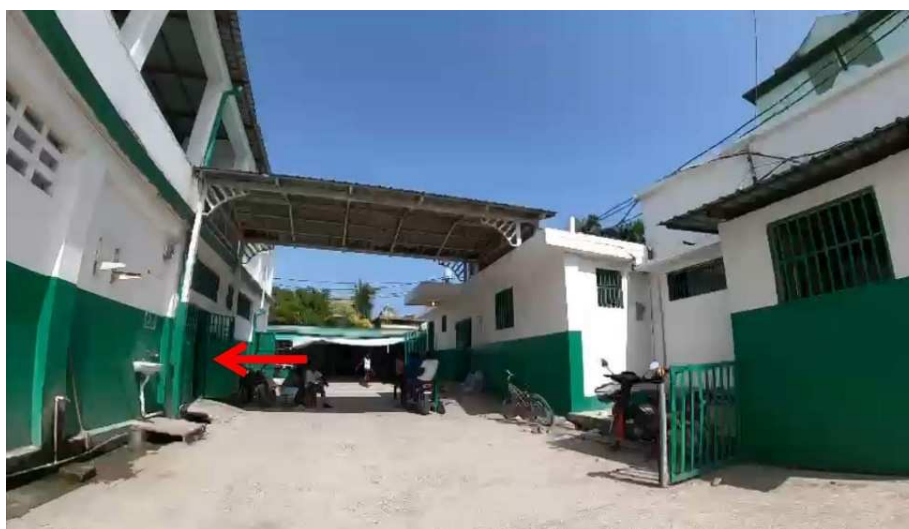
- Damage: There was significant cracking to one of the internal columns. The column was on the left in the room straight ahead of the entrance, as indicated in Figure 6.
- Assessment constraints: We were unable to access any of the upstairs floor and large parts of the ground floor.
- **Recommended restrictions:** Access to the room with the damaged column (it appeared to be an operating theatre) should be prohibited, including the area that is above this room.

Figure 6 - Access into the room with a damaged column is indicated by the red arrow.

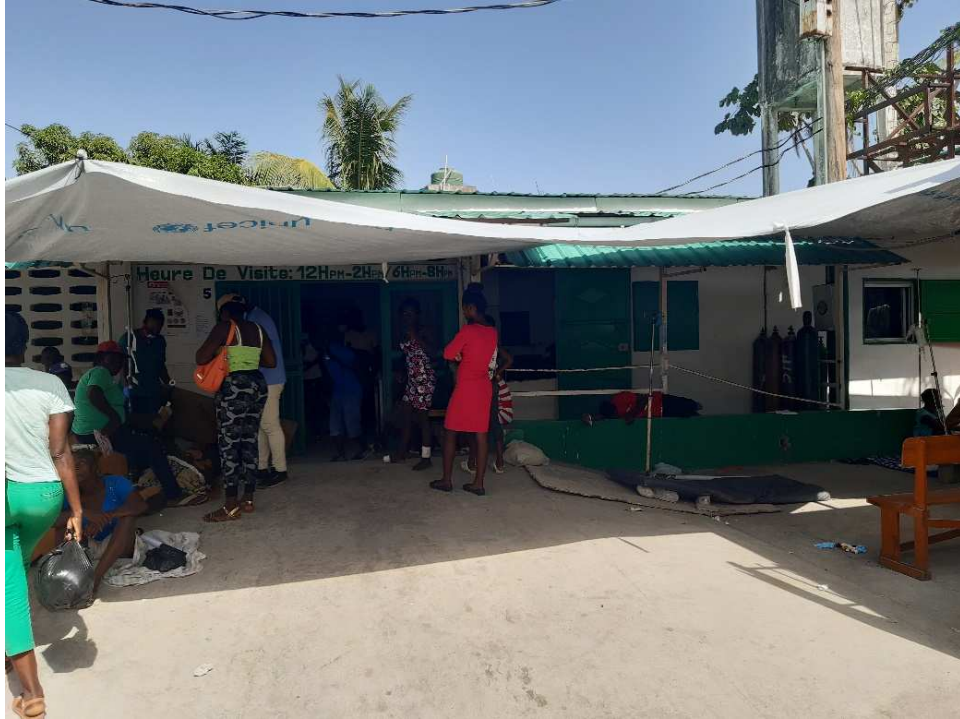
Figure 7 - Building 2

- Damage: There was some cracking to the right of the entrance, but this was deemed to be affecting non-structural elements.
- Recommended restrictions: None

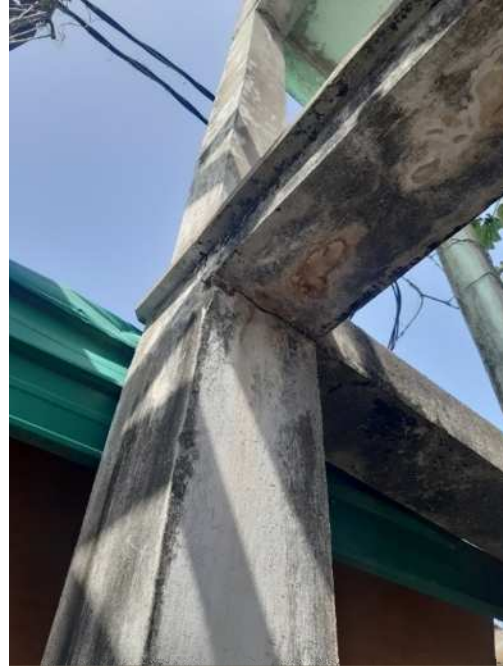
- Damage: Cracking was observed between most of the beam and column joints. There was also spalling on some of the concrete beams although its assumed, due to the condition of the rebar, this was historic damage
- **Recommended restrictions:** Cordon off the damaged water tower to a distance of 1.5 times the height of the tower area

Figure 9 - Cracking between the beam and column joints

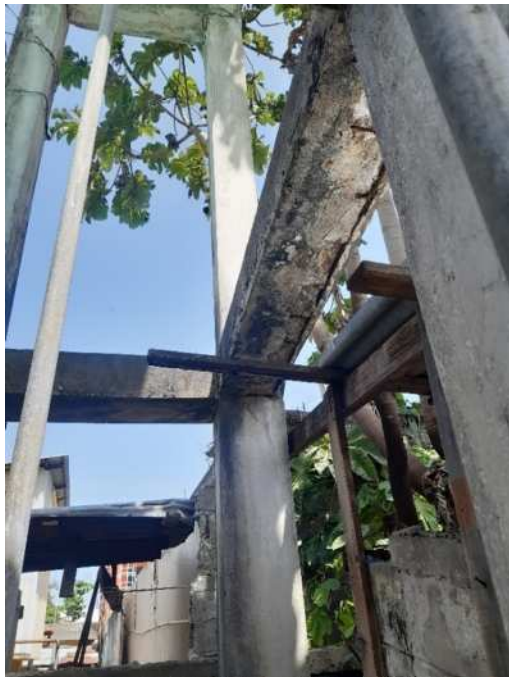
Figure 10 - Spalling of the concrete on the beam

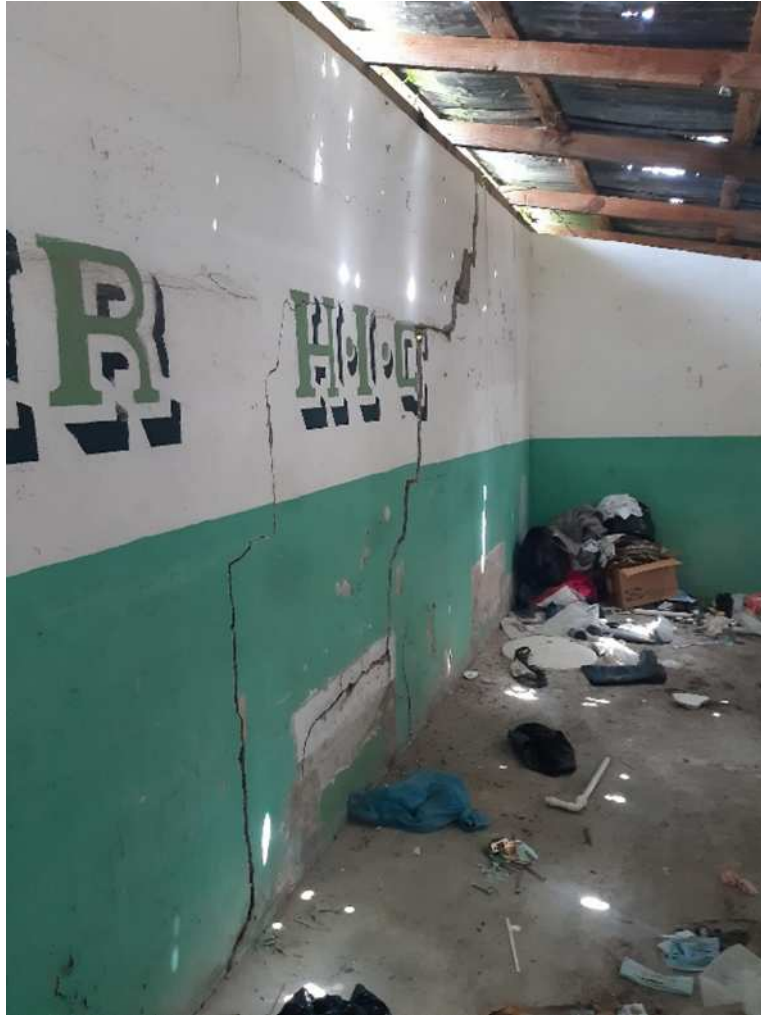
- Damage: Large cracks were observed in the rear wall
- **Recommended restrictions:** Our recommendation is that the building is unsafe to use

Figure 11 - Building 4, cracks in the rear wall

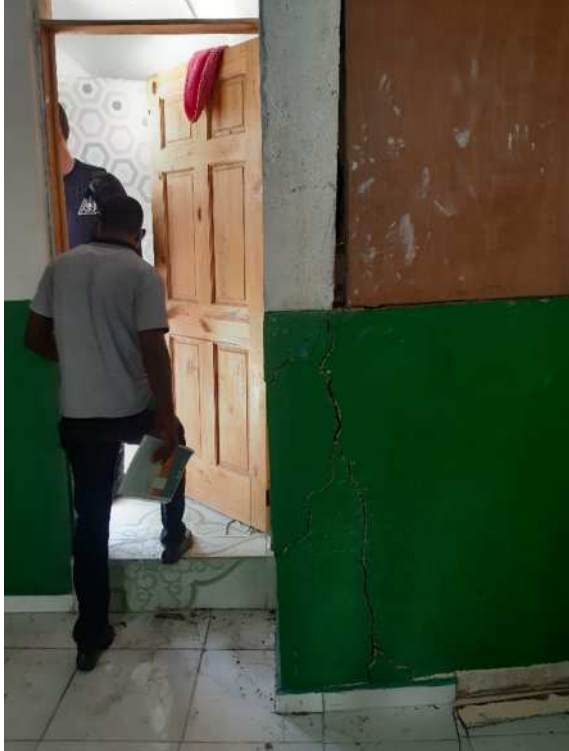
Figure 14 - Cracking observed on the opposite side of the wall shown above

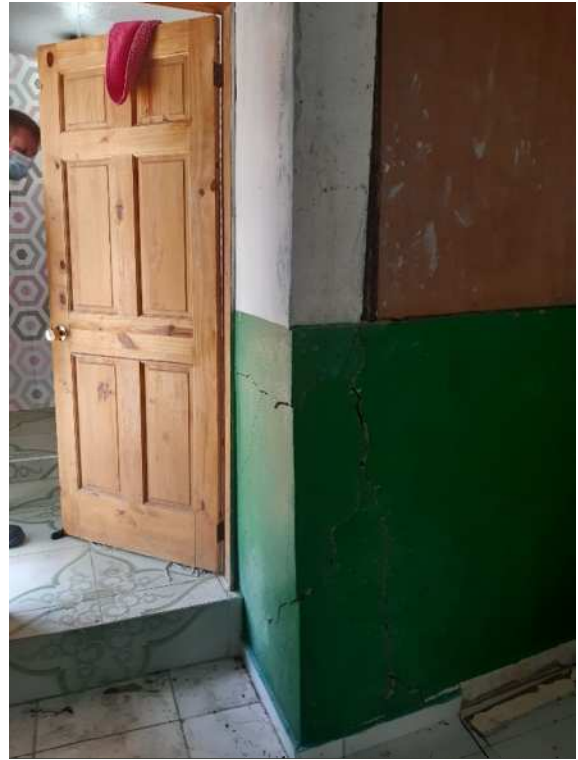
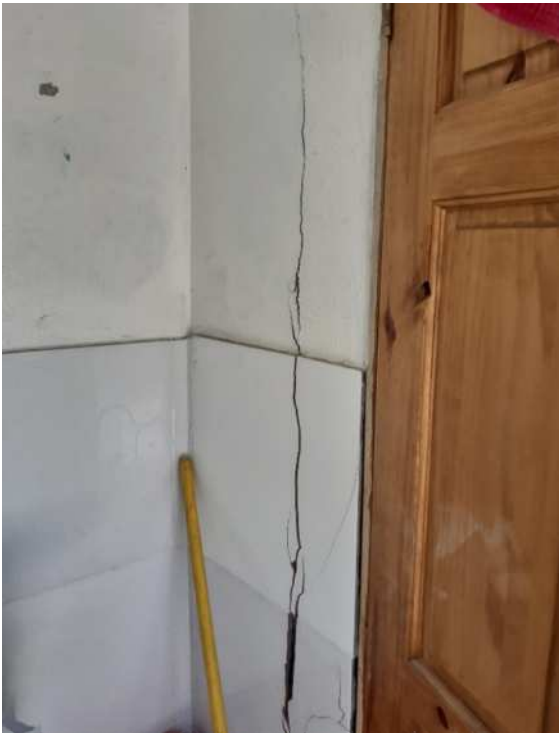
- Damage: The wall next to the rear doorway has some cracking and was leaning.
- Recommended restrictions: Access through the rear entrance should be restricted, and this end of the building should be cordoned off.

Figure 13 - Cracked and leaning wall in Building 5

Figure 12 - Cracked and leaning wall in Building 5

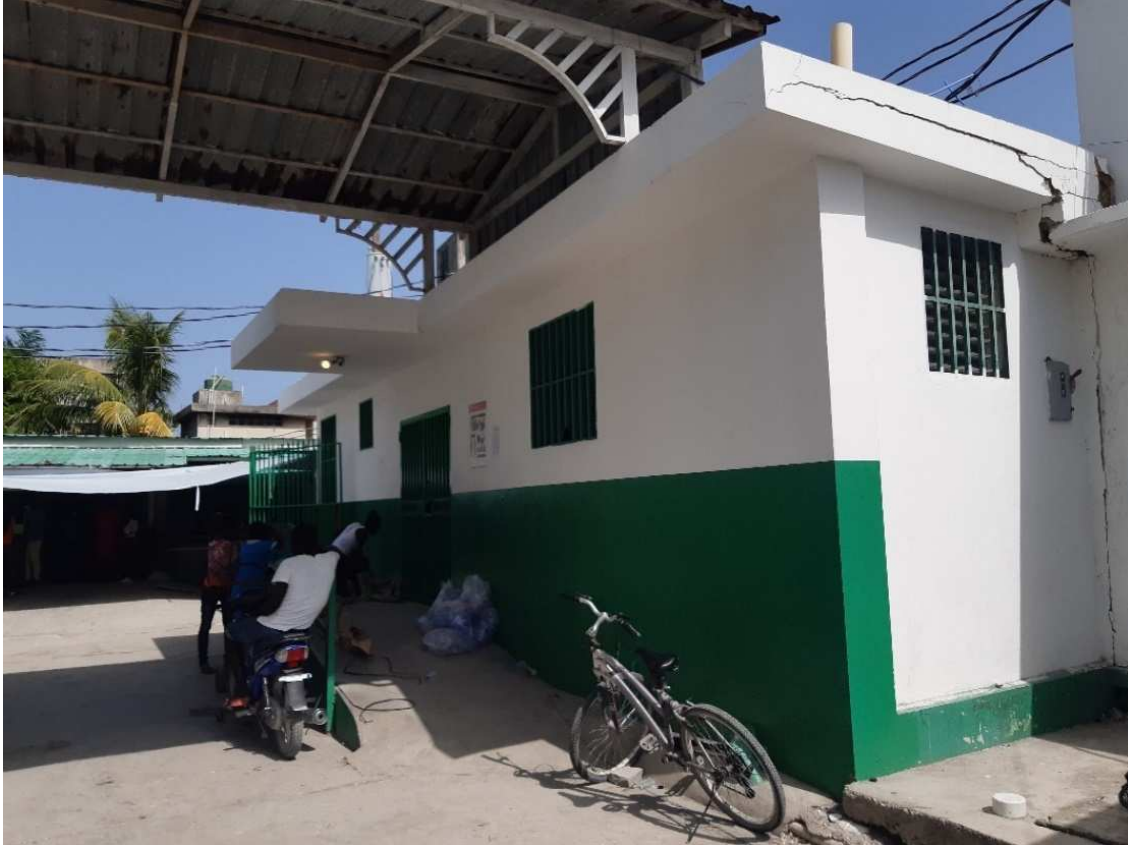
- Damage: Cracking was observed on the external edge of the roof slab, shown in Figure 15 below
- Assessment constraints: The rear of the building, behind the first set of rooms could not be accessed
- Recommended restriction: Cordon off the external area around the cracked beam

Figure 15 - Building 6, image shows cracking to the external edge of the roof slab

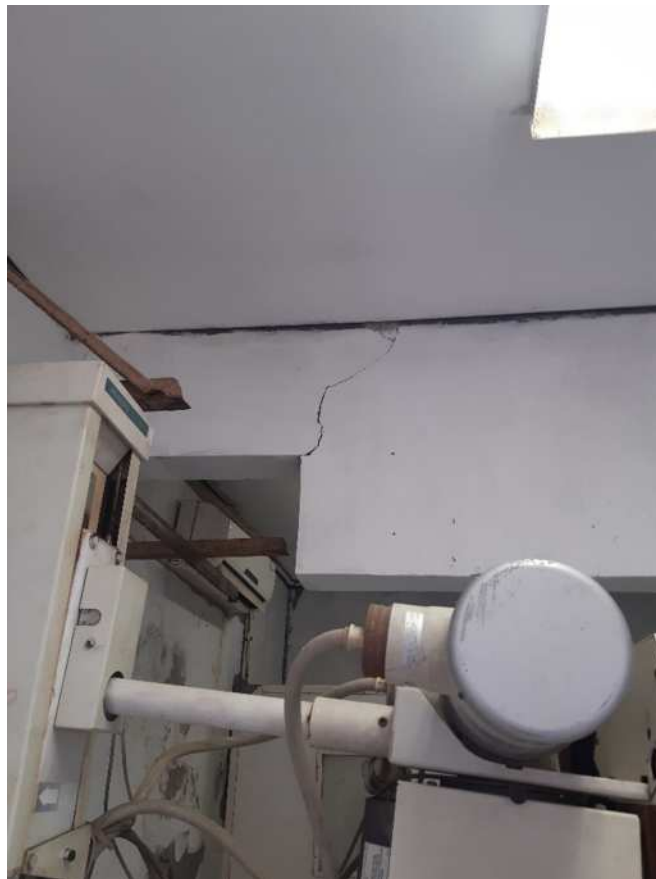
- Damage: Cracking through a beam that is supporting the floor above. Cracking present where the beam changes depth.
- Assessment constraints: We were unable to access any of the upstairs floor. The rear of the building, behind the first set of rooms could not be accessed
- **Recommended restrictions:** Our recommendation is that the building is unsafe to use

Figure 17 - Cracking of the supporting beam

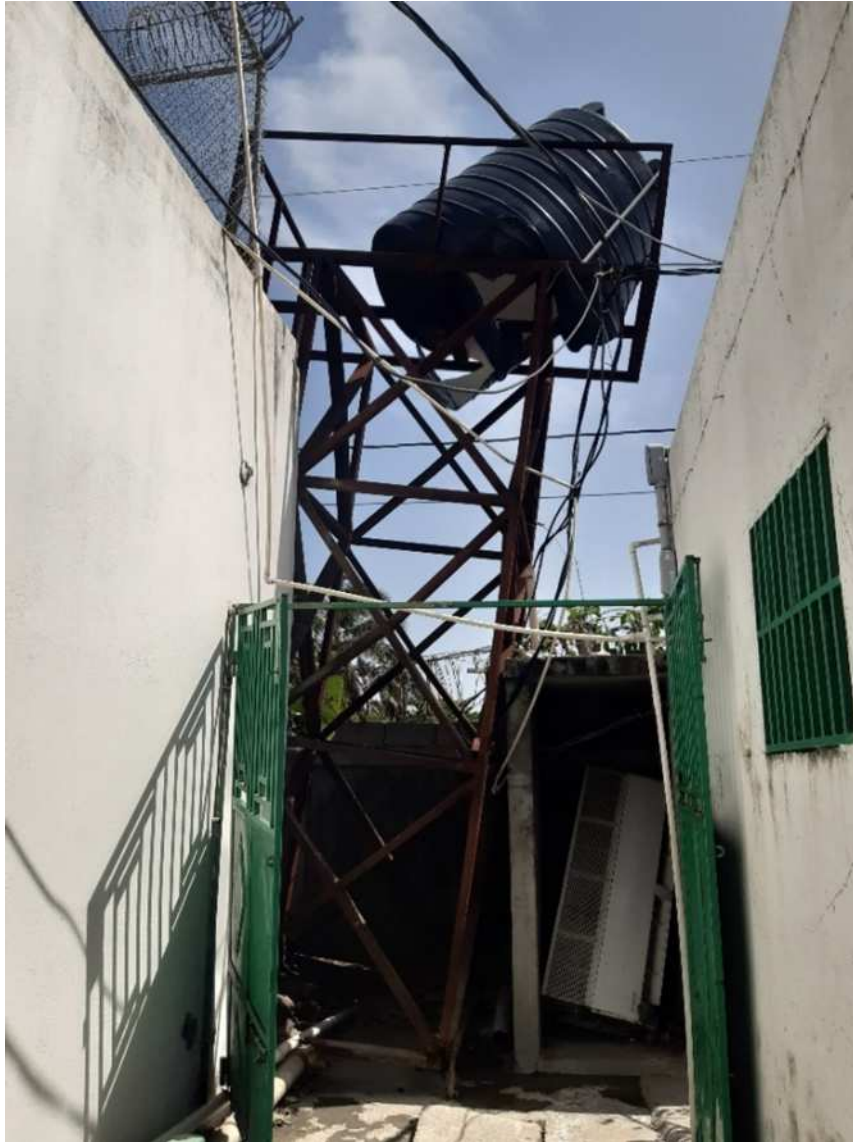
Figure 20 - Building 10

- Damage: The tower was significantly leaning which has displaced the water butt which is no longer secure.
- Recommended restrictions: Cordon off the damaged water tower at a distance of 1.5 times the height of the tower area

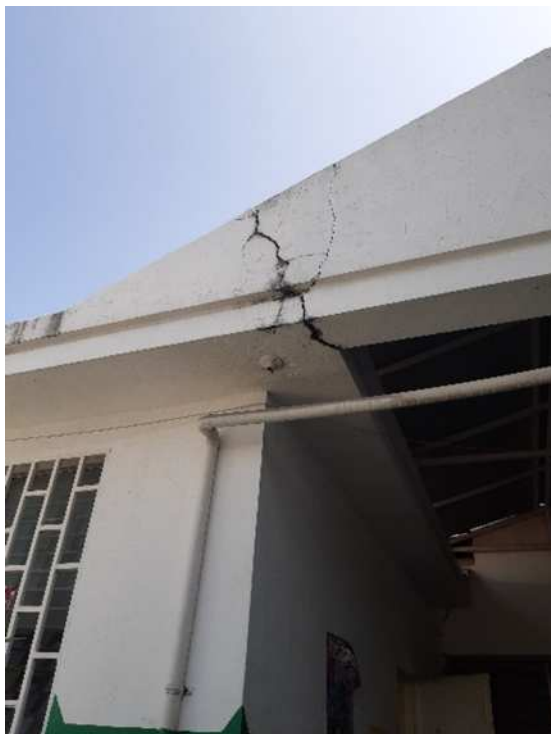
- Damage: A significant crack is present on the entrance arch causing it to be structurally unsafe (see Figure 22). A crack in a supporting beam (see Figure 23). Damage to an external wall that is supported a steel trussed roof. Damage to lintels.
- **Recommended restrictions:** Our recommendation is that the building is unsafe to use

Figure 22 - Crack in the entrance arch

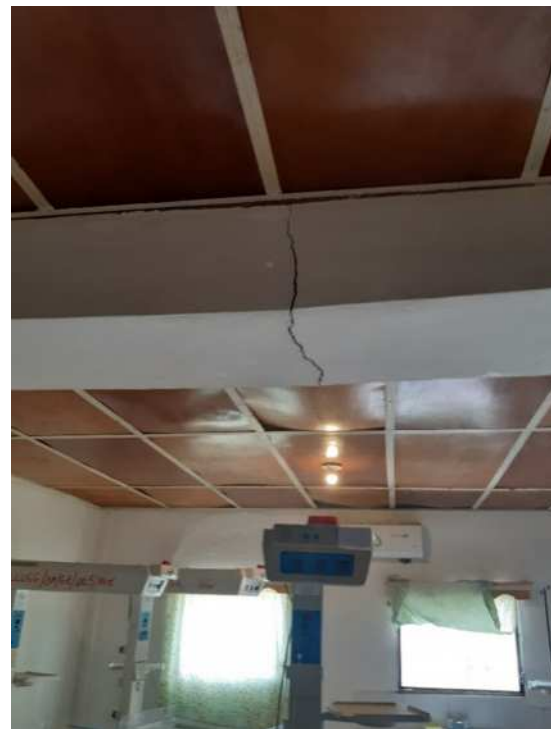
Figure 23 - Crack in a supporting beam

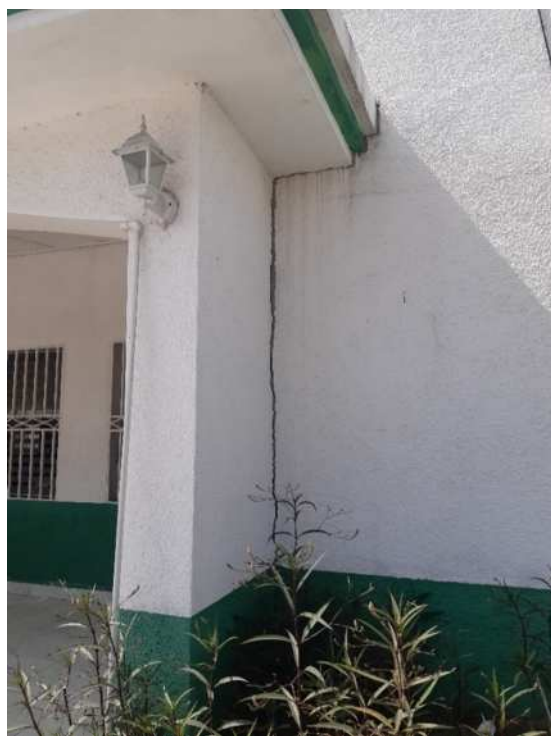
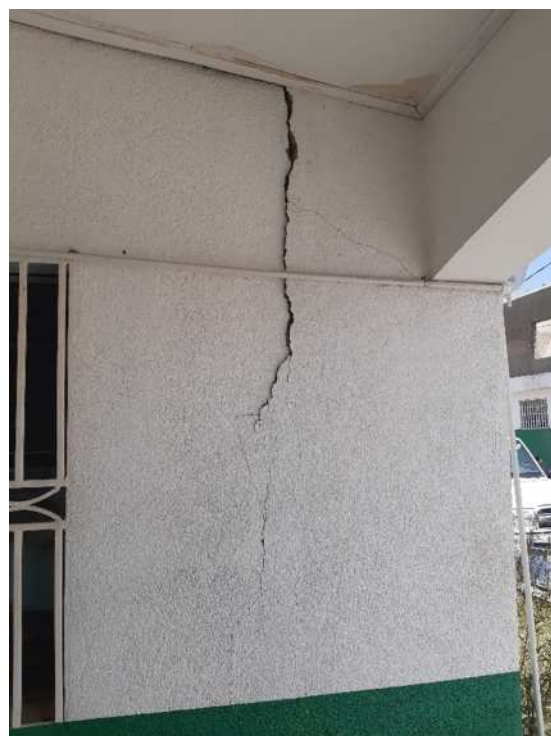
- Damage: The supporting structure to the edge of the entrance overhang was cracked and leaning, see Figure 27.
- Assessment constraints: The area shown in Figure 26 was not accessed.
- **Recommended restrictions:** We advise that the area under the right-hand side of the portico (when looking at the building, Figure 27) should be restricted.

Figure 27 - Crack on the supporting structure of the portico

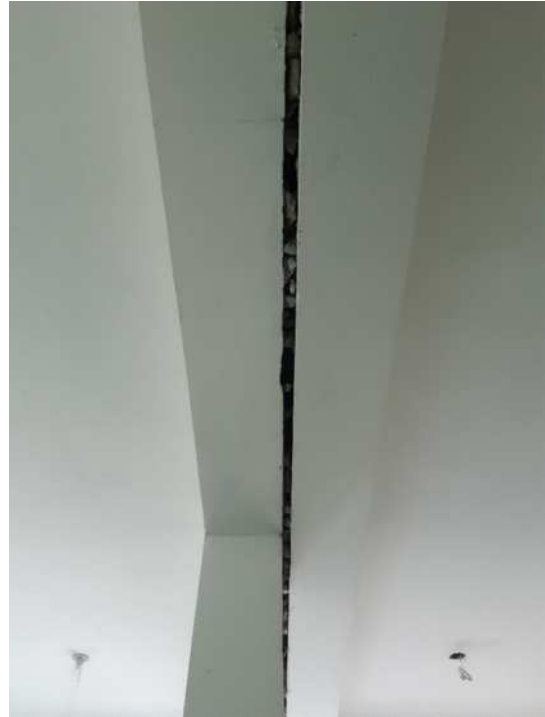
- Damage: Minor cracking to external infill walls, deemed as non-structural damage. Cracking was observed along a movement joint. The structures either side had moved separately from on another and although looks like a significant crack it does not effect the structural integrity of the building.
- **Recommended restrictions: None required**

Figure 30 - Cracking along the movement joint in building 15

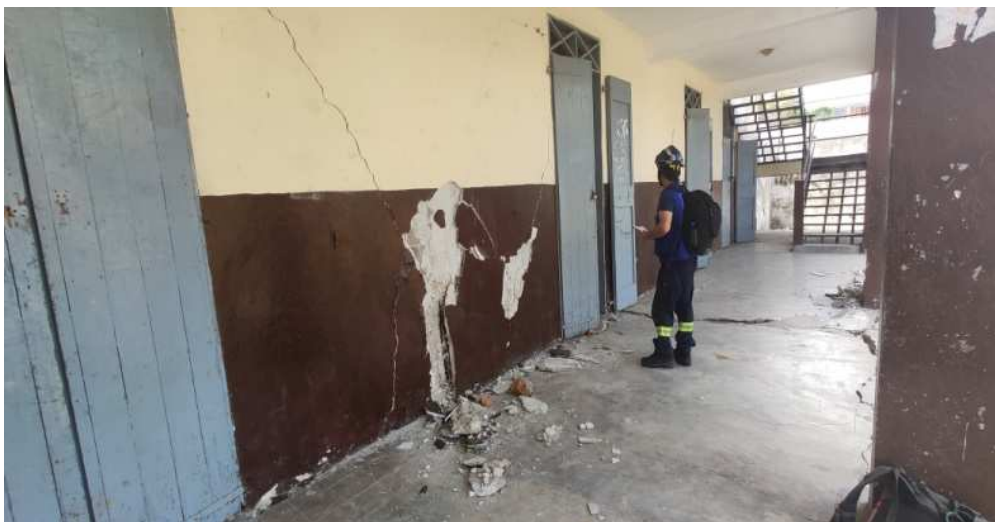
Figure 34 – Building 20

- Damage: The North-East end of this classroom block exhibits structural cracking that is detrimental to the safe use of the facility In the quadrangle between the classroom blocks there is a UNICEF tent which local residents are using as a safe refuge. This is sufficiently distant from the buildings to avoid hazards associated with further seismic events.
- **Recommended restrictions- Access to the building to be restricted until a detailed evaluation confirms whether it is safe for use or needs to be evacuated.**

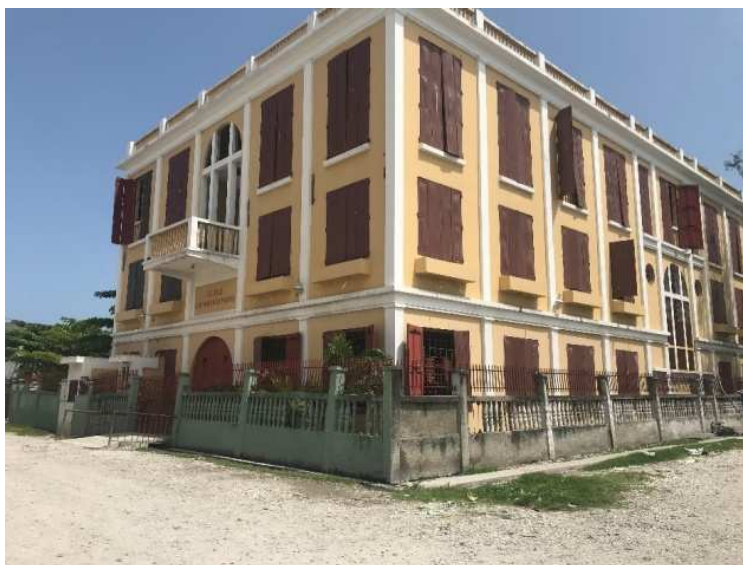
Figure 36 - Building 21

- Damage: The rectangular classroom block encloses a paved courtyard where it is evident that the ground surface has risen significantly above its original level. Also it appears that the building level has dropped relative to the adjacent pavement. Some ponding of surface water around the building reflects these changes. The degree of “ground heave” internally raises concern regarding potential for voiding below the surface that could represent a hazard to users or to circumstances associated with redressing the level differentials. In the south eastern part of the building there is some significant structural cracking of ground floor walls and this appears to relate to the ground movement.
- **Recommended restrictions: Access to the building to be restricted until a detailed evaluation confirms whether it is safe for use or needs to be evacuated.**

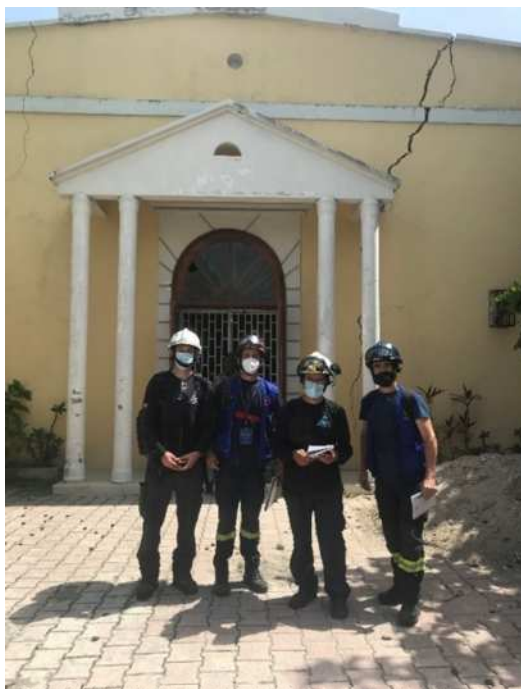
- Damage: There is significant cracking evident externally at the east facade and extensive further structural cracking that is most readily observed from inside the “auditorium” building. The “ground heave” of the building’s paved floor appears to correspond with cracking in the walls. The degree of structural cracking of this building renders it hazardous to people in its vicinity and potentially vulnerable to failure in the event of further seismic effects.
- **Recommended restrictions: Our recommendation is that the building is unsafe to use.**

Figure 38 – Building 22 structural cracking visible at the East facade

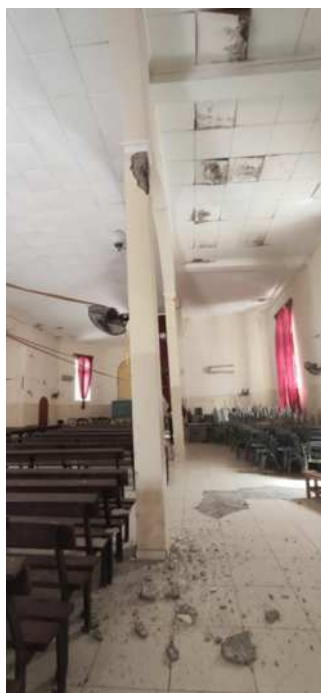
Figure 39 - Extensive structural cracking observed from inside the “auditorium” building

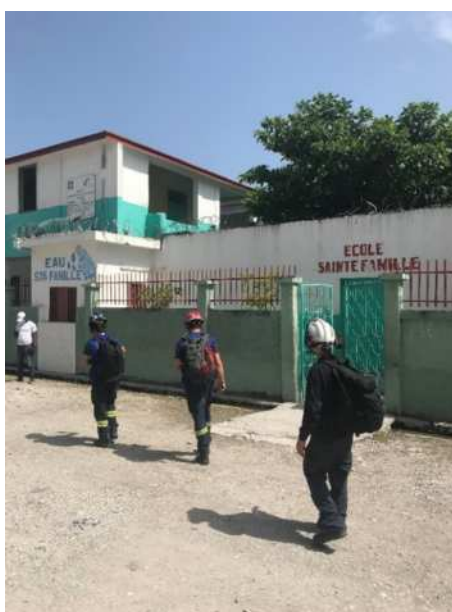
Figure 41 - Building 24

- Damage: This building exhibits areas of varied cracking that are insufficient to suggest that the building structure is compromised. However the presence of the adjacent, and significantly damaged, “auditorium” building should be regarded as a considerable hazard.
- **Recommended restrictions: Access to the building to be restricted until a detailed evaluation confirms whether it is safe for use or needs to be evacuated.**

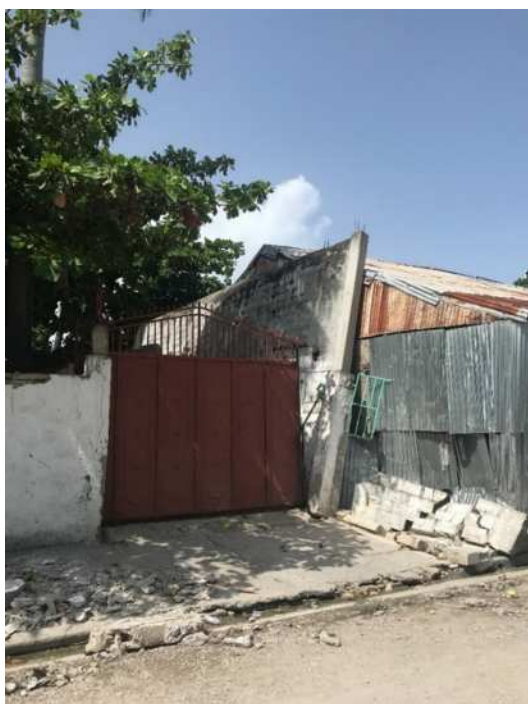
- Damage: The administration building itself is found to be free from any significant damage. However the property's 7m high southern boundary wall has failed by rotating at its base and is only prevented from collapse by leaning against the neighbouring property. This adjacent property is inhabited and the current circumstances are unsafe and very unsatisfactory.
- **Recommended restrictions: Access to the neighbouring building to be restricted until a detailed evaluation confirms whether it is safe for use or needs to be evacuated.**

Figure 42- Building 25 boundary wall

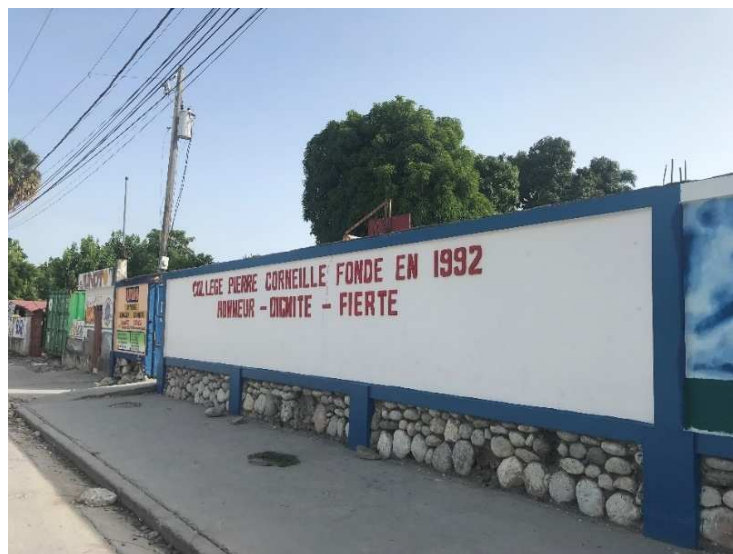
Figure 47 - Building 30

- Damage: This college building extends for a 100m distance perpendicular to the road. For the most part it is free from damage but at the end remote from the road there is evidence of ground movement that has resulted in structural cracking.
- **Recommended restrictions: It is recommended that access into the building is prohibited in the zone of ground settlement and of the associated structural defects.**

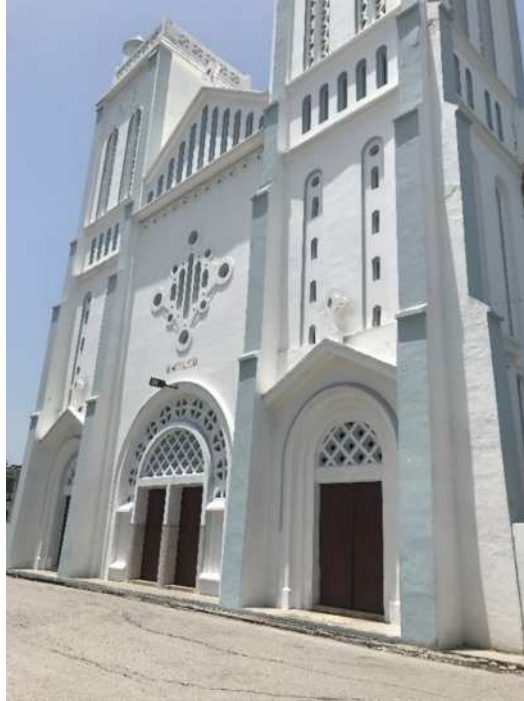
Figure 52 - Building 35

- Damage: The building has been made secure and only external assessment was possible. However evident change of relative levels at street frontage appears to have occurred and requires further investigation.

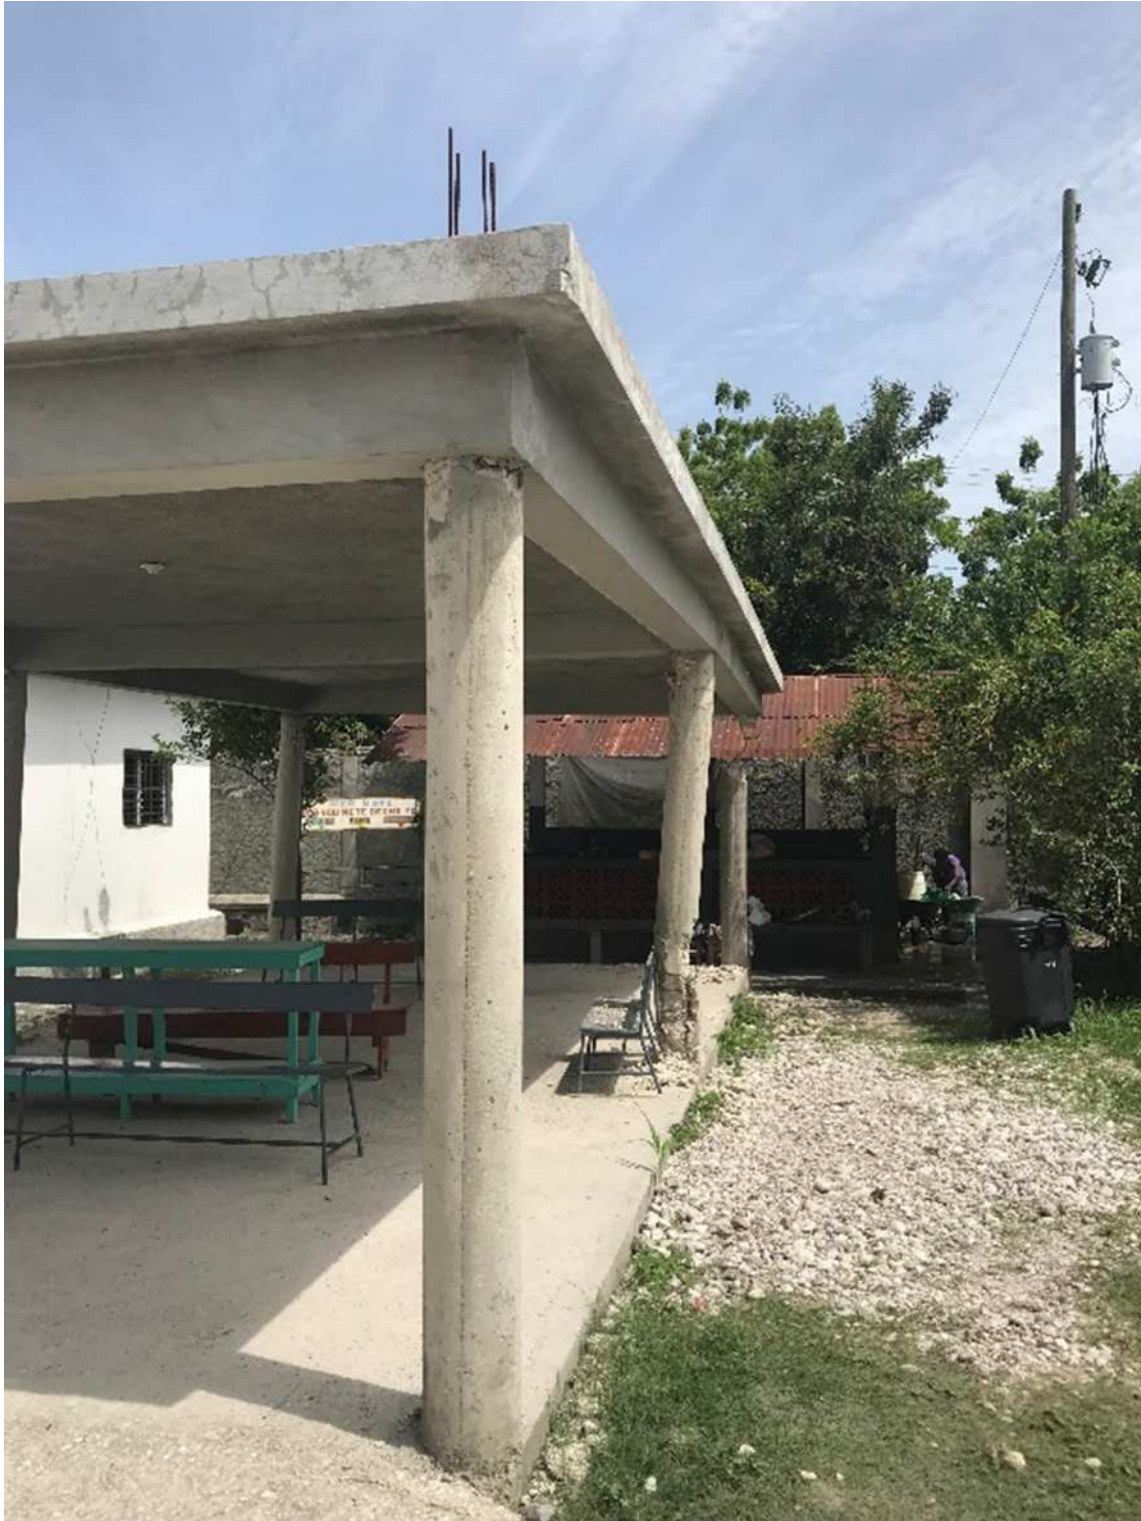
Figure 54 - Building 37

- Damage: The structural failure of column supports exhibits extreme effects of sway frame behaviour. The consequent damage renders this shelter/car port unsafe to use.
- Recommended restrictions: Our recommendation is that the structure is unsafe to use.

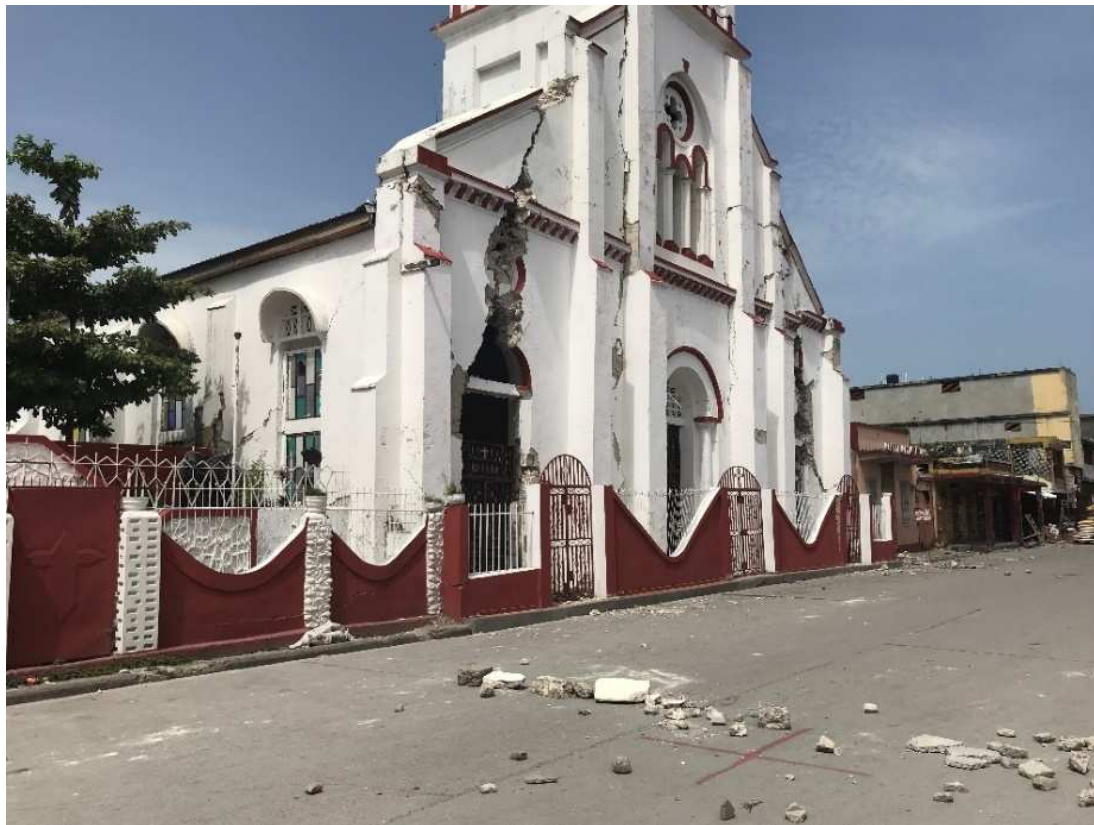
Figure 55 - Building 38

- Damage: Extensive cracking and areas of localised collapse render this building highly unstable.
- Recommended restrictions: Our recommendation is that the structure is unsafe to use. Significant expansion of the existing exclusion zone around it is recommended.

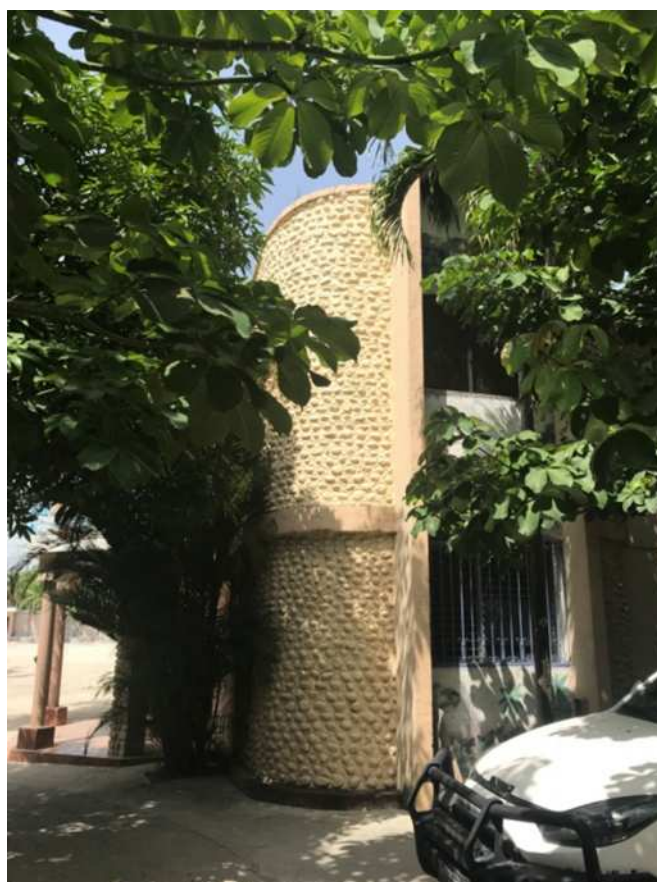
Figure 58 - Building 40

- Damage: The reception building, built at the same time as the now-demolished main block, has suffered minor cracking while uplift and cracking have affected floors at ground level.
- Recommended restrictions: Access to the building to be restricted until a detailed evaluation confirms whether it is safe for use or needs to be evacuated.

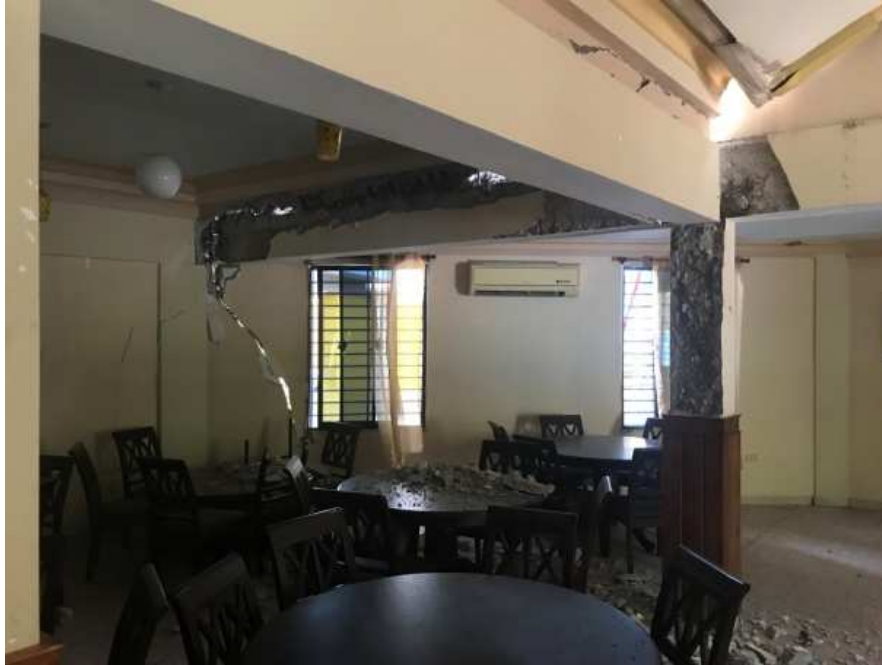
Figure 59 - Building 41

- Damage: The roof over the restaurant has a substantial reinforced concrete structure that has suffered significant damage resulting from the earthquake. This damage is beyond repair.
- Recommended restrictions: Our recommendation is that the structure is unsafe to use.

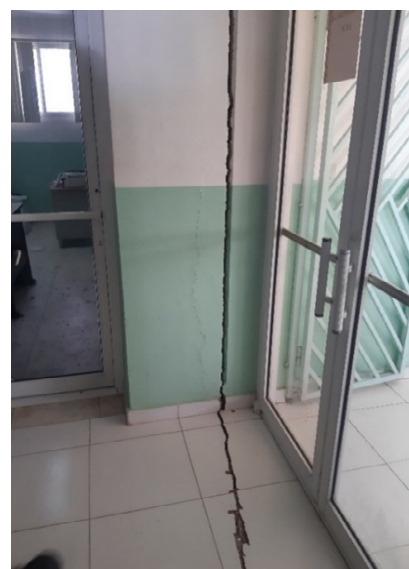
Figure 68 - Movement joint cracking

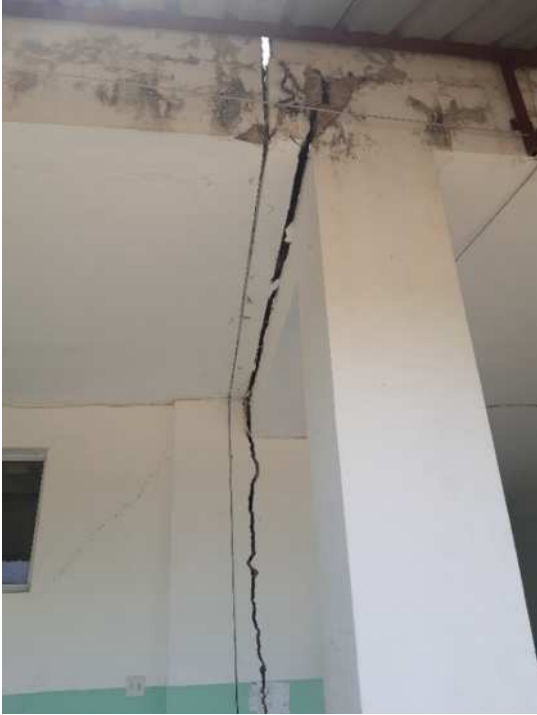
Figure 69 - Movement joint cracking resulting in loose fill

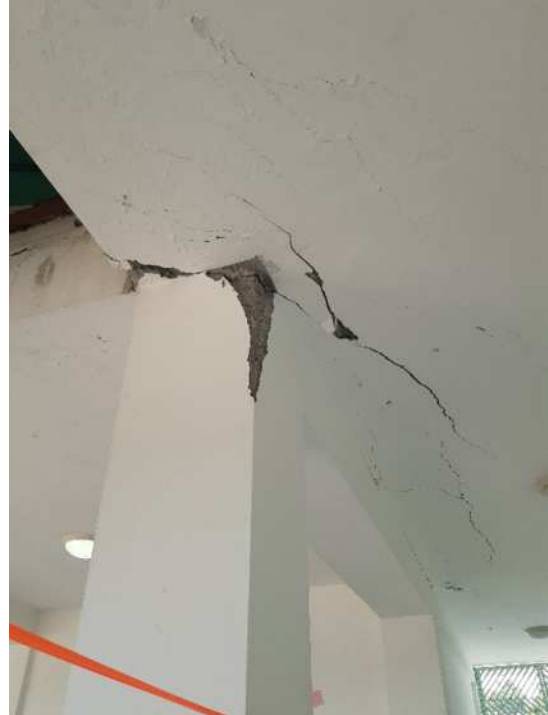
Figure 70 - Cracking around the column head and slab

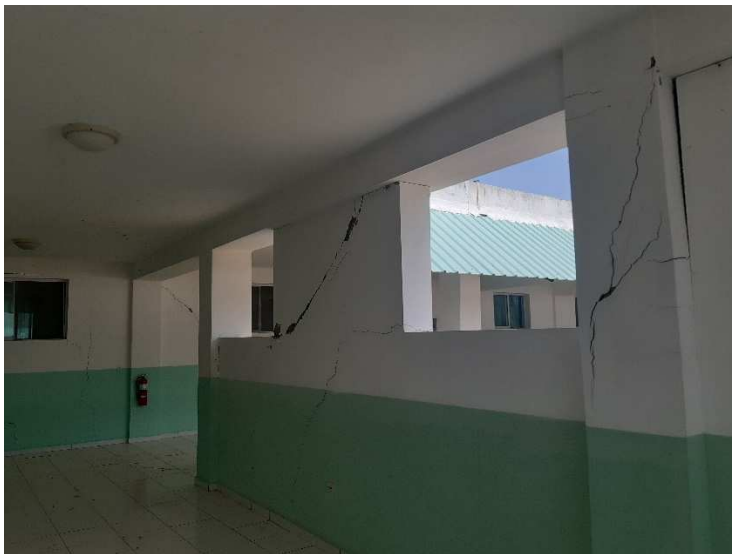
Figure 71 - Column cracking and short column shear crack

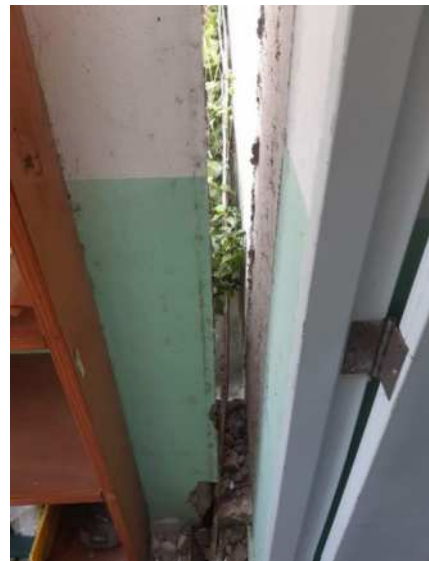
Figure 72 - Subsided extension
