Earthquake Damage Inspection Form (EDIF)

Rapid Inspection Form

Country:	Türkiye	
Province/District:	Hatay	
City/Town:	Serinvöl / Hatay	
Building Name:	Mustafa Kemal Sitesi	
Building Owner or Staff name:		
Building Location:	Latitude:	Longitude:
Insert a Screenshot from Google Earth and/or complete address	Mustafa Kemal Sitesi No: 108, Kapi: 22 Üniversite Kampusu yani Serinvöl /Hatay	
Date of the Site Visit:	May 24, 2023	
Name of the assessor:	Dr. Thomas ZILLY	
Building Age and Original use:	<ul style="list-style-type: none"> • Year of Construction: around 2000 • Original use of the building: Residential 	
Available information regarding building construction:		
<ol style="list-style-type: none"> 1. Facility/Building Site Layout? No 2. Structural Floor Plans? No 3. Any previously performed seismic assessment? No 		
How many floors are in the building (Including ground floor): 4		
How many underground floors are in the building: 0		
Which is the floor occupied by UN personnel: 3

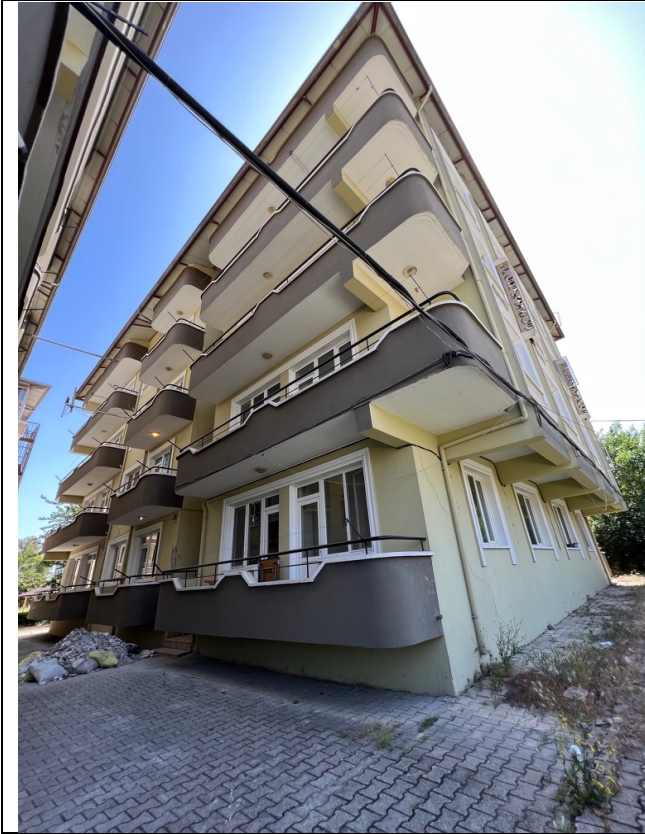
OUTSIDE
On the building external walls are huge cracks to note on the plaster and cracks on columns.
Some soil settlement is to note on the surrounding area of the building.

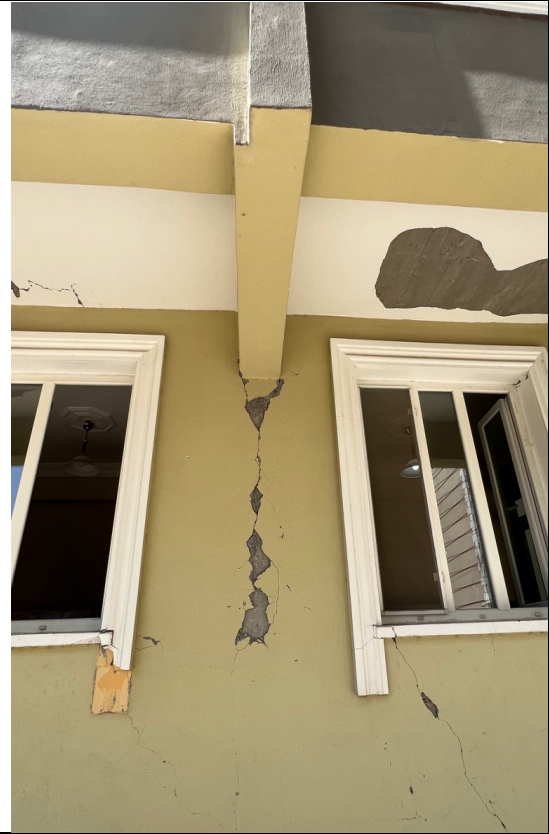
On a column of the external wall was a crack observed

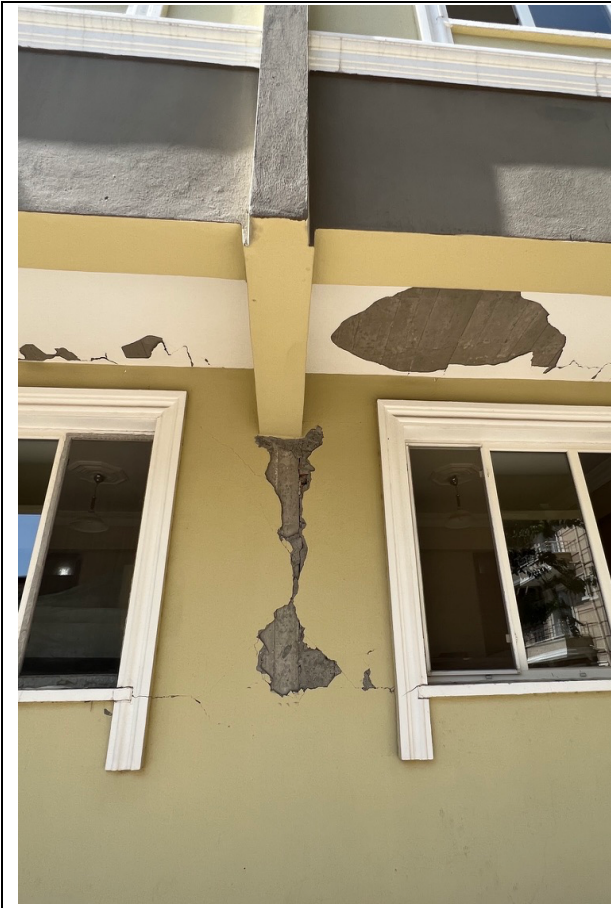
On another column of the external wall was also a crack observed

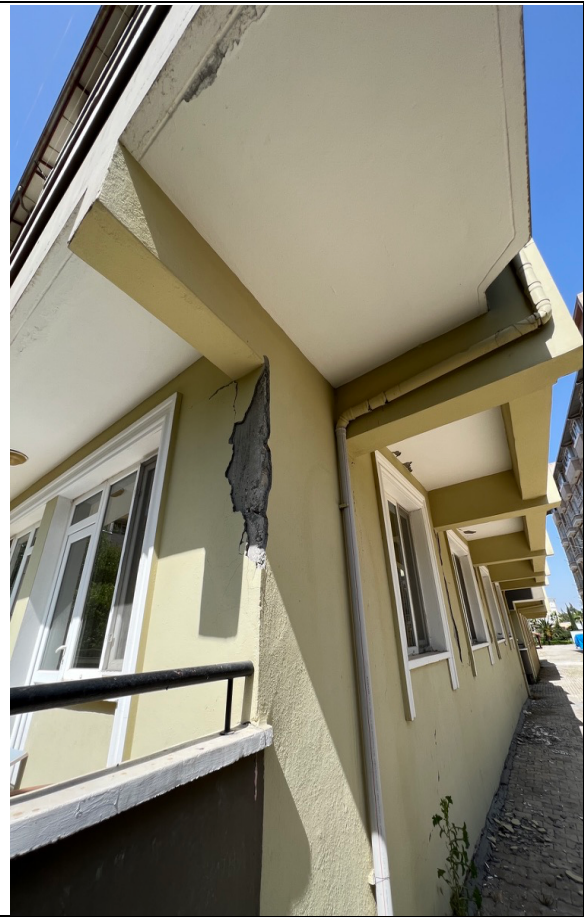
On the corner of the building was a crack on the column of the external wall observed

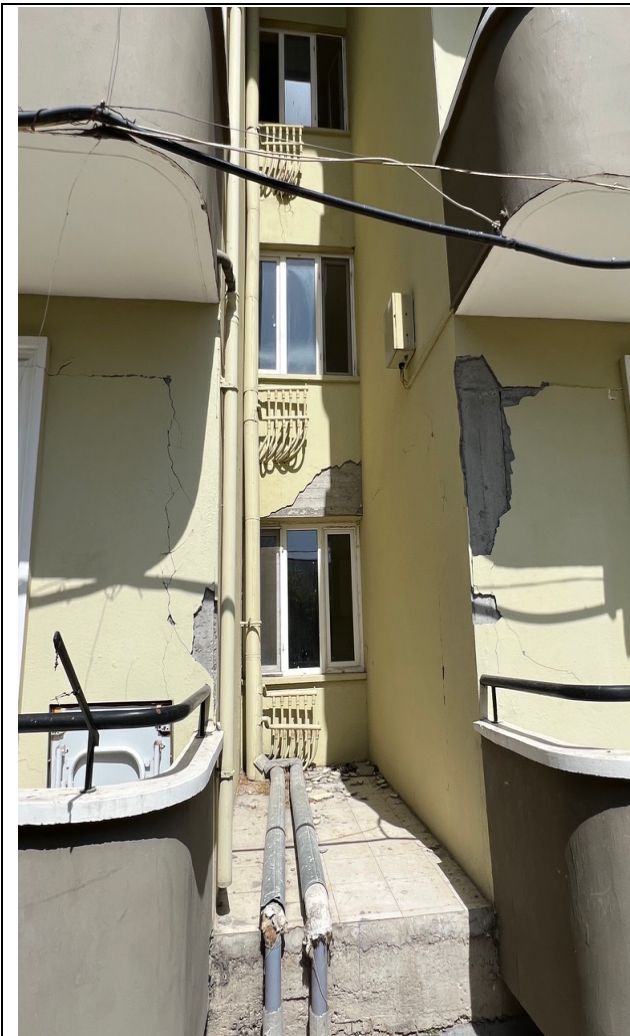
On another column of the external wall was also a crack observed (right side of the photo)

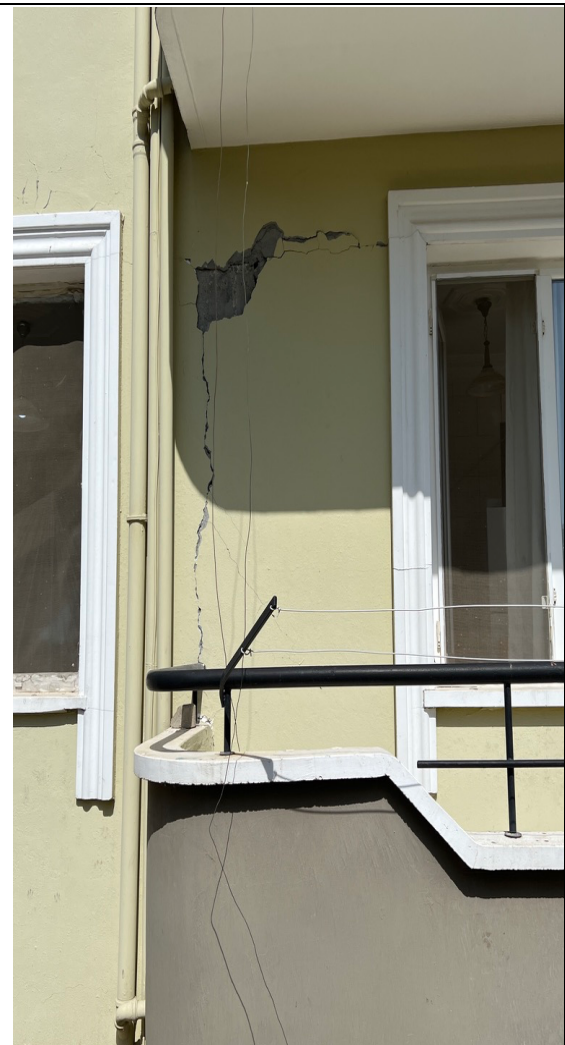
On another column of the external wall was also a crack observed

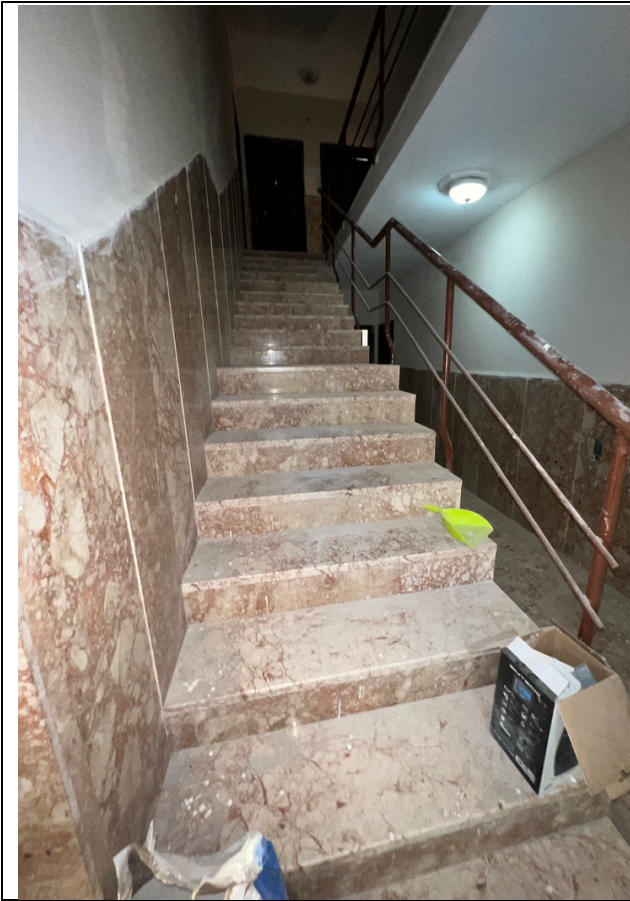
STAIRCASE AREA

The stairs and the walls, floors and ceiling of the staircase area were recently repaired, and no visual damages were observed

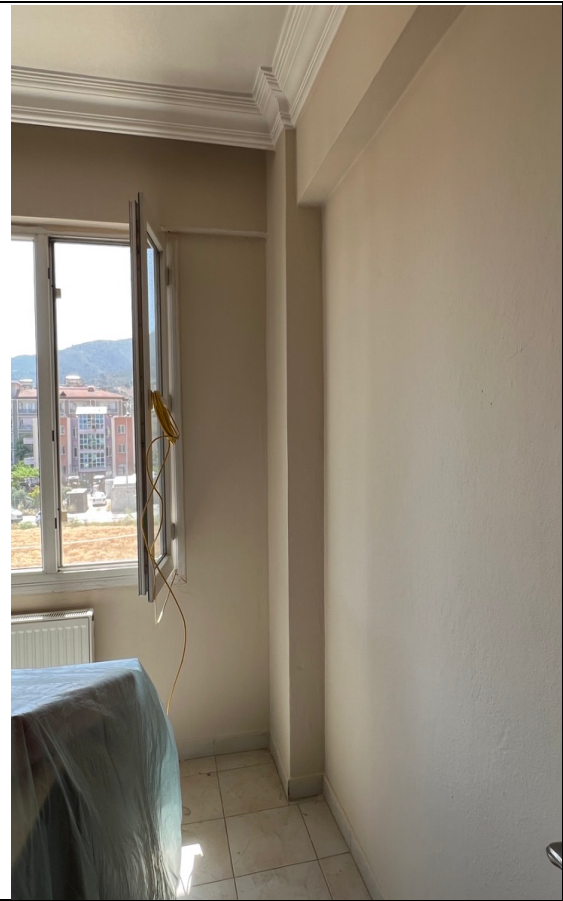
INSIDE THE STAFF APARTMENT

On the structural system of the staff apartment were no visual damages observed, as the building repair works are almost finished

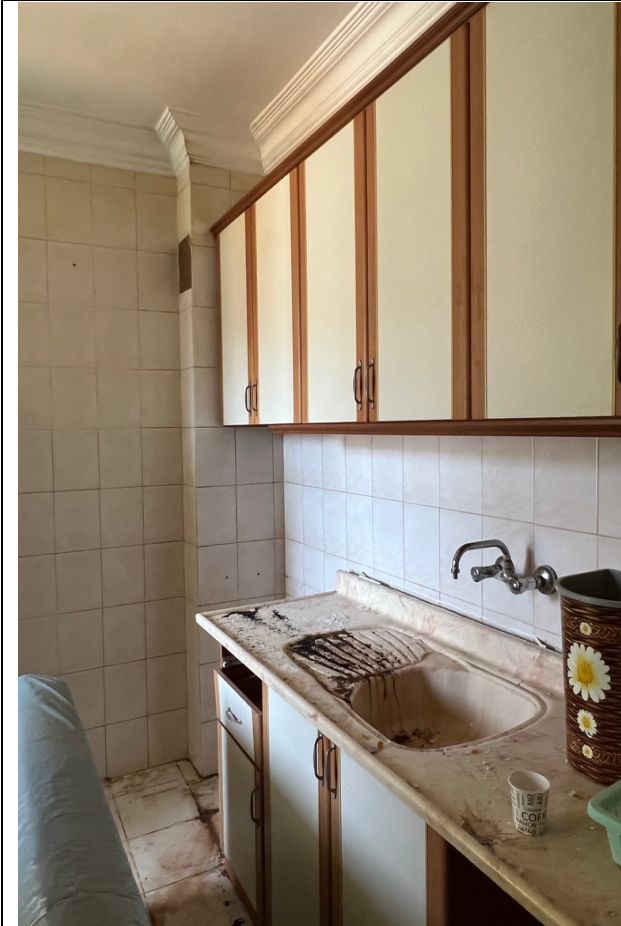
Inside the staff apartment were no structural damages observed, as the repair works are finished inside the apartments.

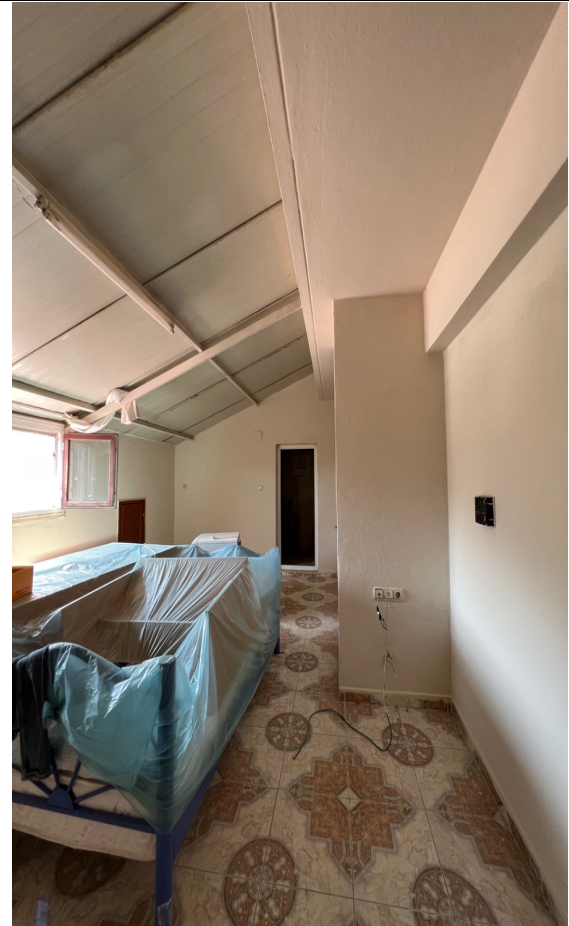
On an apartment below the roof, was no damage on the roof system observed
