## RESULTS OF THE MGB LANDSLIDE AND FLOOD ASSESSMENT (1:10,000 SCALE) OF PARTS OF BAGANGA IN THE PROVINCE OF DAVAO ORIENTAL

Due to the effects of Typhoon Pablo in some parts of Region XI, the Mines and Geosciences Bureau-Department of Environment and Natural Resources Regional Office No. 11 (MGB-DENR XI) prioritized the conduct of landslide and flood assessment and mapping (1:10,000 scale) of areas within the municipality of Baganga, Davao Oriental on January 16 to 26, 2013 being one of the worst hit areas. The assessment is in line with the government's efforts aimed at reducing, if not, totally mitigating the destructive effects and impacts of natural hazards on the populace. Comprising the geohazard assessment team are Ms. Beverly Mae M. Brebante, Ms. Abigail June L. Agus and Mr. Allen June B. Buenavista, geologists; Mr. Virgilio C. Torcido, geologic aide, Mr. Pedro P. Calunsag and Mr. Julie P. Benenos, drivers, all from the MGB regional office.

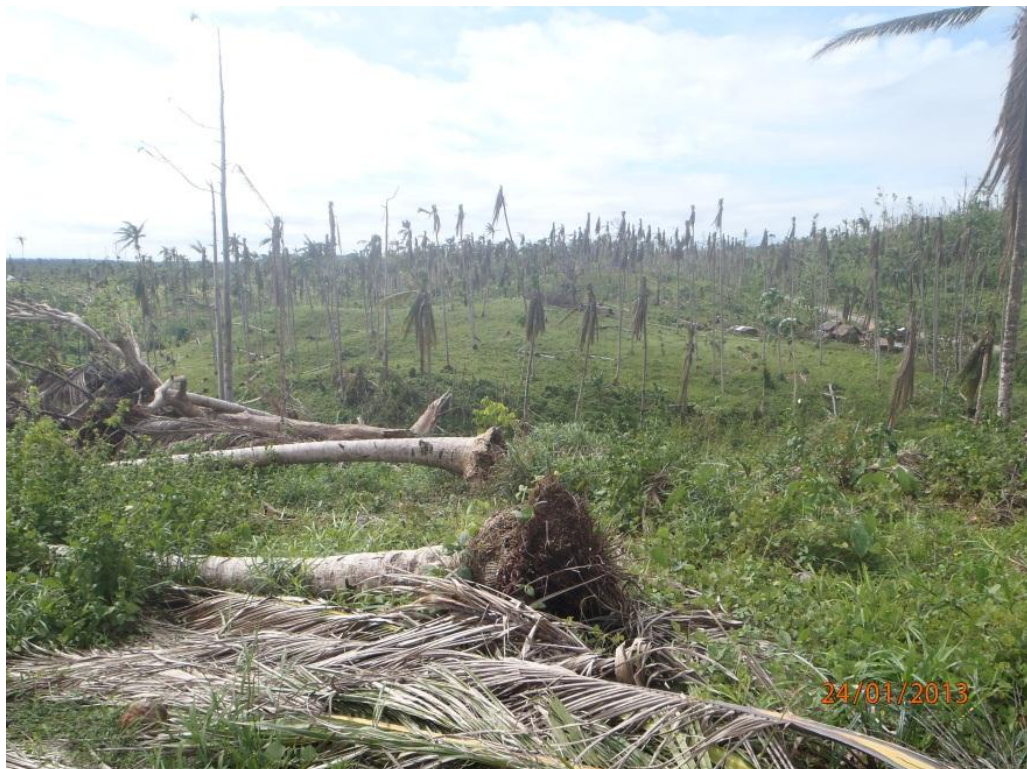
The private land is owned by Mr. Jerry Morales and has a land area of 8 hectares. It is centered approximately in geographic coordinates 7°32'57.1" north latitude and 126°34'7.4" east longitude. The assessed site is characterized by rolling terrain and is located along the National highway. The site is underlain by red silty clay and is presently vegetated with various shrubs and grasses with few remaining coconut trees and bamboos along shallow drainage hollows. Ponding was noted within the property due to the low infiltration capacity of the underlying material. Based on the assessment, the area is ***suitable for residential development*** but proper drainage must be installed in order to confine and direct surface run-off. Minor slope modification is also needed during the development.

*Rolling terrain of the proposed relocation site in So. Paopagon*

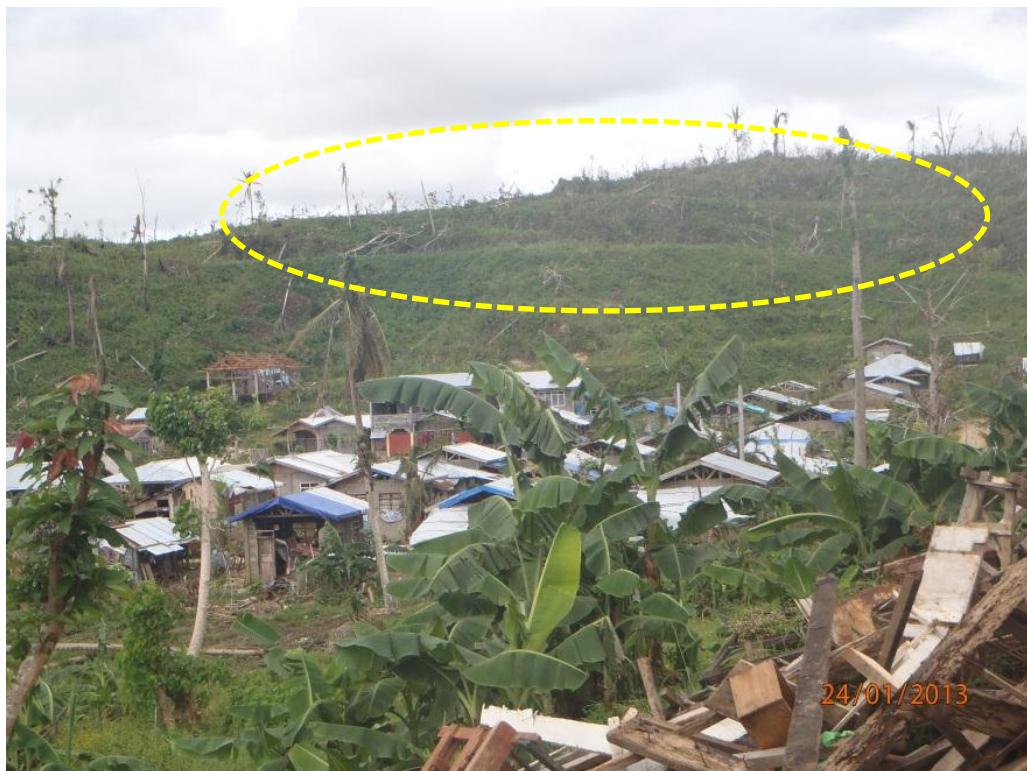
The developed site is situated on a flat to nearly flat land surrounded by moderately steep slopes and is located west of Crispin Roxas National High School. The area can be reached by any type of vehicle through its all-weathered road from the National Highway. The underlying material of the area is composed of limestone. As per interview, the western slope is where the remaining houses are to be built. During the ocular inspection, no slope instability was noted however surface run-off and ponding were observed. Based on the assessment, the area **can be utilized as permanent resettlement site** but installation of proper drainage system must be given emphasis in the development. Slope modification such as benching must also be applied to the west slopes where the additional houses are proposed to be erected.

*Photo of the assessed site taken from Crispin Roxas NHS (looking southwest). The portion encircle is where the additional development is proposed.*

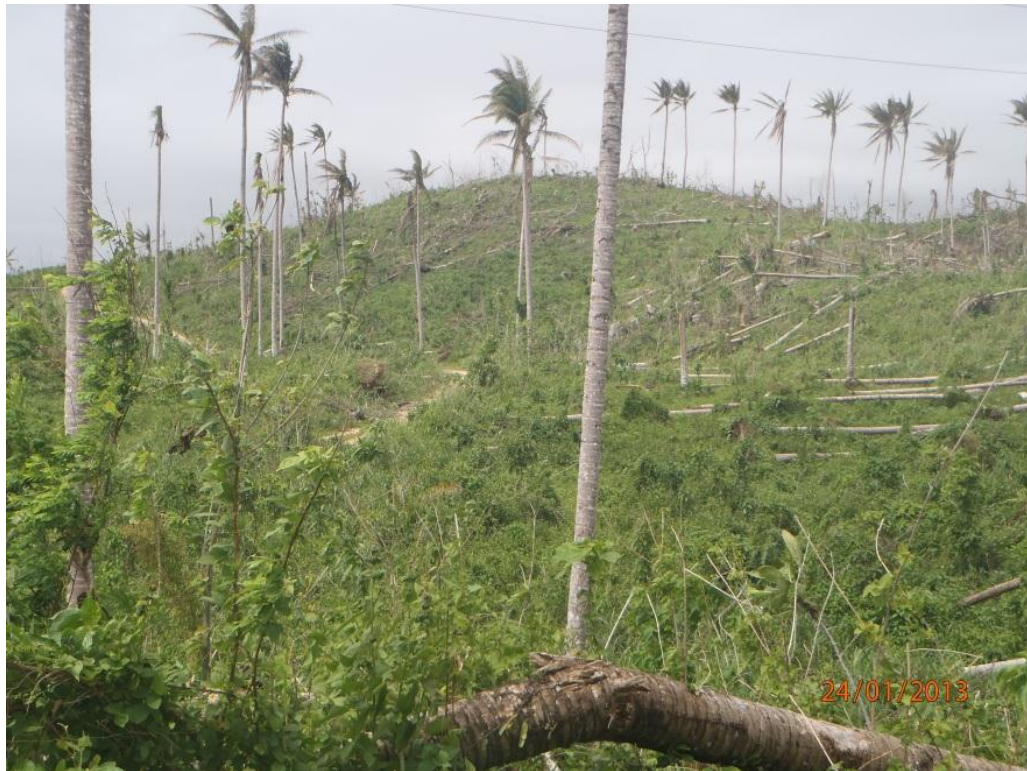
The assessed site has a total land area of 6.3 hectares owned by Mr. Bert Madinansel (2.6 hectare) and Ms. Lilia Casano (3.7 hectares). It is approximately centered in 7°40'53.1" north latitude and 126°32'48.4" east longitude. The site is characterized by rolling terrain and is underlain by limestone and siltstone. North of the area is the well-known Balite Hot Spring. Vegetation in the area consists of cogon, coconut and various shrubs. It is also proximal to an existing dirt road towards the quarry site. Assessment of the area shows that the site **can be developed into residential area**. The hilly portions should be leveled to utilized its maximum capacity and avoid soil erosion. Moreover, appropriate slope modification must also be initiated in sloping areas and proper drainage system be installed. Further, houses to be built in the site should conform to the standards set by the National Code for Buildings and Structures with the foundations designed to ensure stability.

*Rolling terrain of the assessed site*

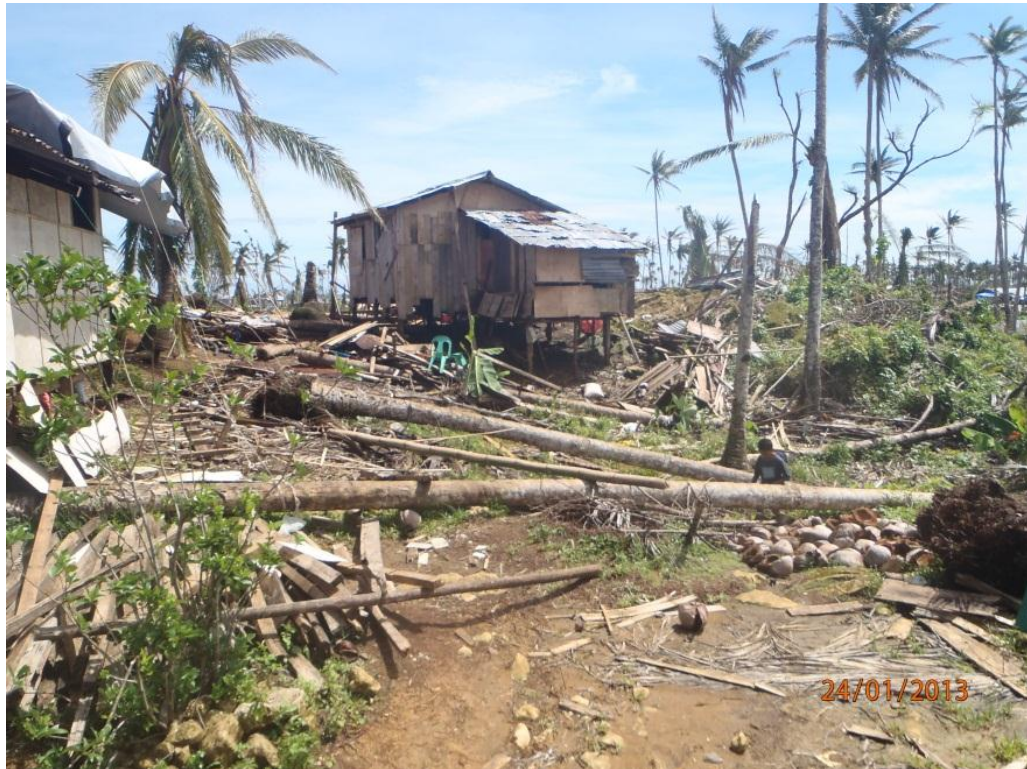
The proposed site in Po. Walingwaling is centered in geographic coordinates 7°41'32.5" north latitude and 126°32'44.9" east longitude and is located proximal to Bankucaan Creek which flows in EW direction. The creek is developed by NIA to irrigate the rice fields at the flat lands. The site is also underlain by calcareous siltstone. At present, the elevated portion of the site is already a built-up area with around 15 houses existing. A drainage/irrigation canal traverses the low-lying area. Based on the inspection, **only the elevated portion should be utilized as a permanent resettlement site** as the

*Upper or elevated portion of the assessed site*

low-lying areas is susceptible to inundation due to the presence of Bankucaan Creek and Irrigation canals. During the development, the hilly section should be leveled and appropriate drainage canals must be installed to direct surface run-off to the creek. Creek bank protection must also be constructed along the Bankucaan creek to mitigate further scouring and erosion.

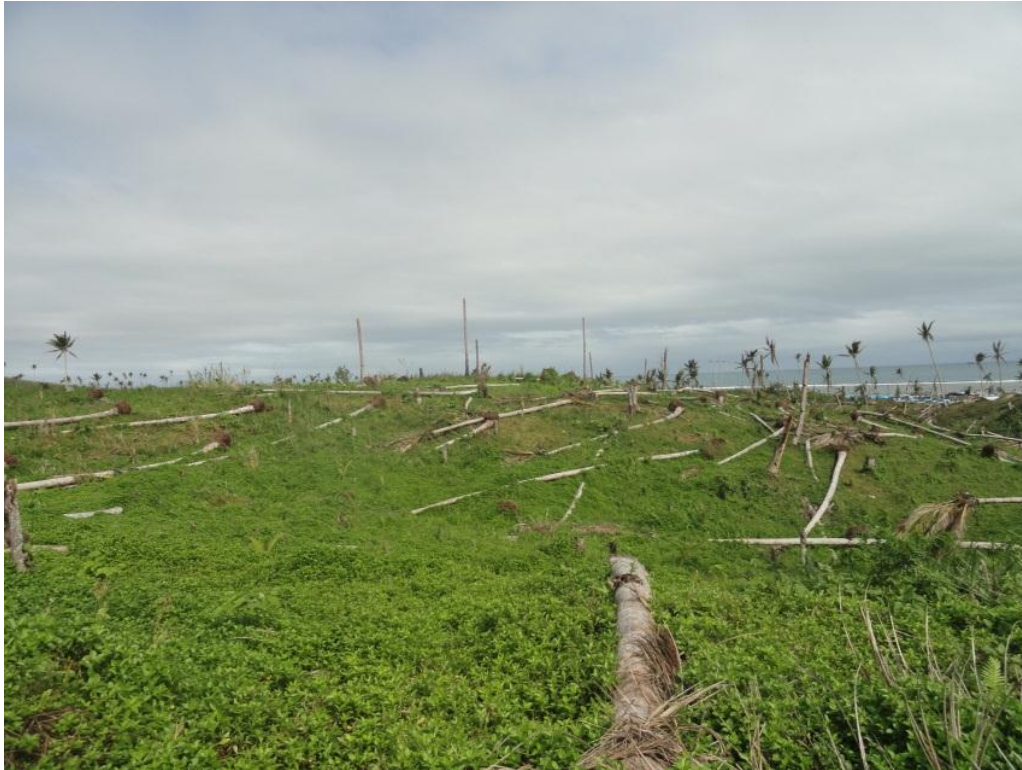
*Gently rolling hill topography of the property.*

Based on field ocular inspection, the area is ***suitable for relocation site***; however, the following recommendation should be strictly follow upon developmental stage to ensure safety. Well planned grading should be undertaken to maximize the land area for residential settlement. In case of development along ravines/ valleys, proper engineering methods such as above mention and or other slope modification should be employed to ensure safety and stability of the ground. Elevating or

backfilling of lower portions of the property is also advised to avoid localized flooding and water ponding and proper drainage system should be installed to efficiently channel water and minimized slope erosion.

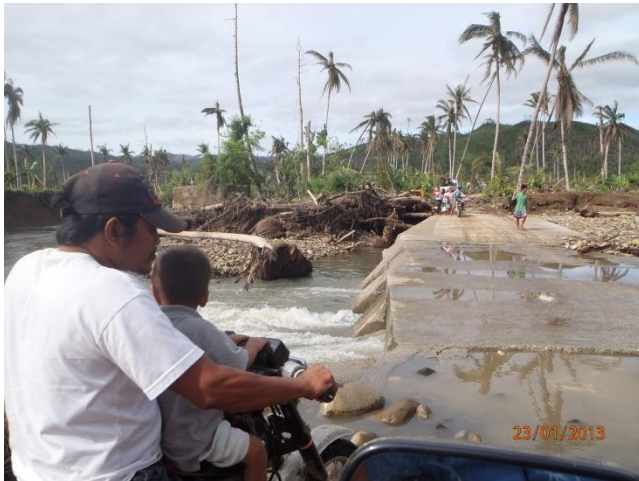
<p>downstream in So. Olin. Active scouring observed along the bank of Olin creek while debris material was noted at the banks of the creek</p> <p>As per interview, highest flooding event that affected the area was in 1948 where floodwater reached to about 3 meters high while in 1990, flooding also affected the area with almost the same flood level during Typhoon Pablo.</p> <p><b>Recommendation:</b></p> <ol style="list-style-type: none"> <li>(1) Relocate residents farther north at the elevated portion of the sitio.</li> <li>(2) Elevate spillway and regularly clear the culverts from debris to avoid damming and overflowing of water</li> <li>(3) Install creekbank protection such as gabions along Olin Creek downstream (spillway)</li> <li>(4) Monitor rapid increase/decrease in creek/river water levels, possibly accompanied by increase turbidity (soil content)</li> </ol>
So. Abuyuan	<b>Low</b> but <b>High</b> at the northern slopes where active shallow landslides were noted	<b>Moderate</b>	<p>So. Abuyuan is drained by two creeks, Olin and Abuyuan creek. During Typhoon Pablo, flood height ranged from 0.5 to 1 meter. Scouring of 3 meters wide was noted along the bank of Abuyuan creek while micro landslides were also observed along the slopes in Olin creek. NIA dam was damaged due to flood debris.</p> <p><b>Recommendation:</b></p> <ol style="list-style-type: none"> <li>(1) Transfer houses near creeks to the elevated portion of the sitio.</li> <li>(2) Design flood-adaptive houses such as houses on stilts</li> <li>(3) Monitor rapid increase/decrease in creek/river water levels, possibly accompanied by increase turbidity (soil content)</li> <li>(4) Monitor slope failures along the creeks that can possibly result to damming and eventually flashflooding</li> </ol>

*Spill way of Olin Creek, in So. Olin, Brgy. Mahan-ob. Water regularly overflow in this area during heavy precipitation or long duration of rain*

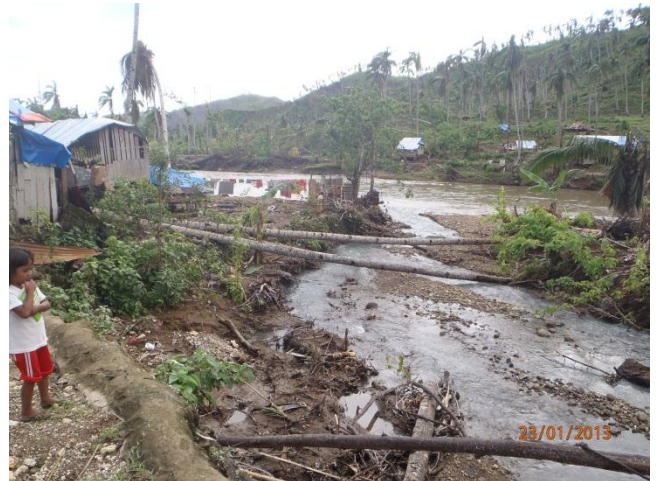
*Danger zone in So. Coog, brgy. Mahan-ob. Confluence of Coog creek and Mahan-ob River*

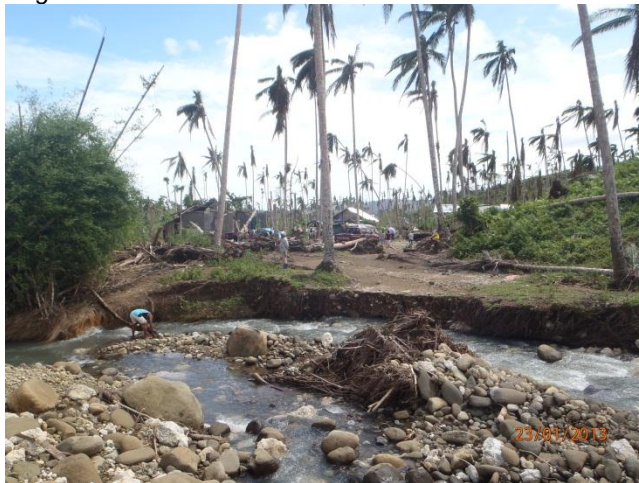
*Abuyuan creek in So. Abuyuan, Brgy. Mahan-ob*

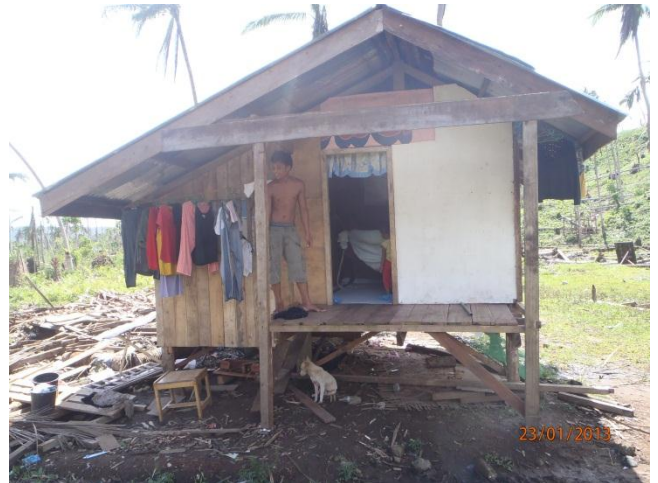
*Flood-adaptive houses in So. Abuyuan*

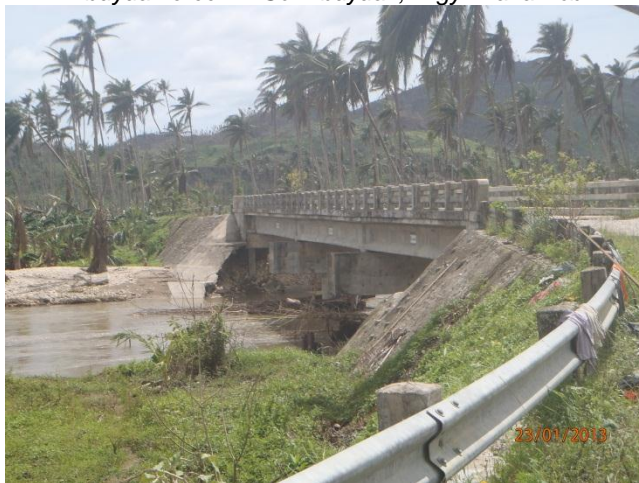
*Scoured footing at the aproach of the bridge to Brgy. Batiano*

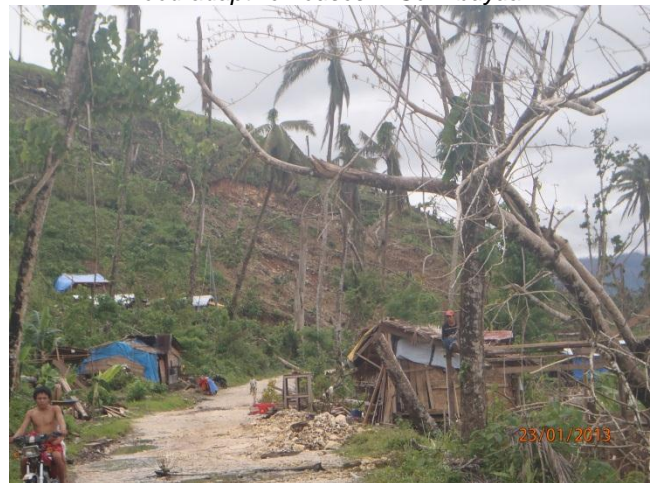
*Active shallow landslide in So. Baboy, Brgy. Central*

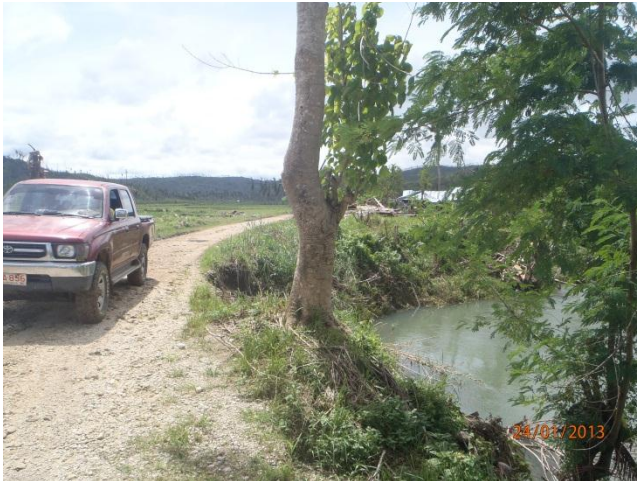
natural drainages	
So. Masao	<b>Moderate</b> in the surrounding slopes	<b>Moderate</b> in most areas but <b>High</b> along Masao Creek	Riverbank erosion observed along Masao Creek. In some portions scouring of the barangay road was also observed  <b>Recommendation:</b> (1) Install proper drainage system that would accommodate the maximum surface run-off recorded in the area and its vicinities. (2) Design flood-adaptive houses such as houses on stilts on areas with low to moderate susceptibility to flooding (3) Construct bank protection such as gabions particularly along meanders or bends of Masao creek that may likely affect the barangay road (4) Monitor rapid increase/decrease in creek/river water levels, possibly accompanied by increase turbidity (soil content)
So. Dum-ag	<b>None</b>	<b>High</b> in areas along Masao Creek but <b>Moderate</b> in other areas	<b>Recommendation:</b> (1) Install proper drainage system that would accommodate the maximum surface run-off recorded in the area and its vicinities. (2) Design flood-adaptive houses such as houses on stilts on areas with low to moderate susceptibility to flooding

*Creek nak scouring in So. Masao, Brgy. Dapnan*

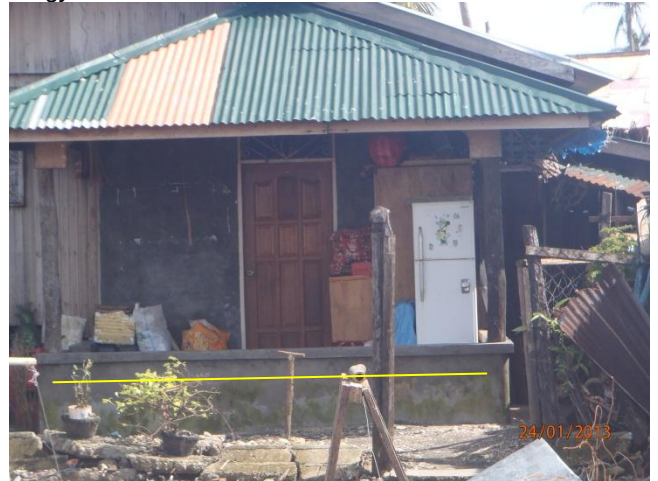
Po. Aster	<b>None</b>	<b>Moderate</b>	<p>Situated on a spit landform and backswamp vegetated with nipa, coastal erosion is very evident. The area is also affected by strong waves during storm surge. Ponding of water is noted</p> <p><b>Recommendation:</b></p> <ol style="list-style-type: none"> <li>(1) Back swamps should not be converted into residential zones as these areas are susceptible to coastal flooding and water ponding</li> </ol>

*Flood height in Po. Aster, Brgy Lucod*

<ul style="list-style-type: none"> <li>(2) Maintain a 20-buffer zone from the coastal shores</li> <li>(3) Provide suitable canals or spillway to allow excess water to easily flow out during heavy rains</li> <li>(4) Design flood-adaptive houses such as houses on stilts</li> </ul>
So. Angel's Trumpet	<b>None</b>	<b>Low</b>	<p><b>Recommendation:</b></p> <ul style="list-style-type: none"> <li>(1) Provide suitable canals or spillway to allow excess water to easily flow out during heavy rains</li> <li>(2) Design flood-adaptive houses such as houses on stilts</li> <li>(3) Install cross drains to prevent ponding of water and allow continuous flow of surface run-off</li> </ul>
<b>Barangay Mahan-ob</b>			
So. Coog	<b>High</b>	<b>Moderate</b> at the elevated slopes but <b>High</b> in areas adjacent to Mahan-ob River	<p>Sheet flooding that affected So. Coog Proper was mainly due to damming of culvert along Coog creek by debris during typhoon Pablo. Flood height in areas proximal to the barangay road including Coog ES reached to about 0.5 meters while houses situated near Coog creek and Mahan-ob river were submerged under 1-meter flood water.</p> <p><b>Recommendation:</b></p> <ul style="list-style-type: none"> <li>(1) Declare the low-lying area proximal to Mahan-ob River as no habitation zone</li> <li>(2) Increase the size of round culvert to allow maximum flow of water during heavy or prolonged precipitation. If possible, replace culverts with box culverts of appropriate size.</li> <li>(3) Design houses on stilts to allow continuous flow of water during flooding event</li> <li>(4) Regular maintenance/clean-up of the channel from debris</li> <li>(5) Install proper canals to confine surface run-off from natural drainages or drainage hollows</li> <li>(6) Monitor rapid increase/decrease in creek/river water levels, possibly accompanied by increase turbidity (soil content)</li> <li>(7) Observe for and/or monitor for presence of mass movement (e.g. landslide, tension cracks); Report situation to MGB office and the municipal authorities</li> </ul>

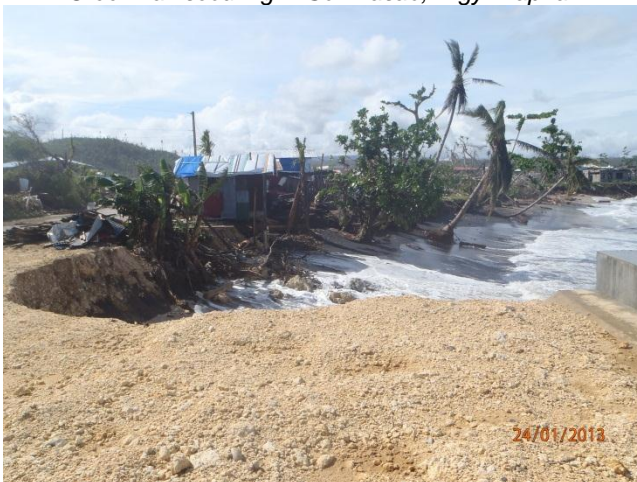
*Coastal erosion in Po. Malinawon, Brgy. Central*

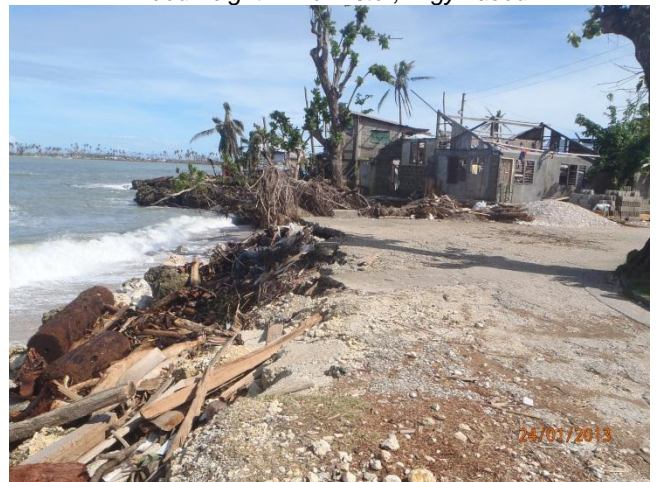
*Active coastal erosion in Po. Durian, Brgy. Central*

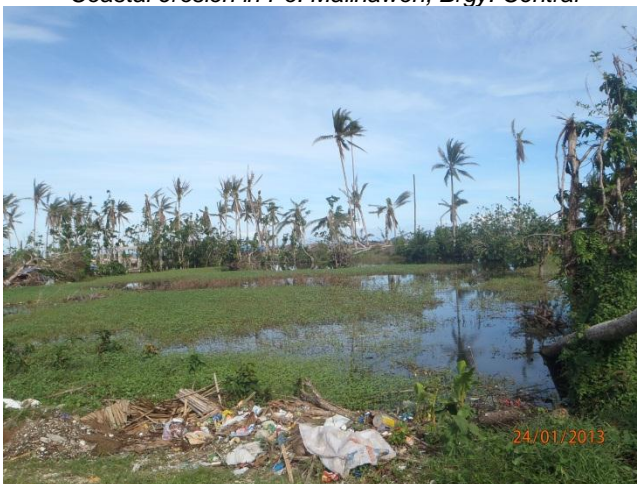
*Water ponding in Po. Baybay, Brgy. Saoquique*

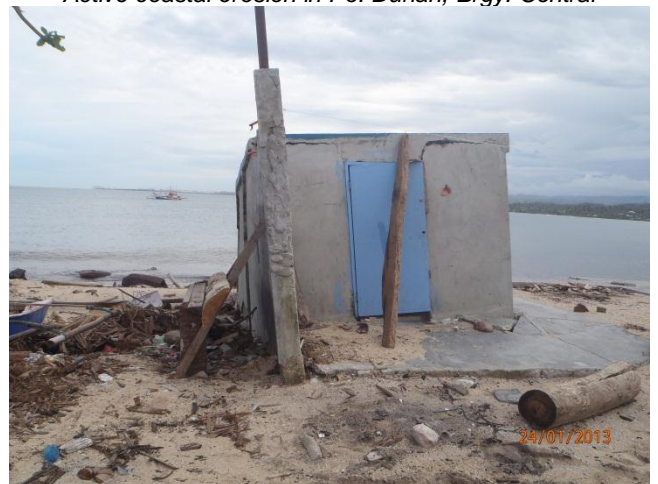
Block 7	<b>None</b>	<b>Low</b>	Liquefaction observed due to intrusion of sea water. Houses are regularly affected by strong waves during extreme weather condition  <b>Recommendation:</b> (1) Install proper drainage system that would accommodate the maximum surface run-off recorded in the area and its vicinities.
Block 8	<b>Low</b>	<b>Low</b> but <b>High</b> at the area proximal to the existing intermittent creek	<b>Recommendation:</b> (1) Install proper drainage system that would accommodate the maximum surface run-off recorded in the area and its vicinities. (2) Declare the area with high susceptibility to flooding as no habitation zone
Block 9	<b>None</b>	<b>High</b> especially at the eastern side of the road and areas proximal to the creek	Presence of perennial creek  <b>Recommendation:</b> (1) Install proper drainage system that would accommodate the maximum surface run-off recorded in the area and its vicinities. (2) Declare the area with high susceptibility to flooding as no habitation zone and relocate to the elevated portion west of the national road

*Effects of liquefaction in Block 7, Brgy/ Lambajon*
