RESULTS OF THE MGB LANDSLIDE AND FLOOD ASSESSMENT (1:10,000 SCALE) OF PARTS OF BOSTON IN THE PROVINCE OF DAVAO ORIENTAL

MUNICIPALITY OF BOSTON, DAVAO ORIENTAL

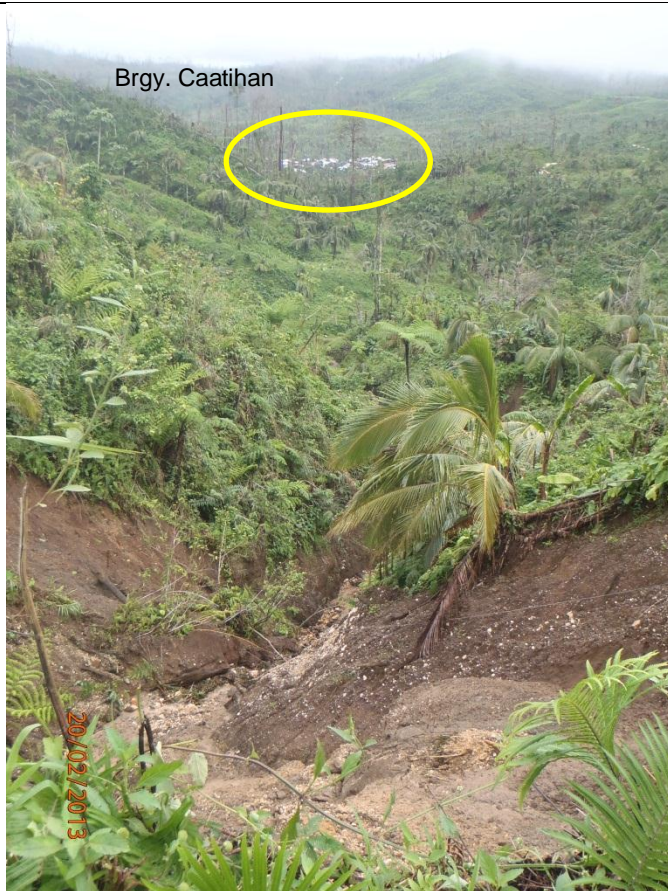
Earth flow noted along the barangay road to Brgy. Simulao.
(Looking northeast; GPS Location: 7°53'18.824"N and 126°16'45.12"E)

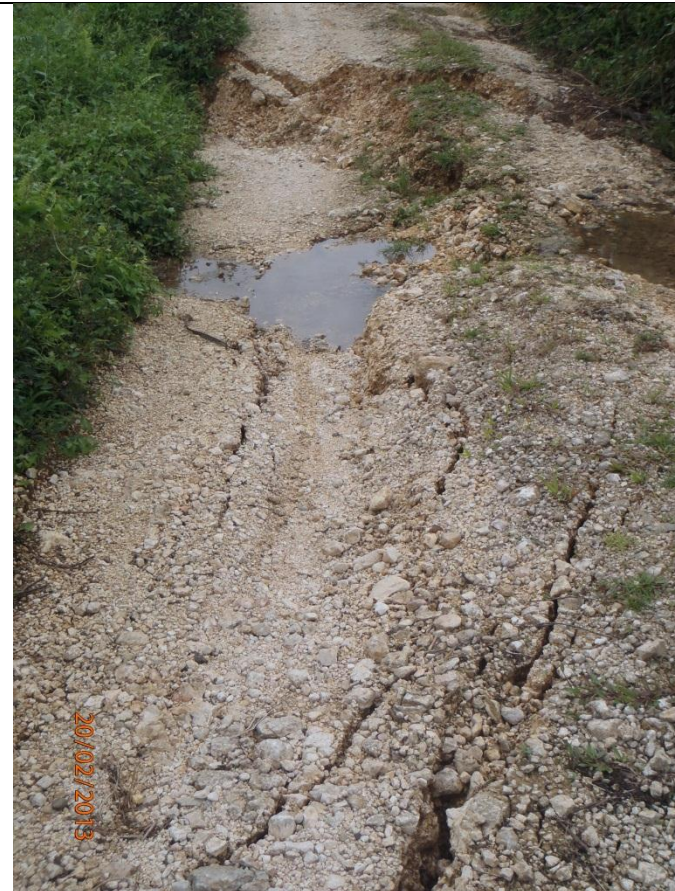
Tension cracks noted along the road going to So. 5M, Vertical displacement of 10 cm and horizontal displacement of 5 cm. Surface water is noted to seep into the cracks
(Looking southwest; GPS location: 7°54'37.438"N 126°18'33.114"E)

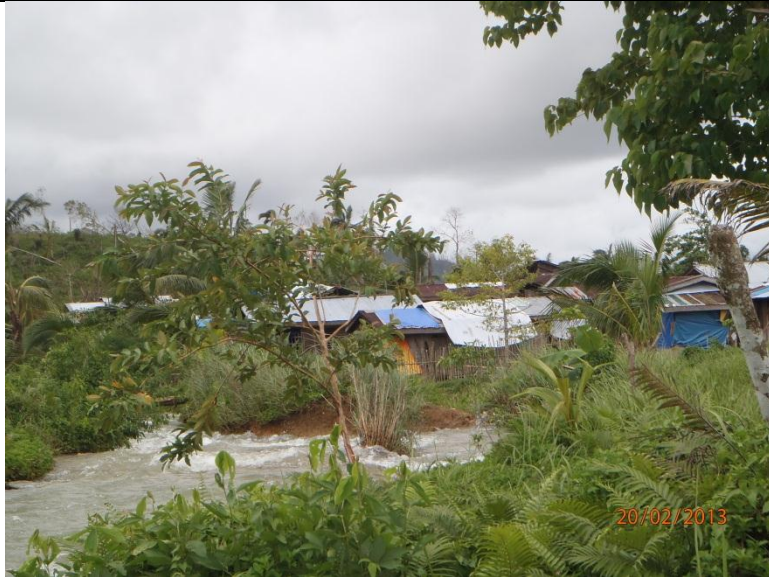
Caatihan River which inundates Po. 2 and Po. 3.
(Looking northwest; GPS location: 7°53'44.313"N 126°17'7.541"E)

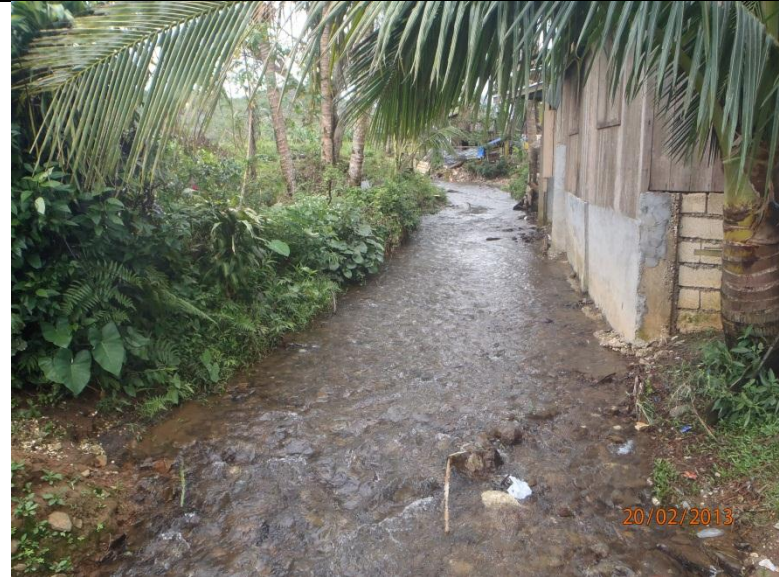
Houses proximal to Biasong creek in Po. 4
(Looking west; GPS location: 7°53'55.121"N 126°16'59.435"E)

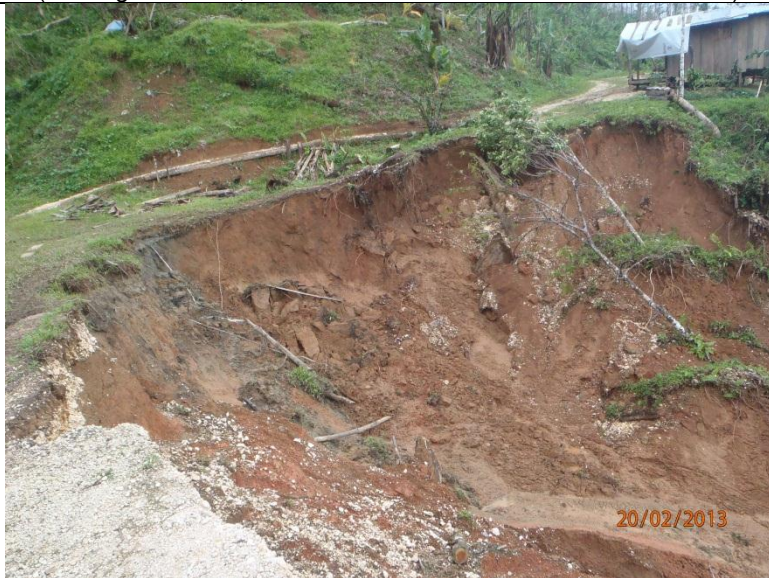
Earth flow in So. 5m along the barangay road
(Looking southwest; GPS location: 7°55'54.464"N 126°18'9.746"E)

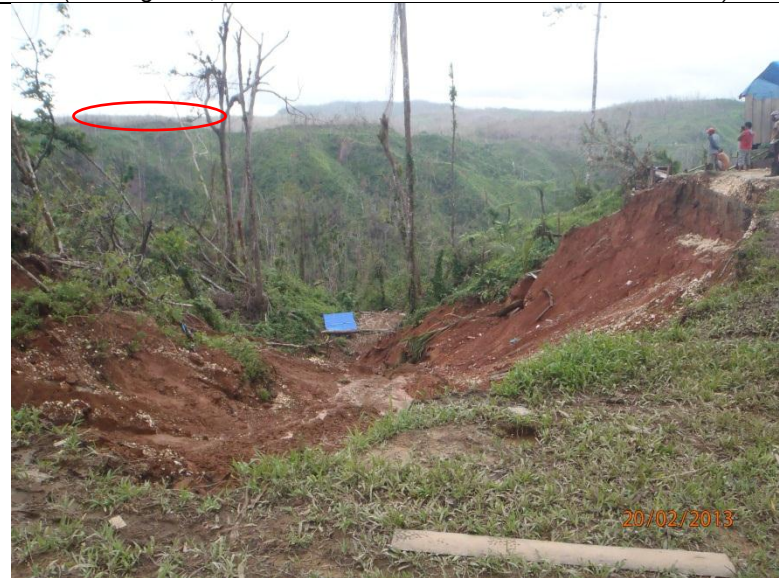
Proposed relocation site of So. 5M
(Looking north; GPS location: ~ 7°57'0.114"N 126°18'21.738"E)

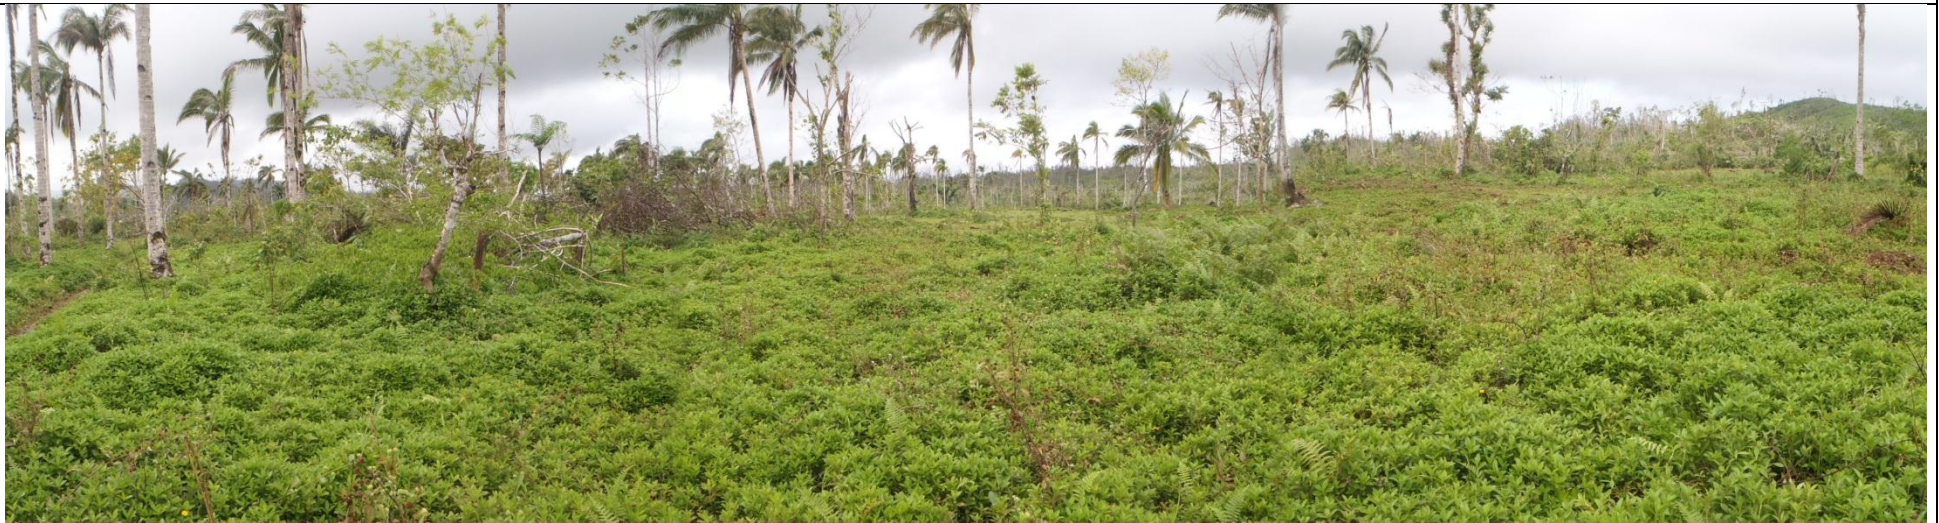
Flat terrain of the proposed relocation site of Brgy. Caatihan (Looking north; GPS location: 7°53'54.128"N 126°17'5.911"E)

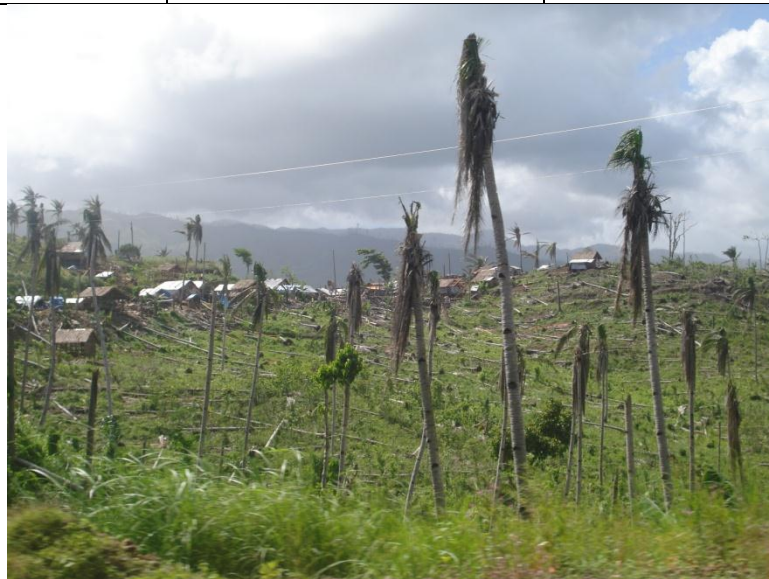
Po. Mahayahay, Brgy. Cabasagan with moderate slopes

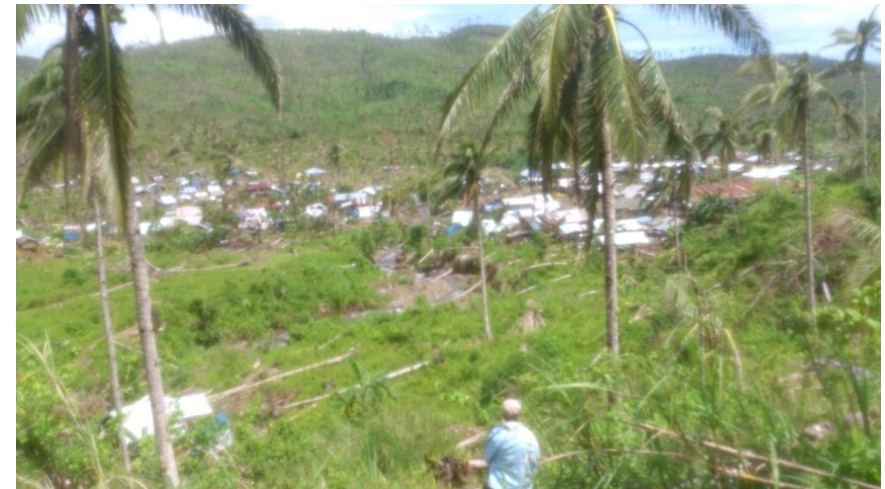
Po. Ipil-ipil, Bry. Cabasagan. Photo taken looking downslope towards the north

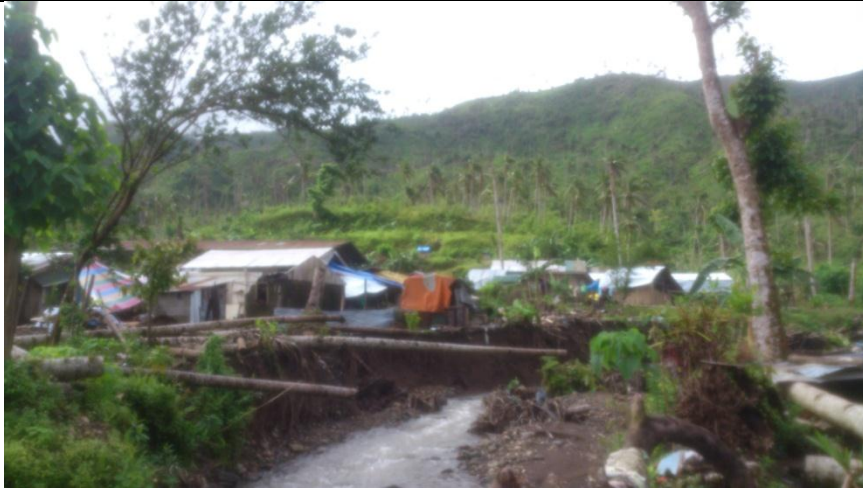
Accelerated river bank erosion in Po. Ipil-ipil, Brgy. Cabasagan

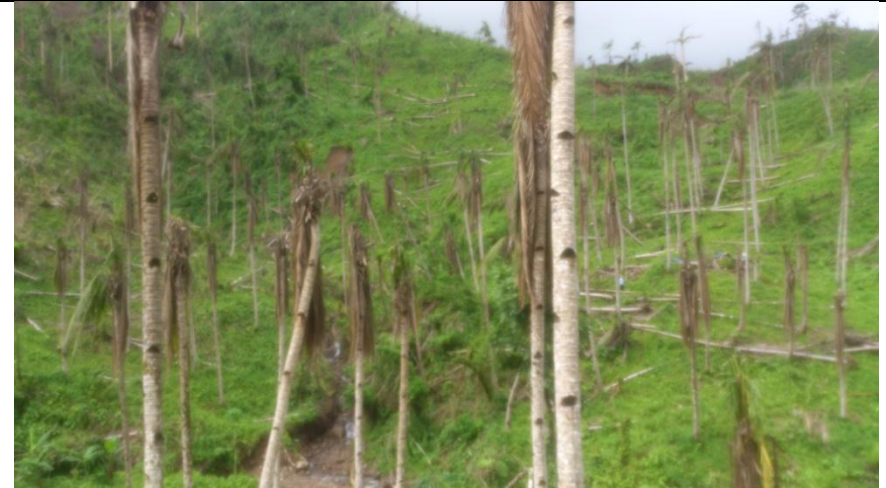
Landslide along flanks of Magtagum Aug Creek in Po. Ipil-ipil, Brgy. Cabasagan

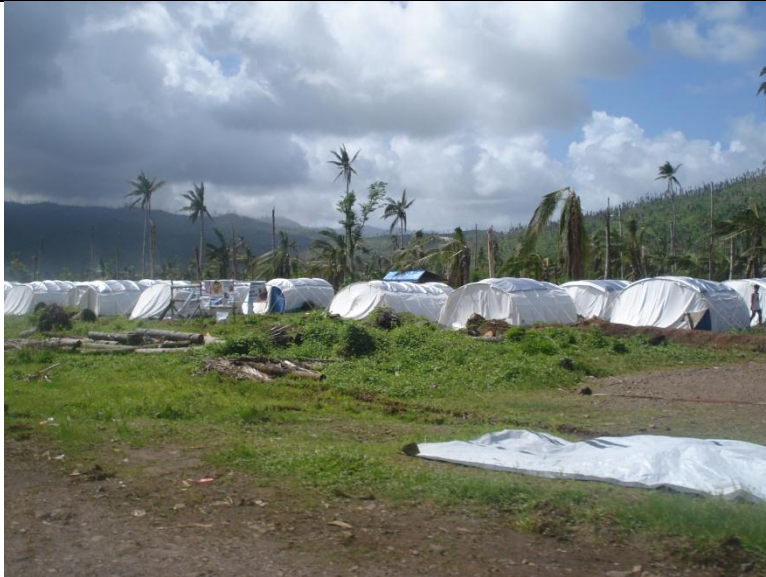
Proposed relocation site in Po. Narra, Brgy. Cabasagan

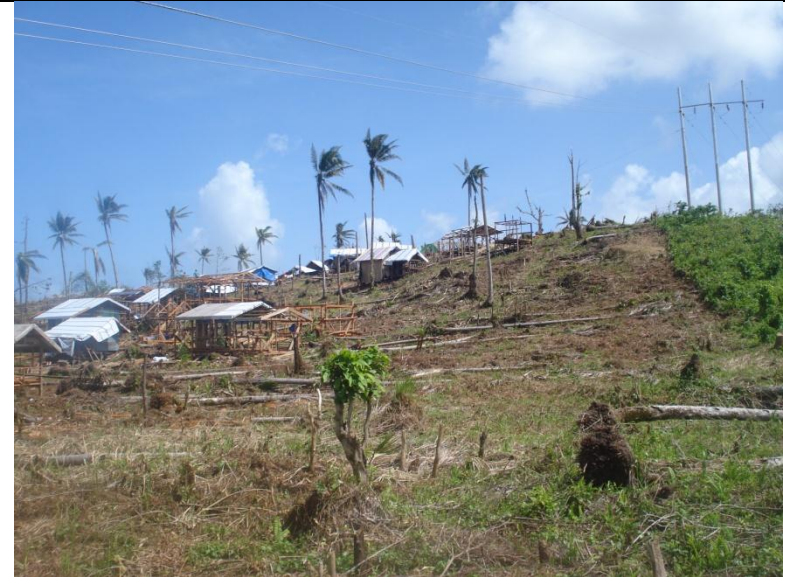
Moderate slopes within the relocation area

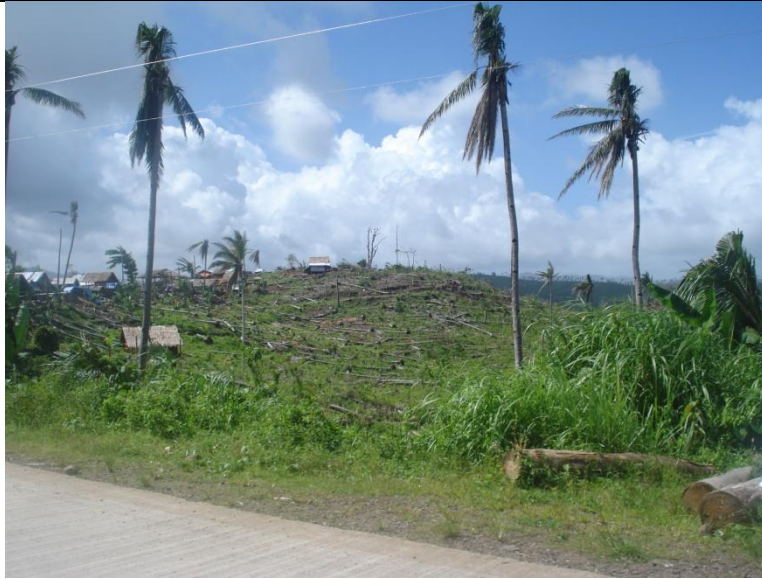
Gentle slopes along the eastern side of the relocation site

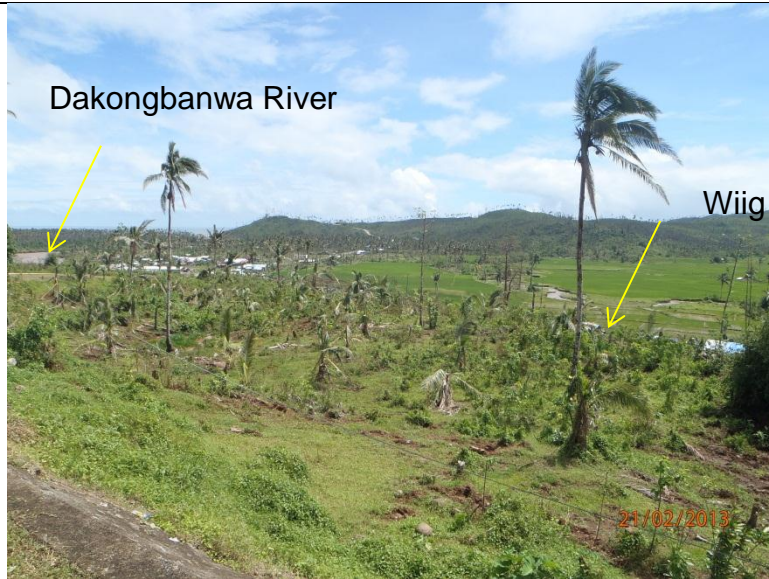
Brgy. Carmen as seen from the ridge
 (Looking southeast; GPS location: 7°52'15.932"N 126°21'5.482"E)

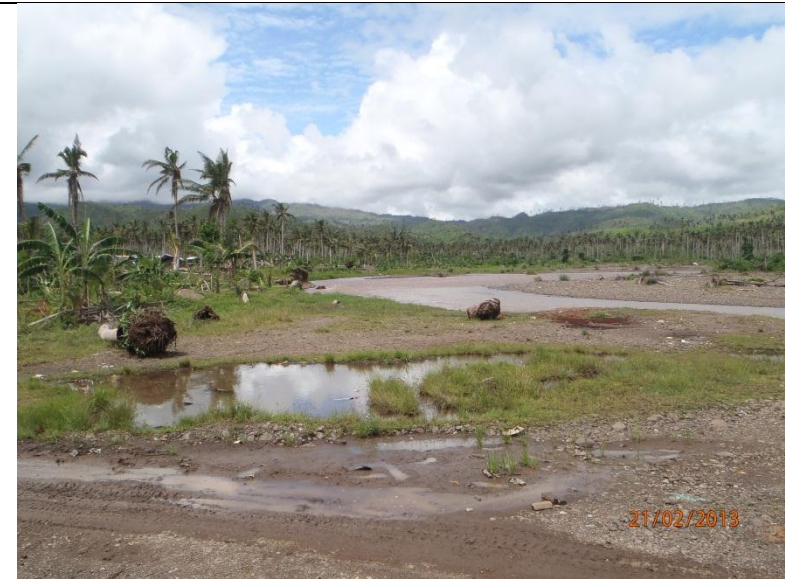
Dakongbanwa River is actively shifting during flooding events, community to the left is Po. Mangga (Looking west; GPS location: 7°52'14.766"N 126°20'58.944"E)

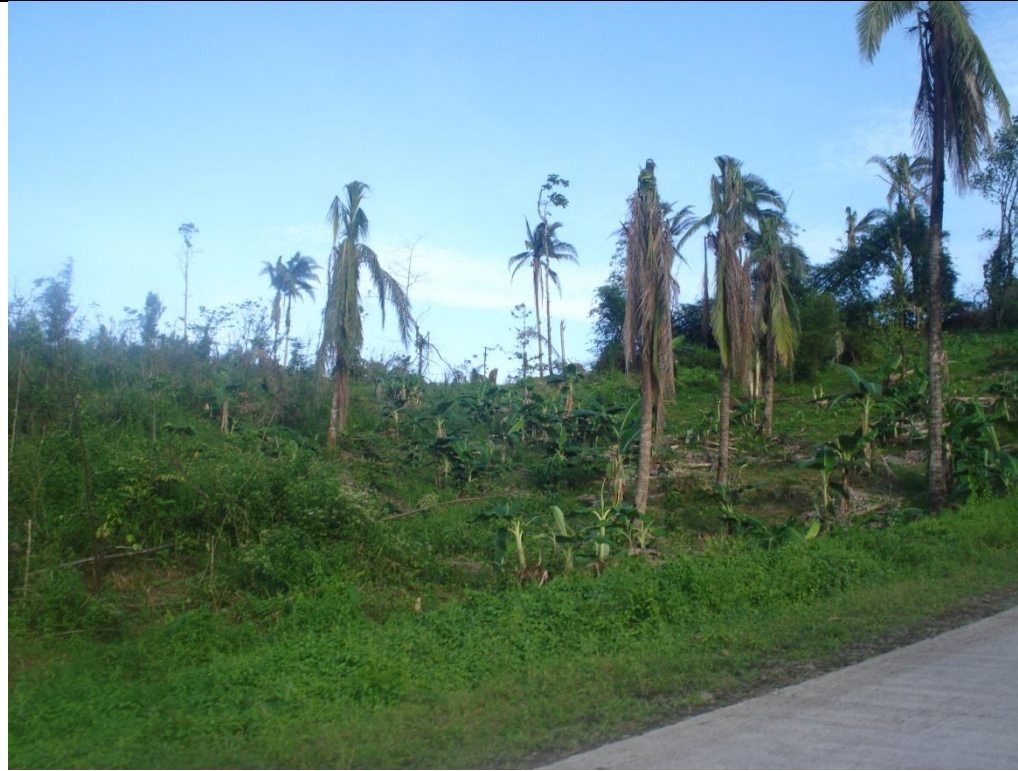
Moderate slopes within the central portion of the proposed relocation site

- Establish proper drainage systems in the future residential communities to efficiently drain storm waters from the slopes.
- Appropriate ground preparation and site grading must be implemented to maximize the usable space in the area as well as attain optimum ground stability.
- A section located south of the national highway should not be utilized as residential area as this portion shows indications of mass movement and is within a gully which serves as a channel for water that drain from the upslope region.

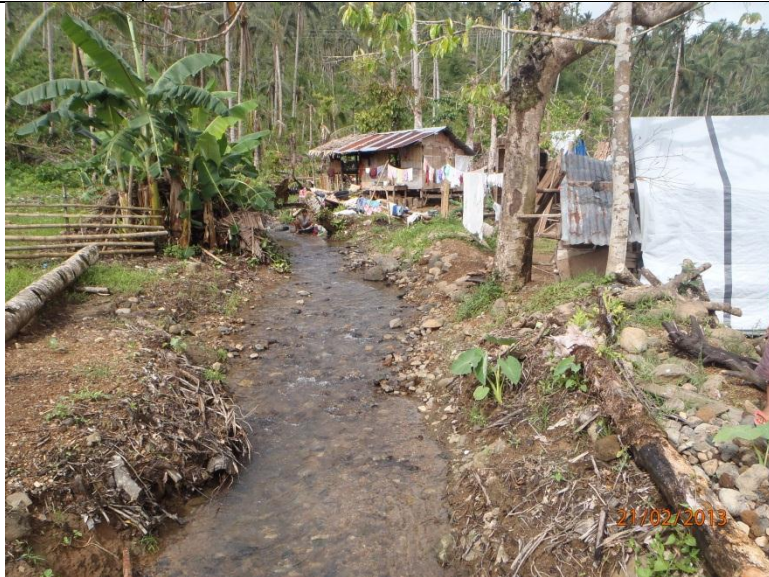
Perennial creek in So. Tigbawan which inundates the whole sitio during heavy rains
(Looking west; GPS location: 7°53'55.168"N 126°21'12.006"E)

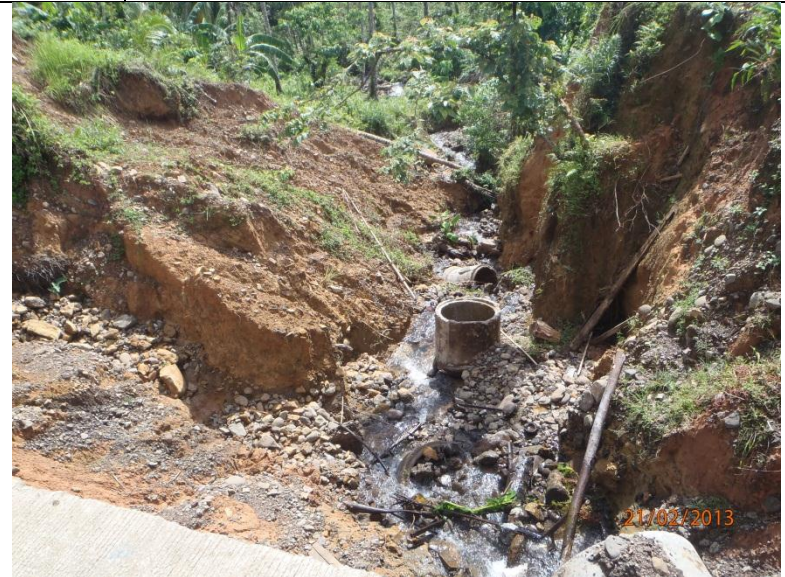
Earthflow and gully development in Po. Baclinan 2 along the national highway
(Looking southeast; GPS location: 7°53'29.765"N 126°21'6.383"E)

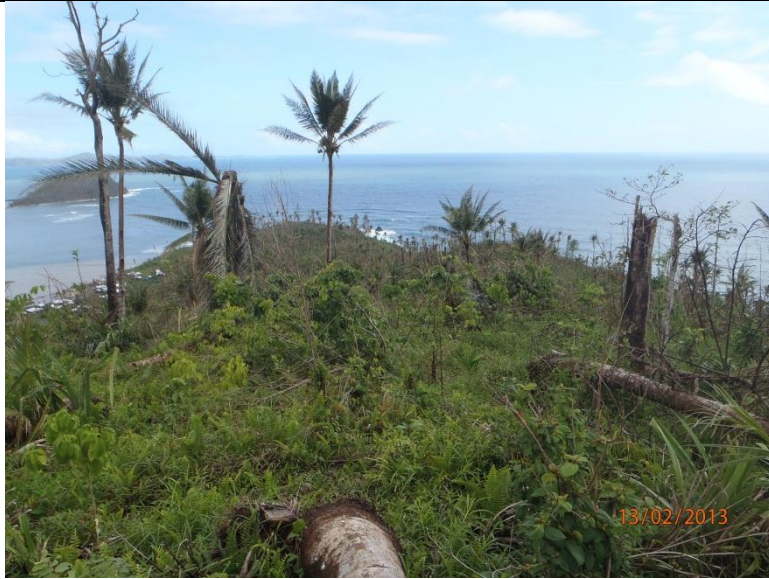
Relocation site (Castillones et al property)
 (Looking north east; GPS Location: 7°51'46.597"N 126°22'40.028"E)

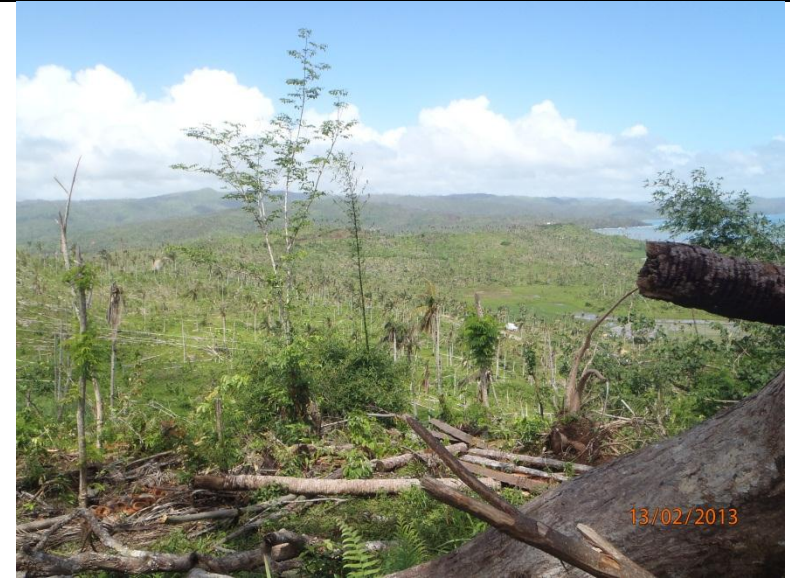
Relocation Site (Uy et al property)
 (Looking northwest; GPS location: 7°51'48.649"N 126°22'7.638"E)

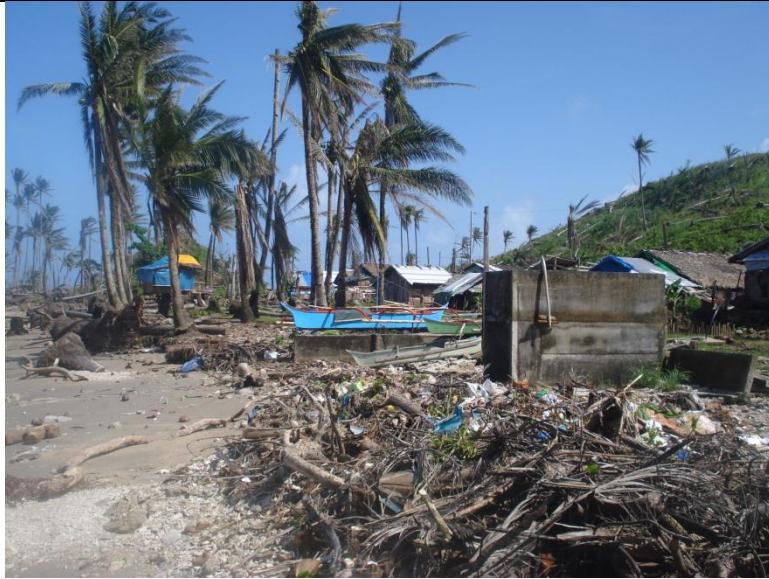
Houses in Po. Mangga 2, Brgy. Sibahay which are very close to the waterline.
Shoreline exhibits active coastal erosion

SIBAHAY			
Mangga 2	Low	Low (High very near the shoreline)	<ul style="list-style-type: none"> Relocate houses situated very close to the shoreline as progressive coastal erosion have been observed
Mangga 1	Low	Low (High very near the shoreline)	<ul style="list-style-type: none"> Relocate houses situated very close to the shoreline as progressive coastal erosion have been observed
Caimito	Very High		<ul style="list-style-type: none"> Relocate residents located downslope of the present slope failure along highway road cut across Sibahay Elementary School Constantly monitor slopes especially during heavy rainfall events Develop early warning systems including signage
Bong-on	Moderate	None	
Durian	High	None	<ul style="list-style-type: none"> Monitor signs of mass movement such as cracks, seepages etc. Report events to concerned agencies and LGU's
Marang	High	None	<ul style="list-style-type: none"> Relocate residents specially houses built along edges of very steep slopes

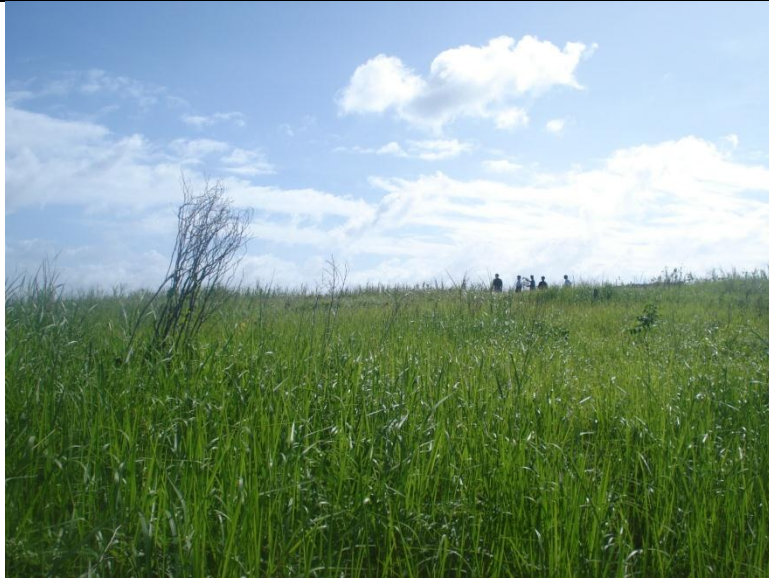
Flat terrain comprising majority of the area in the proposed relocation

- Strict implementation of no build buffer zones along edges of slopes considering the elevated location of the relocation site.
- Drainage networks should be properly designed and established in order properly channel storm waters and avert flooding and inundation in the lower elevation valley sections.

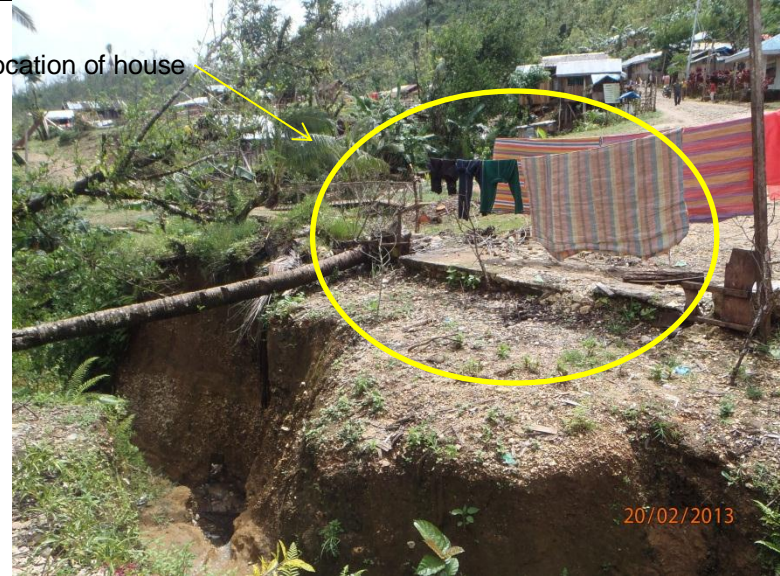
Scouring along the bank of a perennial creek in Po. 3 where 1 house was washed away during Typhoon Pablo.
 (Looking east; GPS location: 7°52'55.404"N 126°14'57.253"E)

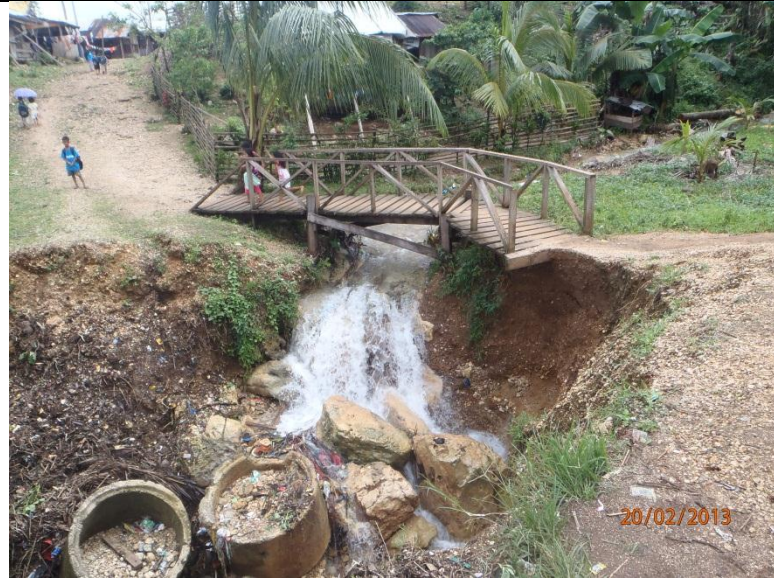
Washed-out culverts along Tugop Creek. Active scouring noted
 (Looking east; GPS Location: 7°52'55.387"N 126°14'58.213"E)

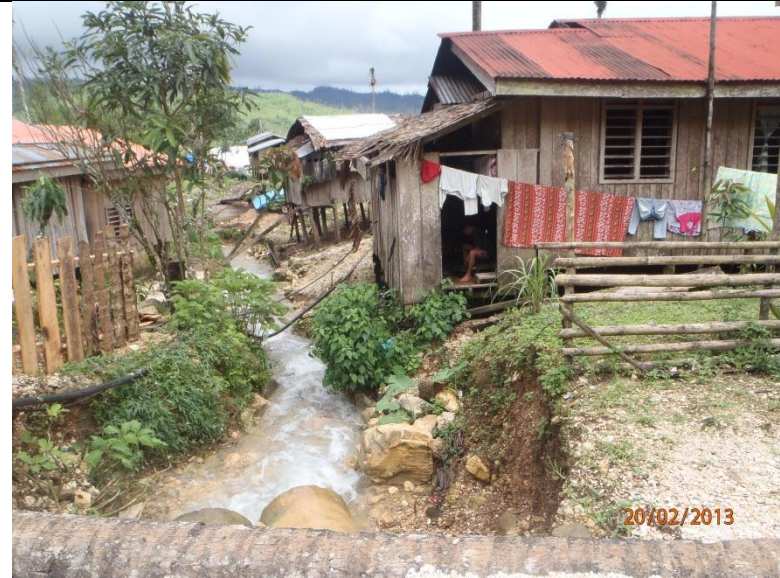
Houses in Po. 2 proximal to Tugop creek which are regularly flooded (0.5 m flood height) are subject for relocation
 (Looking north; GPS Location: 7°52'53.365"N 126°15'0.32"E)

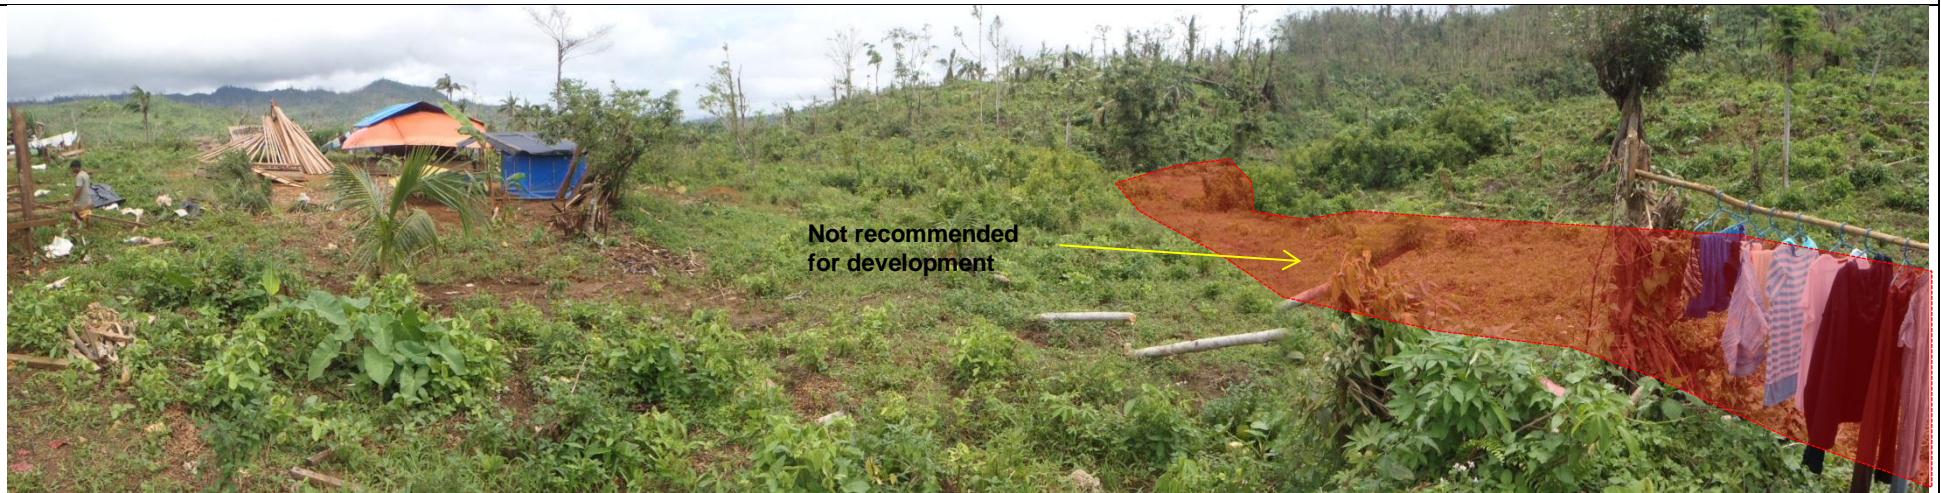
Site 1. Relocation Site (Looking northeast; GPS location: $7^{\circ}52'58.625''\text{N}$ $126^{\circ}15'3.078''\text{E}$)

Site 1. The proposed relocation site is located in Purok 2 and centered approximately in geographic coordinates $7^{\circ}52'58.383''\text{N}$ and $126^{\circ}15'2.543''\text{E}$. It has a land area of about 5 hectares owned by Marjun Latiban. It is characterized by flat to undulating terrain and underlain by limestone and clay as shown in a 2 meter deep pit dug within the property. Boulders of coralline limestone were also noted to be scattered in the area. Ponding is also observed which indicates low infiltration of water due to the type of the underlying material composed generally of clayey soil. Based on the inspection, the area can be utilized as a relocation site however proper drainage system should be installed in the area that can accommodate maximum surface runoff from the surrounding areas. The lower section east of the property is not recommended for development as this serves as a natural drainage of the area.

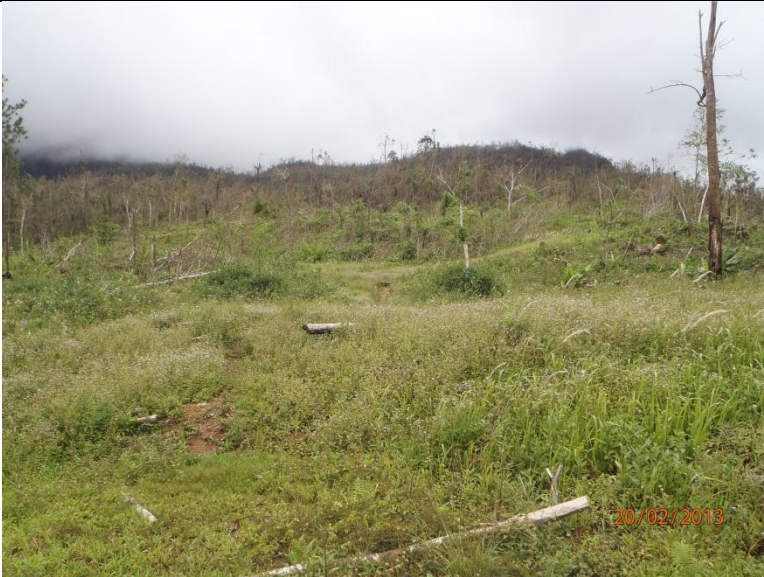
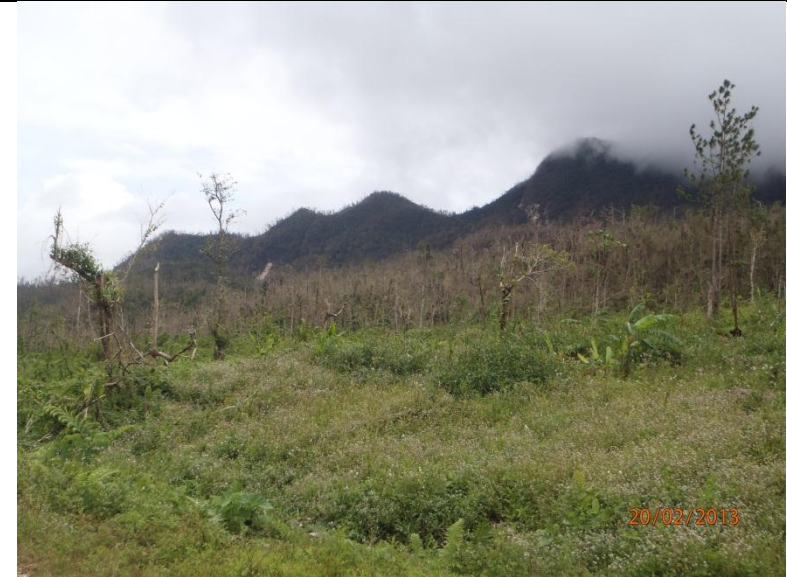
Site 2. Tarok Relocation Site (Looking south(left) and southeast (right); GPS Location: 7°52'36.333"N 126°15'13.852"E)

Site 2. The proposed site (Tarok area) is situated on an elevated area around 700 meters (linear distance) southeast from the barangay proper with geographic coordinates of $7^{\circ}52'36.317''\text{N}$ and $126^{\circ}15'13.948''\text{E}$ at 520 masl elevation. The property is owned by Mr. Willy Ombaogan with land area of about 6 hectares. The area is characterized by flat to undulating terrain with its vicinity drained by several intermittent and perennial creeks. The underlying material is composed of coralline limestone. The area is suitable for land development particularly resettlement site however it is advised that considerations should be given in the drainage system of the area as presence of ponds and lakes were observed in the vicinity. The area should also be inspected if there is presence of caves, cavities or sinkholes underneath prior to land development to mitigate occurrence of land subsidence in the future.
