RESULTS OF THE MGB LANDSLIDE AND FLOOD ASSESSMENT (1:10,000 SCALE) OF PARTS OF CATEEL IN THE PROVINCE OF DAVAO ORIENTAL

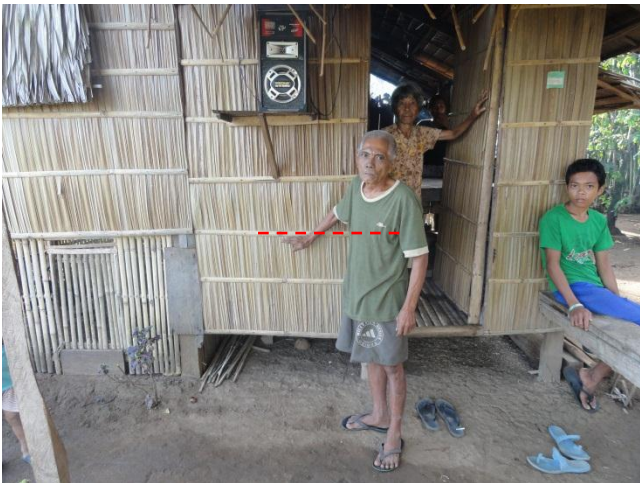
Flood height as indicated by local residents in So. Panan-awan

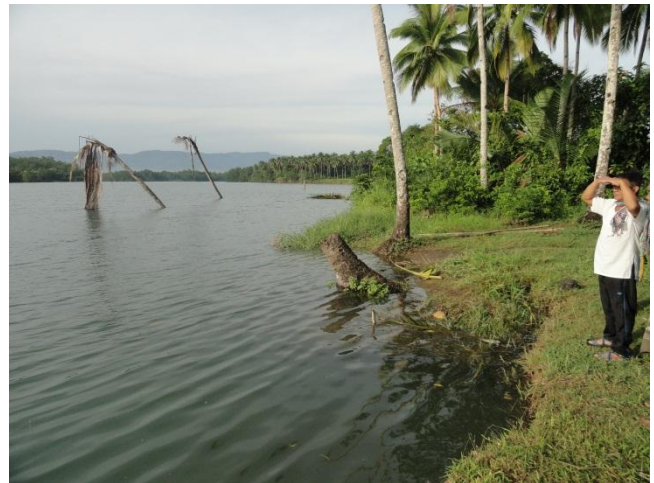
Scoured river bank and water level of Cateel river during high tide in So. Panan-awan

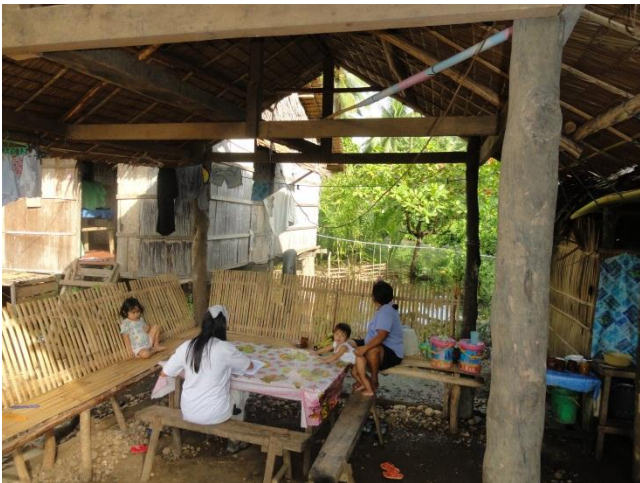
Houses in So. Cogon situated along a creek

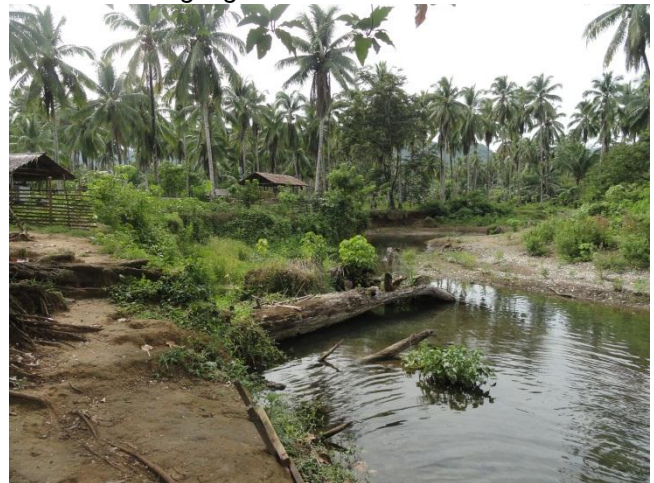
Active riverbank scouring along Lumao Creek

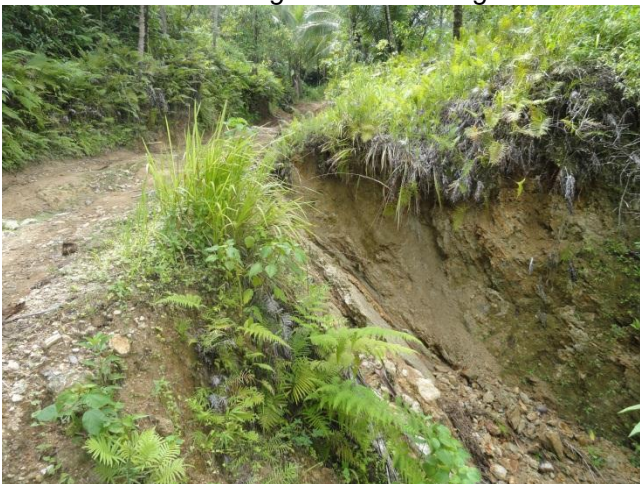
Translatational slide along the road to Canangahan

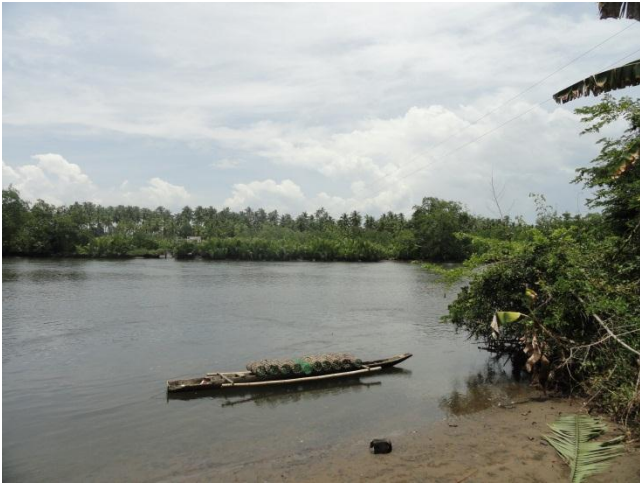
So. Molave in Brgy Baybay is situated on an island bar which is a flood deposit

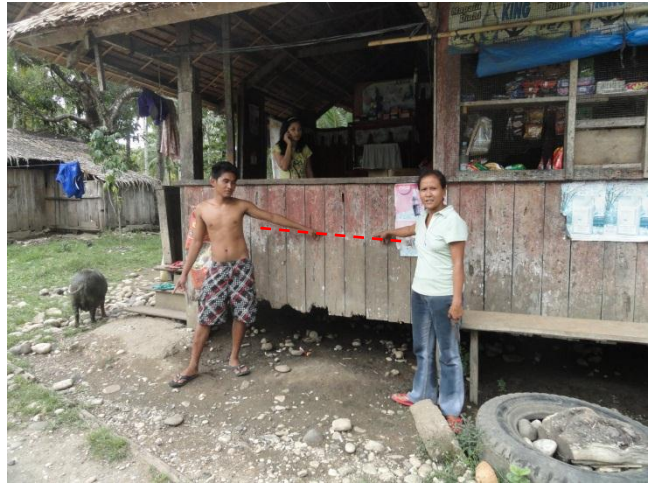
Flood height in Brgy. San Vicente

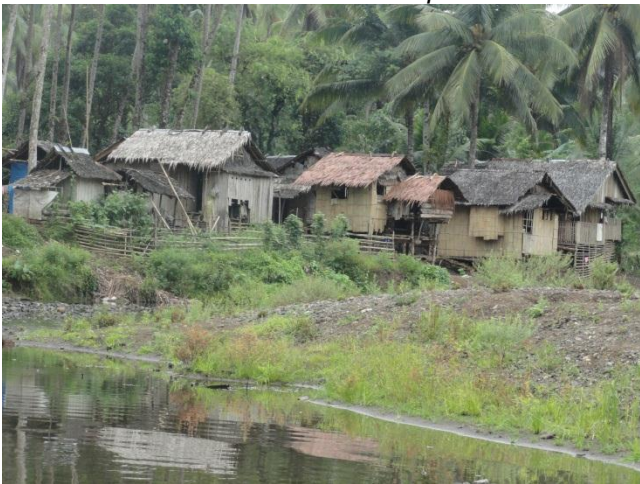
Houses at risk in Phase 2 Brgy. Mainit

officials on geohazard situation; relocation of houses along river banks were scouring is very active
--	--	--	--------------------------------------------------------------------------------------------------------------

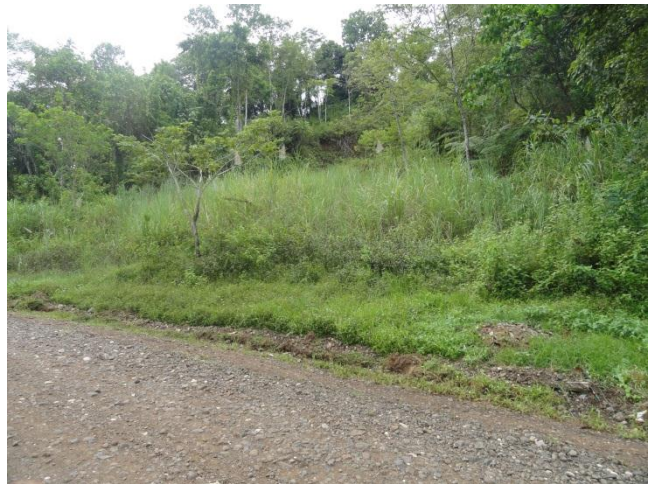
Reactivated rotational landslide directed toward Mainit Brgy Hall and Day Care Center

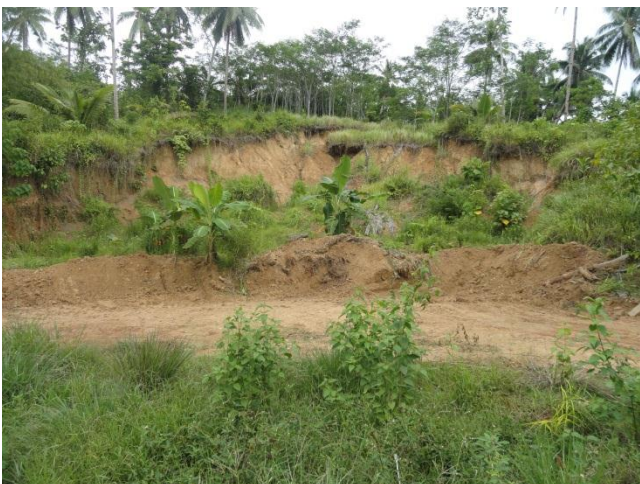
Active slump along the road to So. Canube

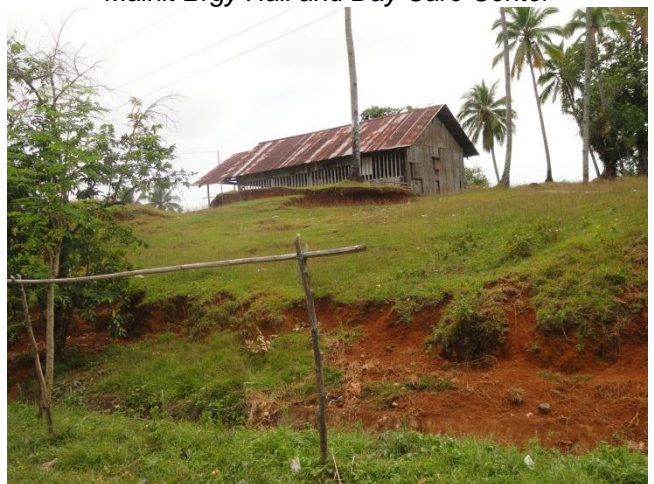
Active slump in Lower Abejod

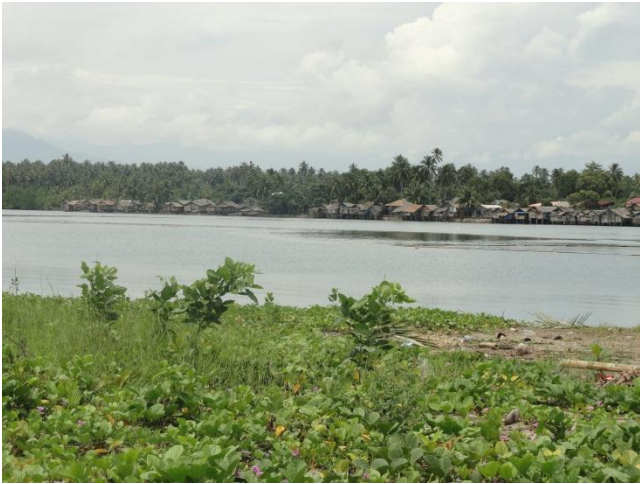
Houses in So. Magupay situated along Cateel Riverbank

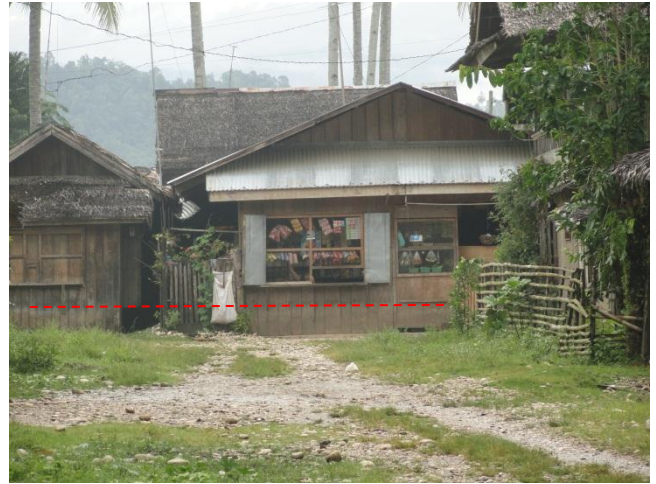
Flood mark in So. Riverside, Brgy. San Alfonso

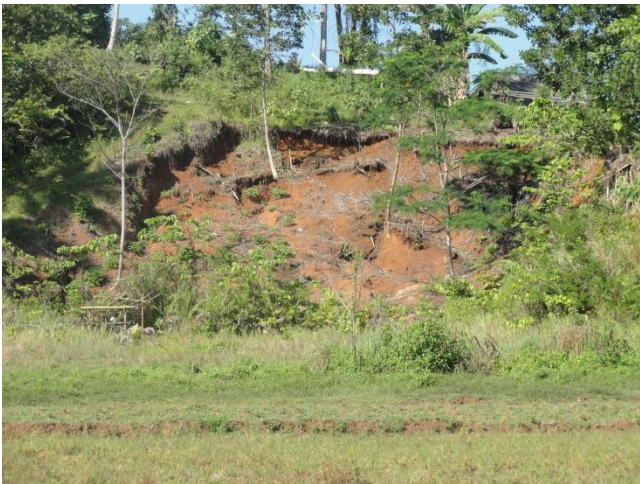
Active slope failure along the road from So. Mangga to So. Magong-ong

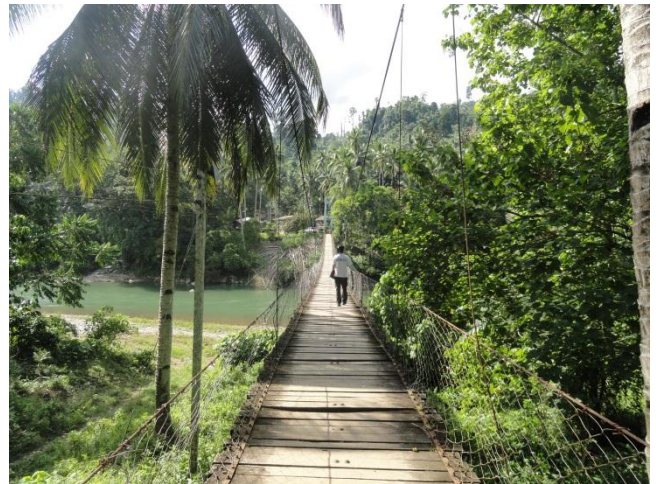
Previously damaged hanging bridge by floodwater in Brgy. Maglahus
