MINES AND GEOSCIENCES BUREAU R-10

RESULTS OF THE MGB RAPID GEOHAZARD ASSESSMENT OF BARANGAYS IN ILIGAN CITY, LANA DEL NORTE

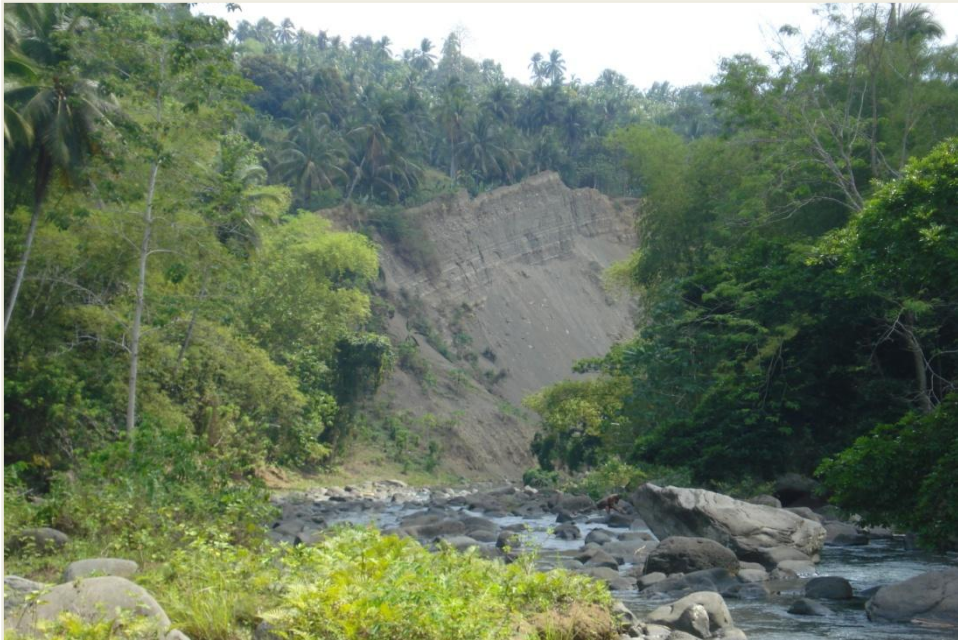
Photo 1. Landslide along Iligan River in Zone 12, Brgy. Abuno

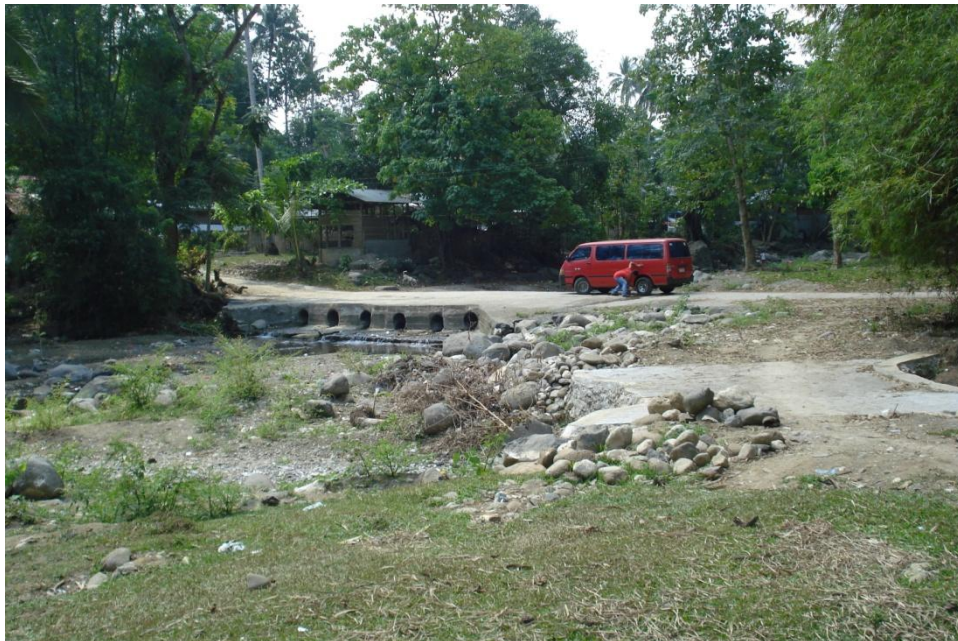
Photo 2. Flooding along Malindawag Creek affects nearby Zone 4 in Brgy. Abuno.

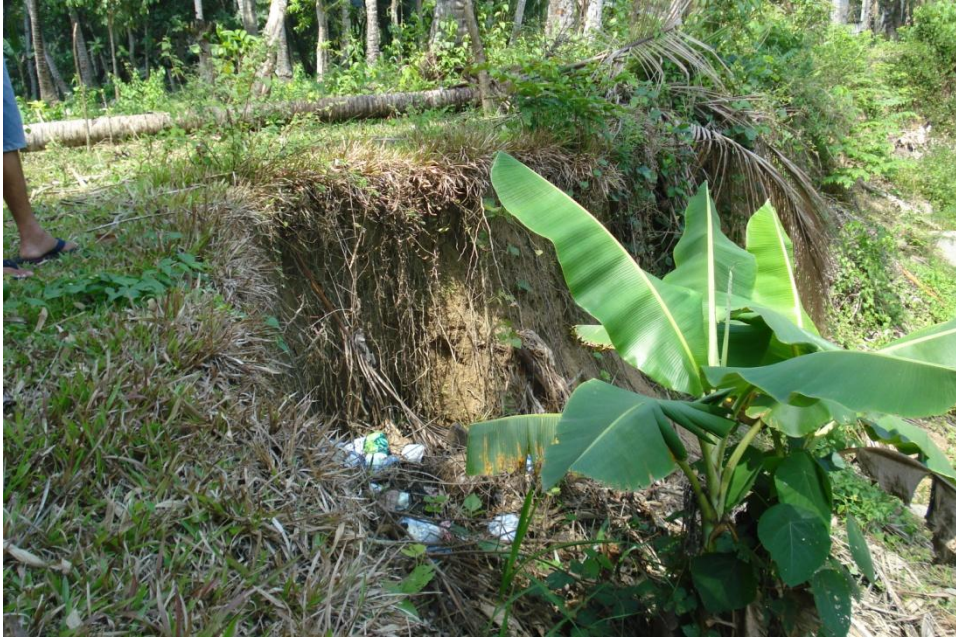
Photo 3. Riverbank erosion was observed along Iligan River in Isla Verde Village, Zone 4, Brgy. Abuno.

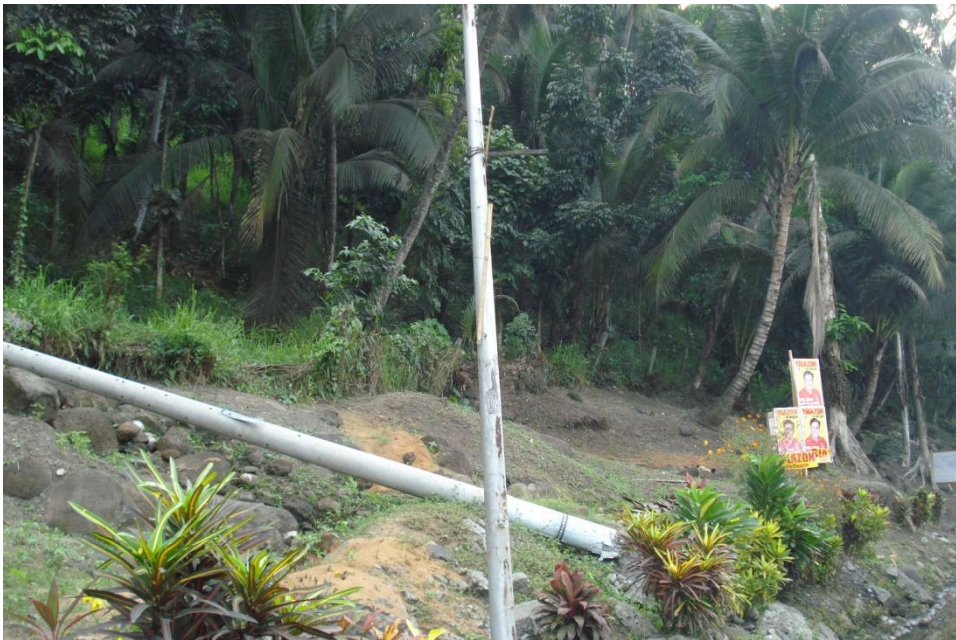
Photo 4. Ground creep was observed along the highway in Brgy. Buru-un as evidenced by bent coconut trees.

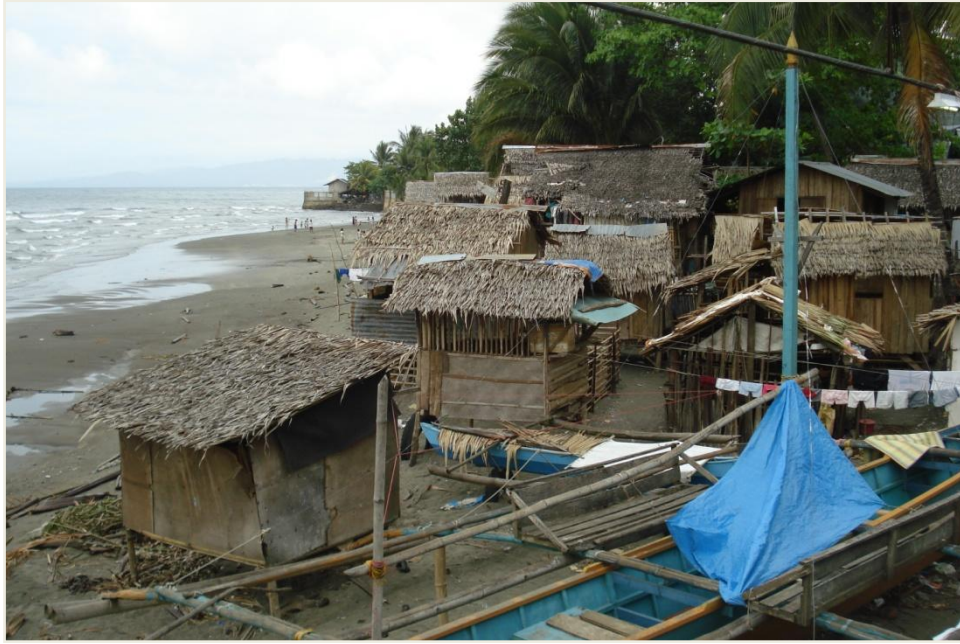
Photo 5. Coastal puroks such as Purok 1A in Brgy. Buruun are prone to storm surge.

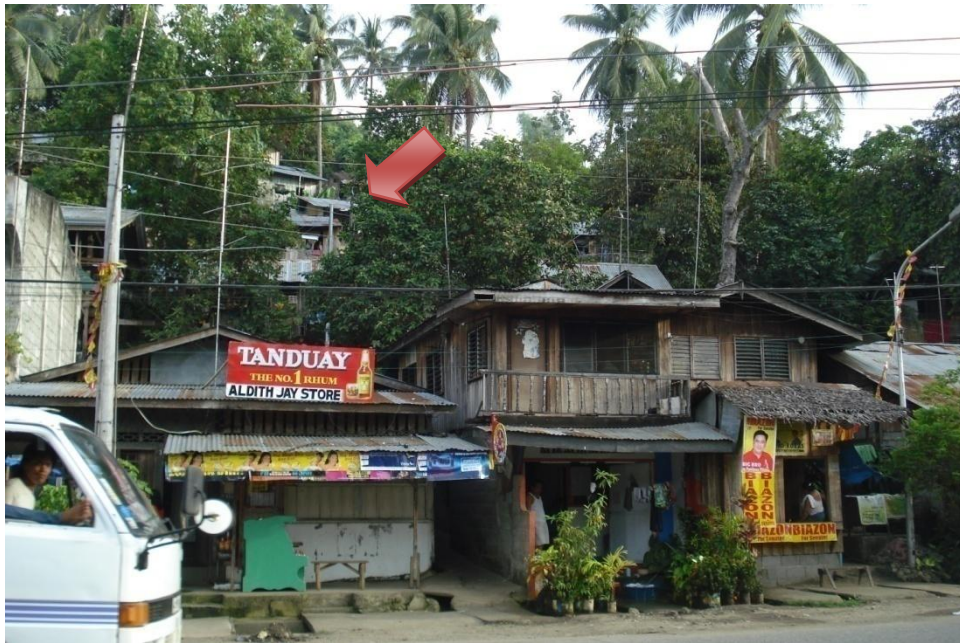
Photo 6. Numerous houses (indicated by red arrow) were built on steep slopes along the highway in Purok 1B, Brgy. Buruun.

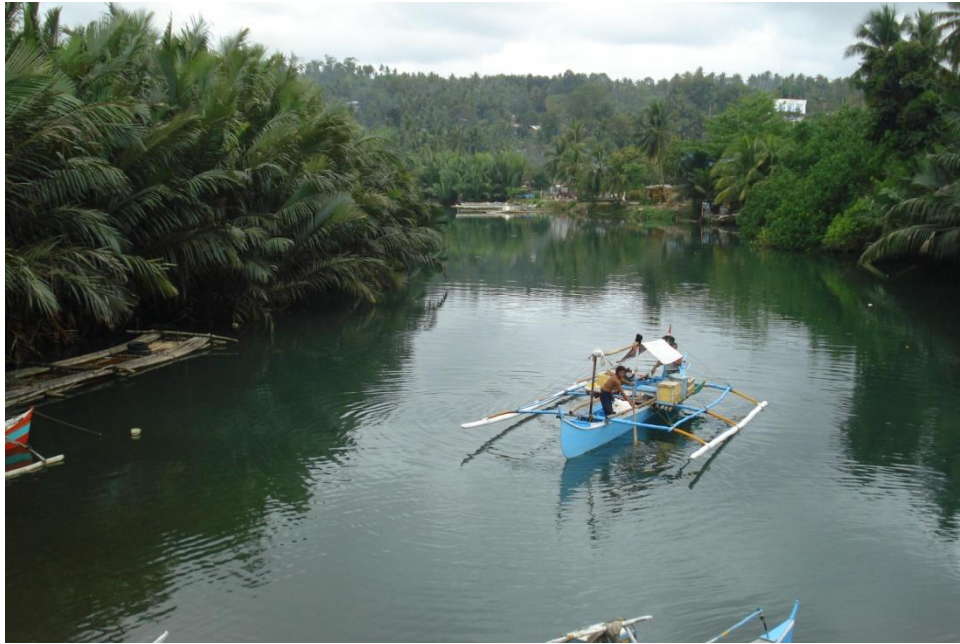
Photo 7. Linamon River, which serves as the boundary between Iligan City and neighboring Municipality of Linamon, is prone to flashfloods that devastate puroks along the river in Brgy. Buruun.

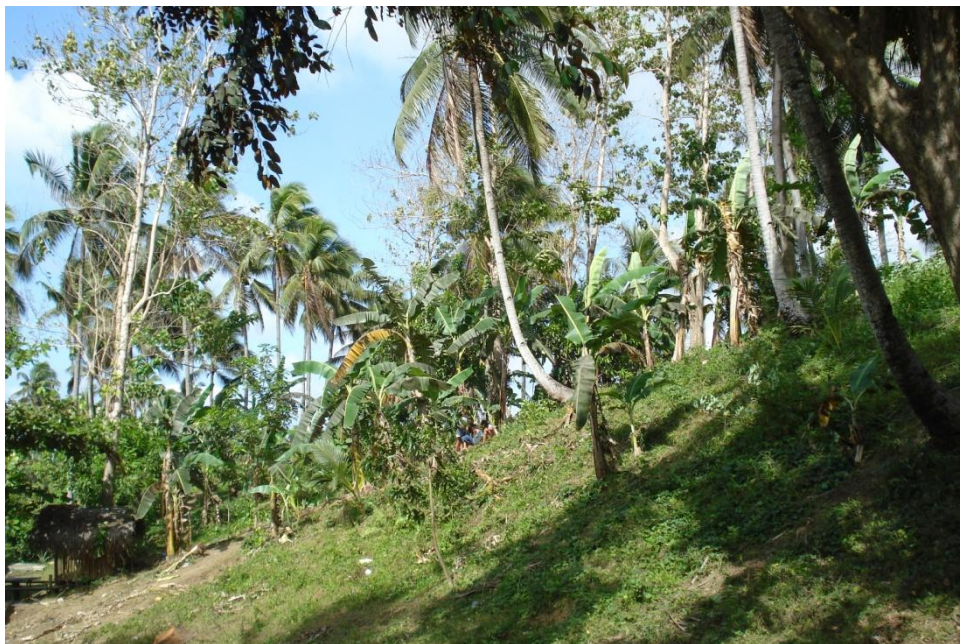
Photo 8. St. Vincent Bel-Air Village, Brgy. Suarez' resettlement area is characterized by relatively steep slopes. Extensive ground creeping was also observed in the area indicating ground movement.

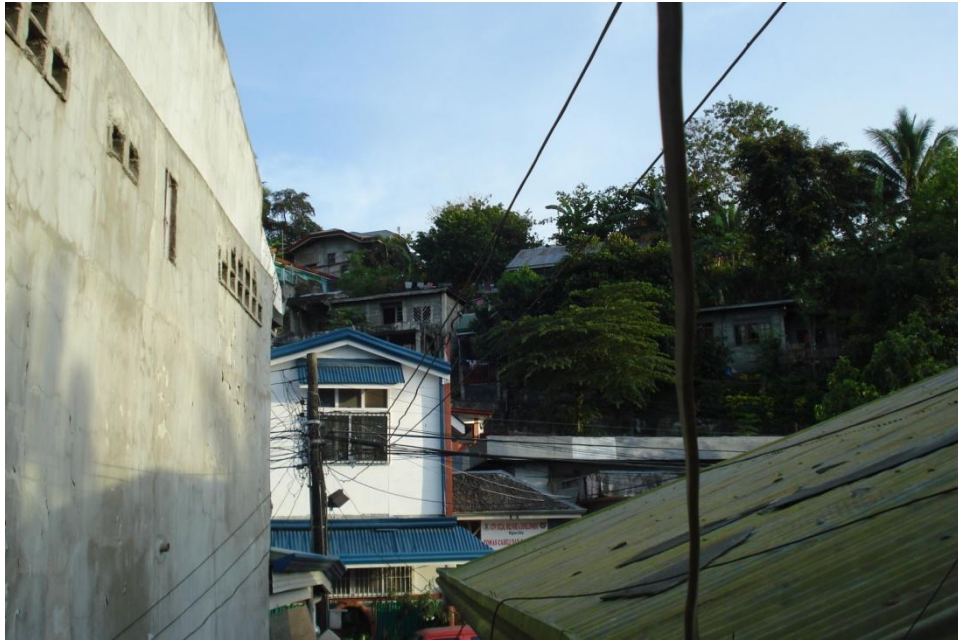
Photo 9. Houses built on steep slopes such as these in Purok 17 Hilltop in Brgy. Tomas Cabili are high risk in terms of landslide.

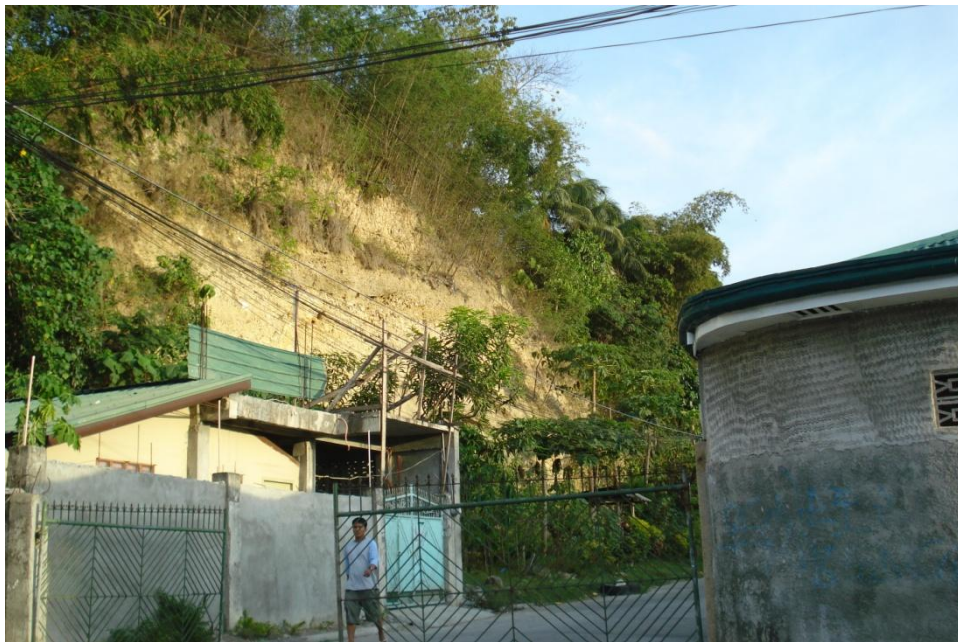
Photo 10. Houses proximal to this limestone cliff in Masinag Subdivision, Purok 15A in Brgy. Tomas Cabili are high risk in terms of landslide.

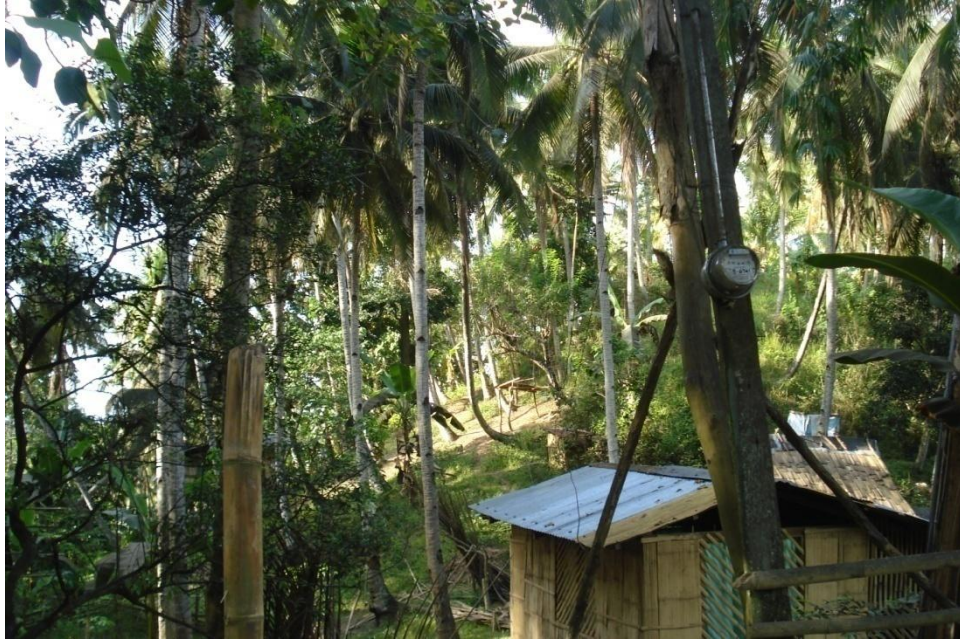
Photo 11. Barangay Upper Tominobo is characterized by hilly to steeply dissected slopes and widespread ground creep.

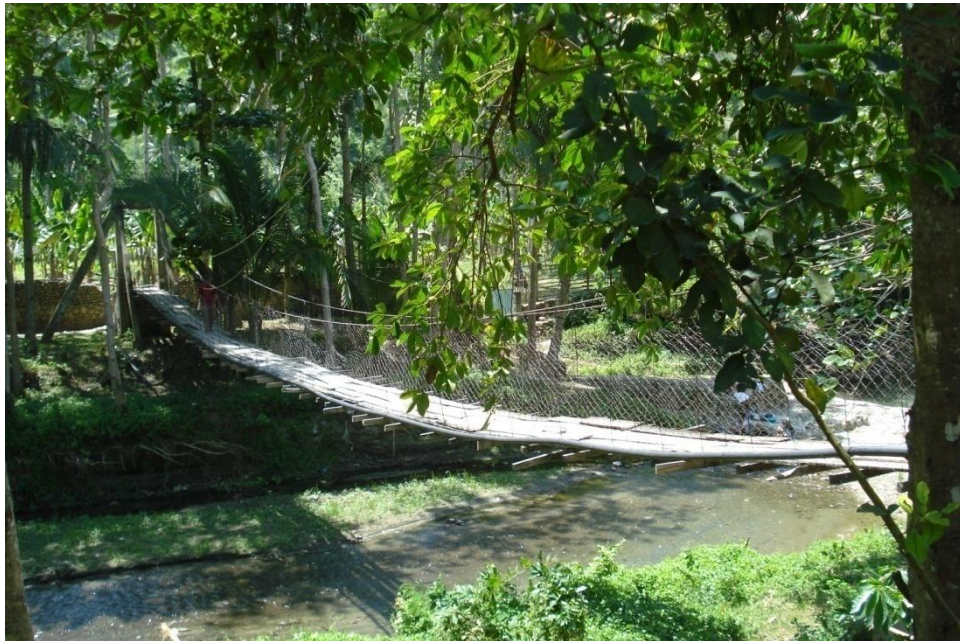
Photo 12. The hanging bridge across Pugaan River in Purok 1B, Brgy. Pugaan was destroyed by flashfloods on May 18, 2009. It has since been repaired.

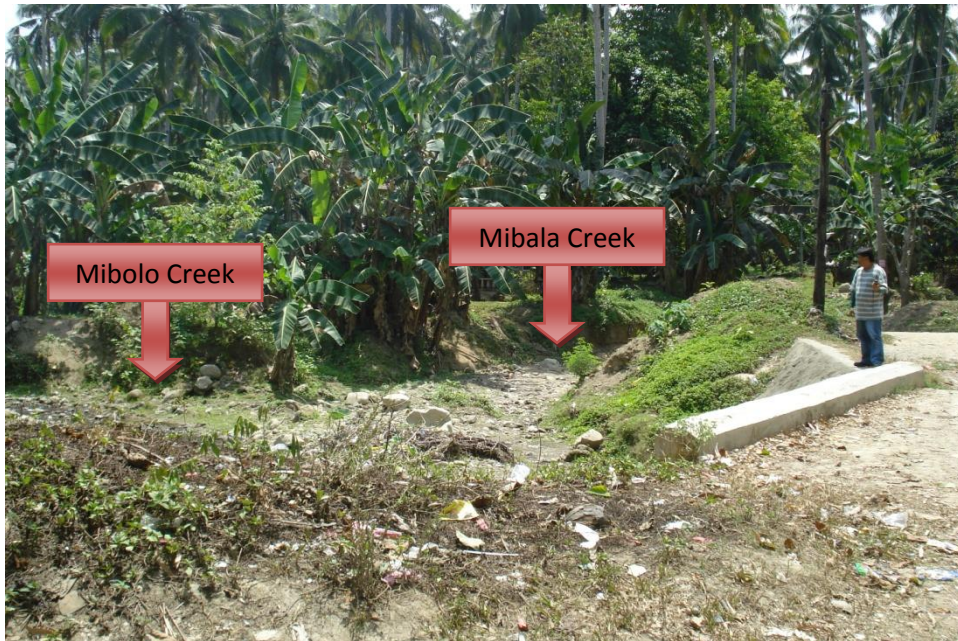
Photo 13. Floodwaters from Mibolo and Mibala Creeks which are tributaries of Iligan River cause flooding in nearby Purok 2B, Brgy. Tipanoy.

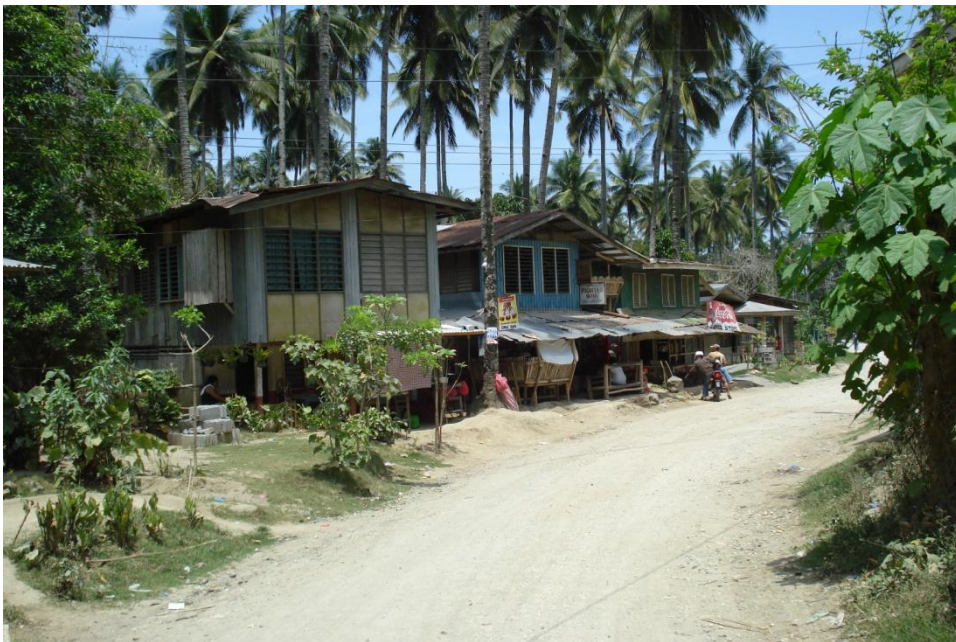
Photo 14. Purok 2B of Brgy. Tipanoy located adjacent to the confluence of Mibala and Mibolo Creeks was inundated by 1m deep floodwaters on May 18, 2009.

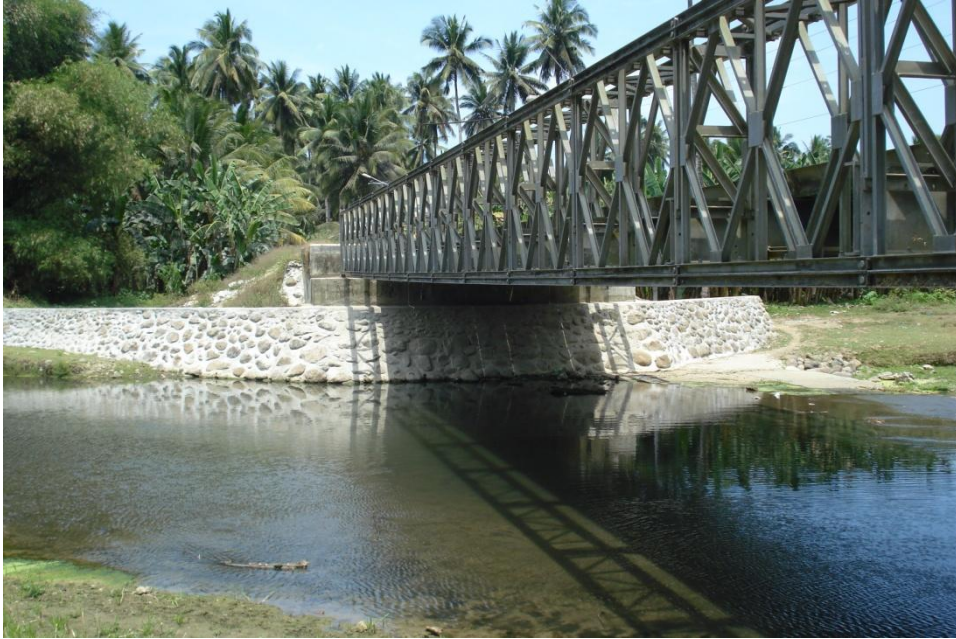
Photo 15. The Tulay ng Pangulo in Purok 8, Brgy. Tipanoy was damaged during the January 2009 flooding event. Riprap structures have since been constructed to protect the base of the bridge from scouring.

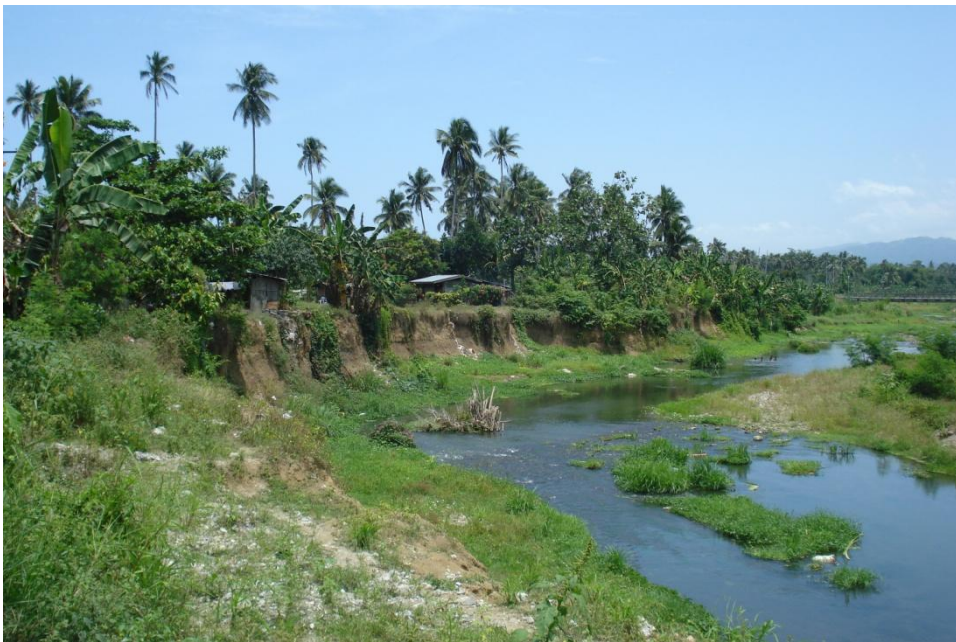
Photo 16. Extensive scouring along this stretch of Iligan River in Purok La Purisima, Baraas, Brgy. Tubod destroyed several houses along the river.

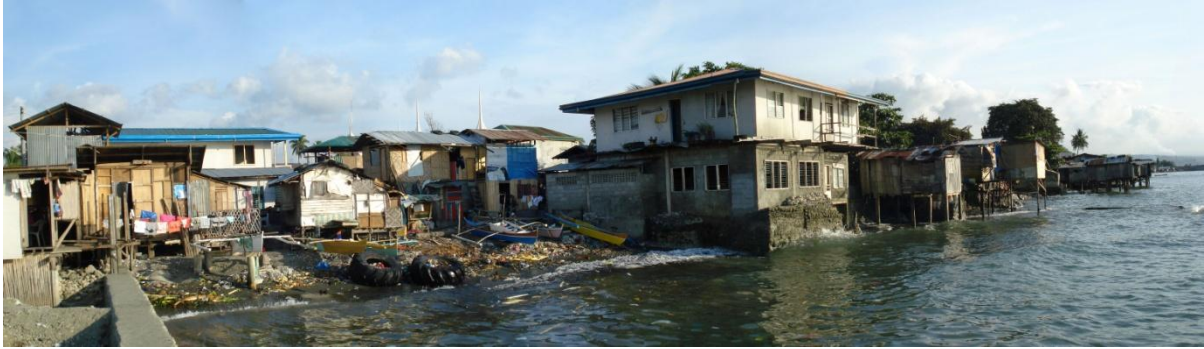
Photo 17. Coastal puroks such as Purok 8 in Brgy. Tibanga are prone to storm surge.

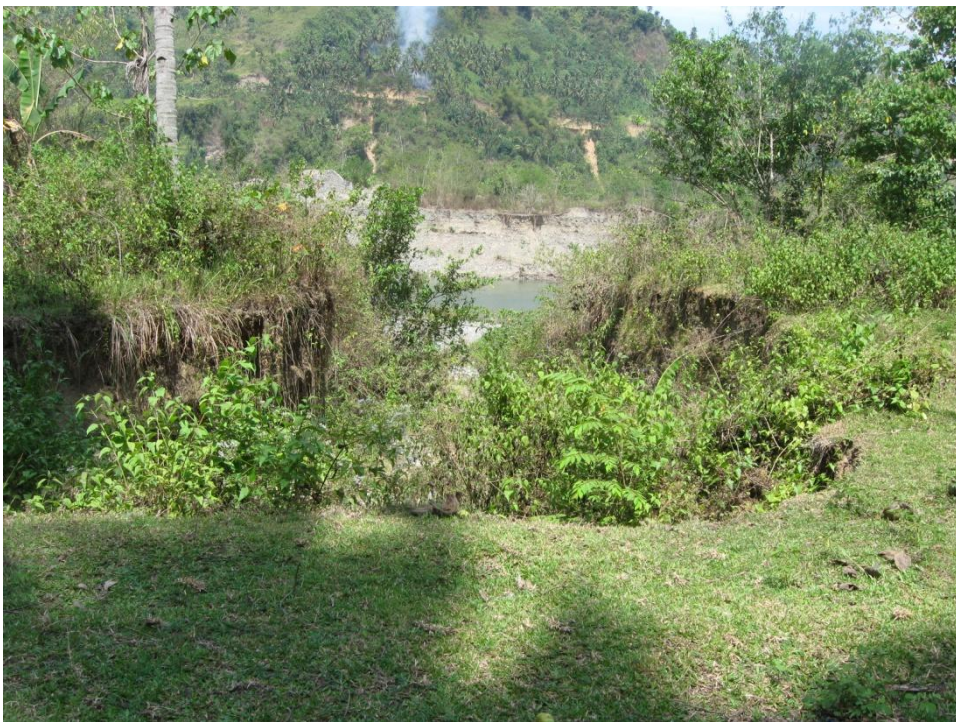
Photo 18. Scouring was observed along the riverbanks of Bonbonon River in Purok 6, Brgy. Bonbonon.

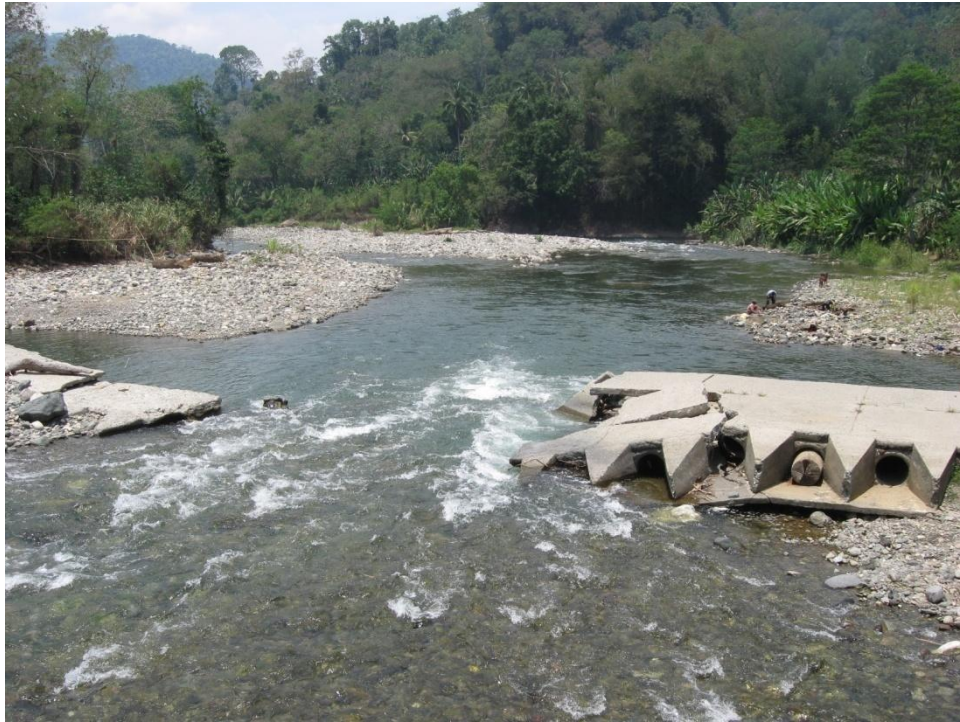
Photo 19. The submarine bridge across Bayug River along the boundary of Purok Kiambong, Brgy. Rogongon and Purok Kadiis, Brgy. Panoroganan was slightly damaged in a 2005 flood and was eventually destroyed by floods in 2009.

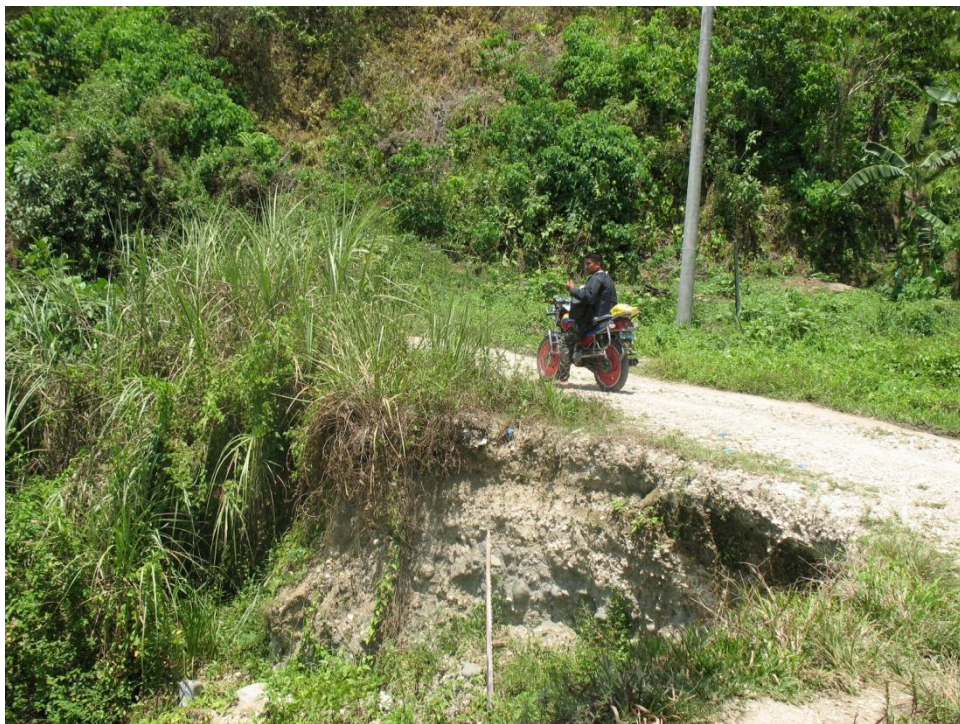
Photo 20. This section of the road in Purok 10, Brgy. Lanipao is prone to landslides.

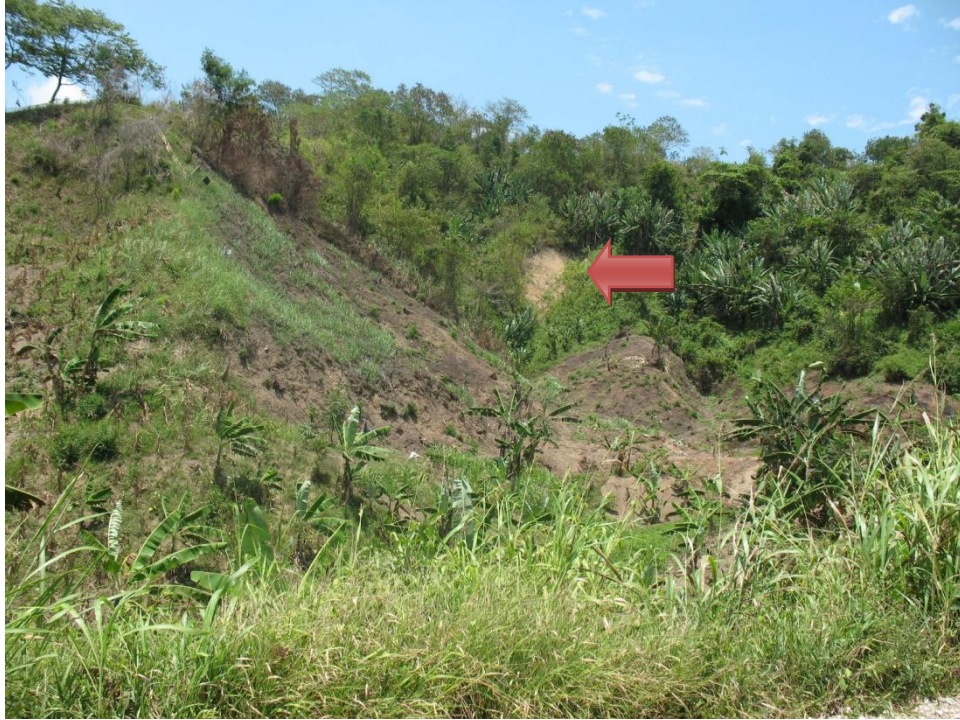
Photo 21. A landslide scar (indicated by red arrow) was observed in So. Comya, Brgy. Dulag.

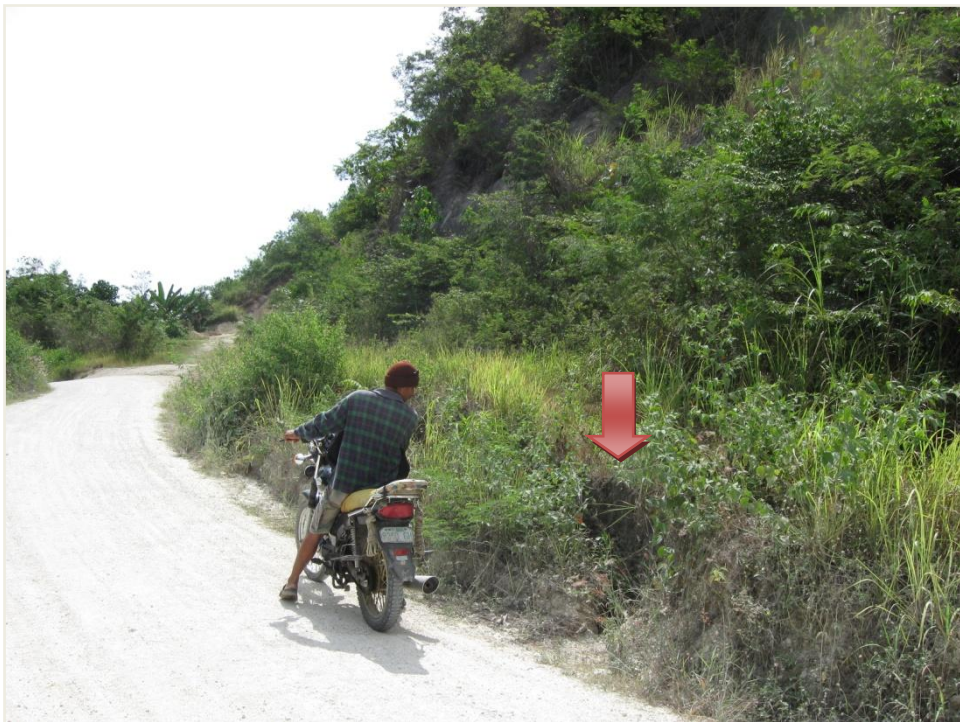
Photo 22. A large crack was observed along the road in Purok 5 Lerop, Brgy. Kiwalan. The crack is reportedly 175 meters long with an average vertical and horizontal displacement of about 0.7 meters and 0.3 meters, respectively. The red arrow indicates one end of the crack.
