RESULTS OF THE MGB RAPID GEOHAZARD ASSESSMENT OF BARANGAYS IN CAGAYAN DE ORO CITY, MISAMIS ORIENTAL

CAGAYAN de ORO CITY, MISAMIS ORIENTAL

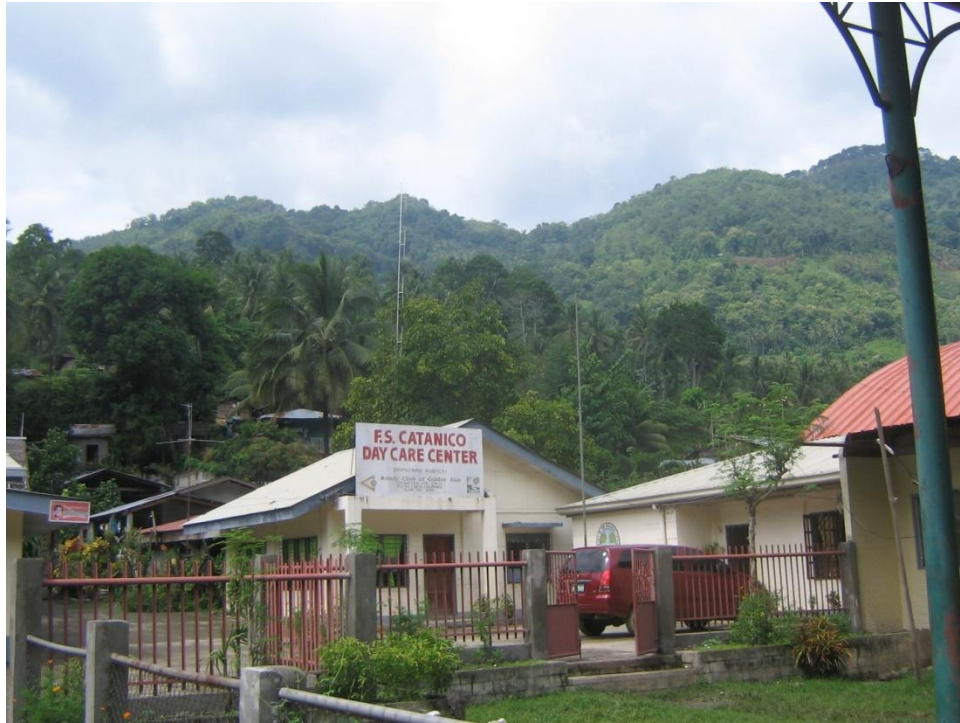
Slopes bounding Brgy. Proper F.S. Catanico with moderate susceptibility to landslides.

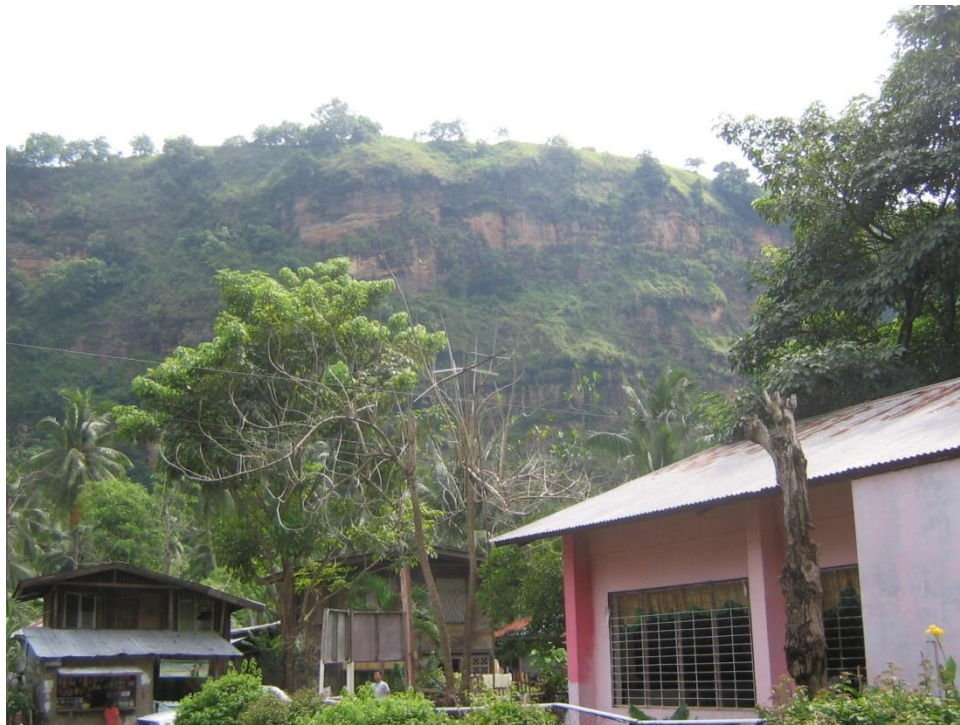
Nearly vertical slopes along Cugman River in Brgy. F.S. Catanico.

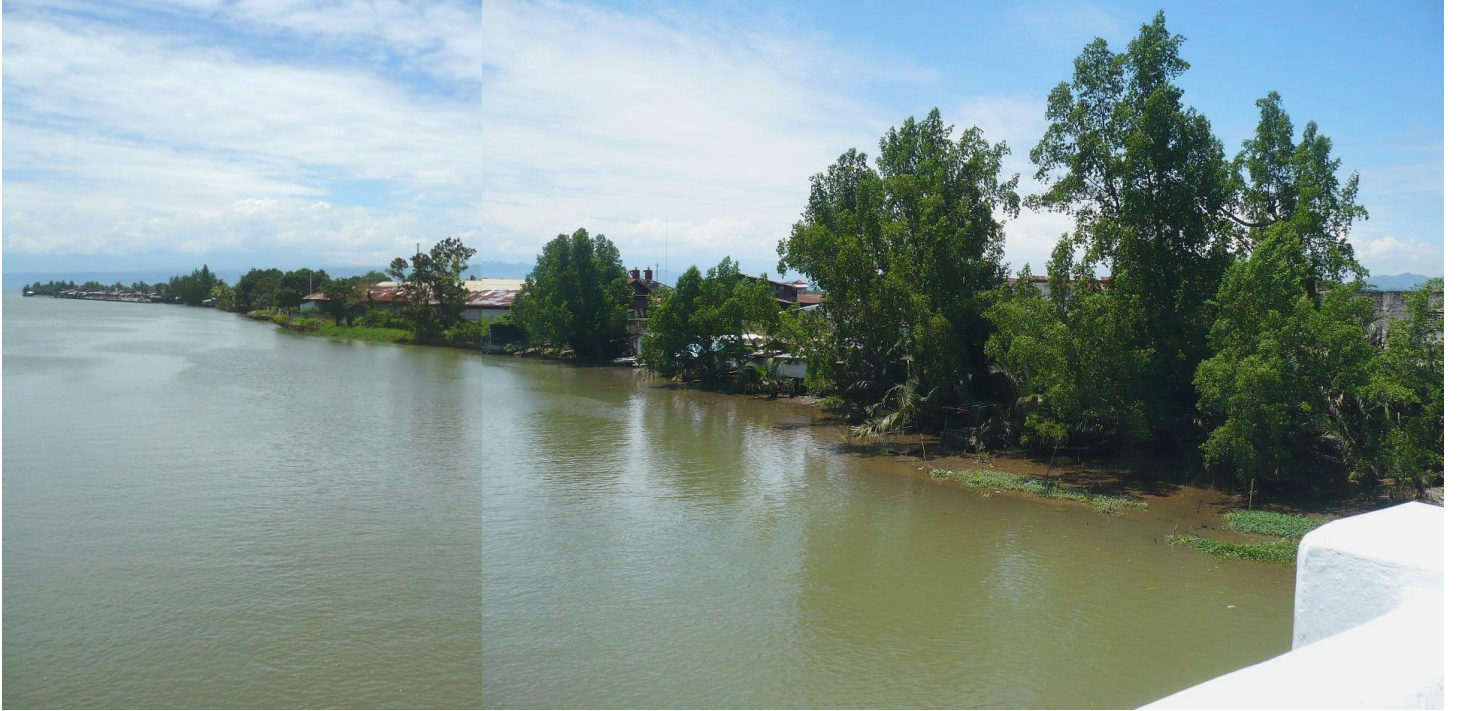
Portions of Brgys. Macabalan and Puntod situated along the floodplains of Cagayan de Oro River are frequently inundated by floodwaters from the said river.

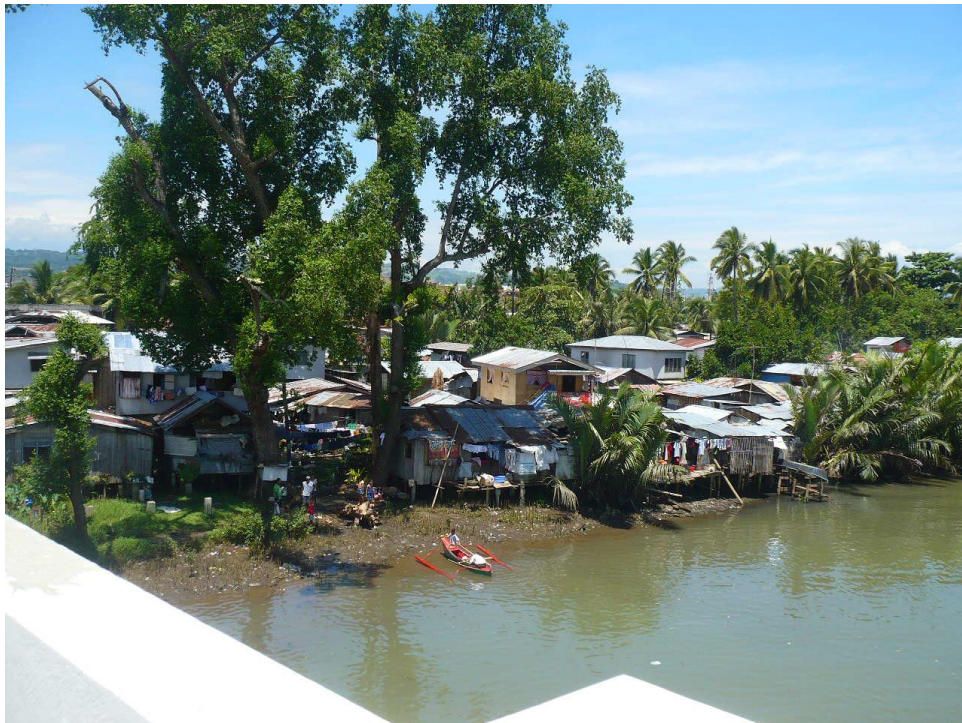
Houses built along the floodplains of Cagayan de Oro River in Brgy. Puntod are highly susceptible to flooding.

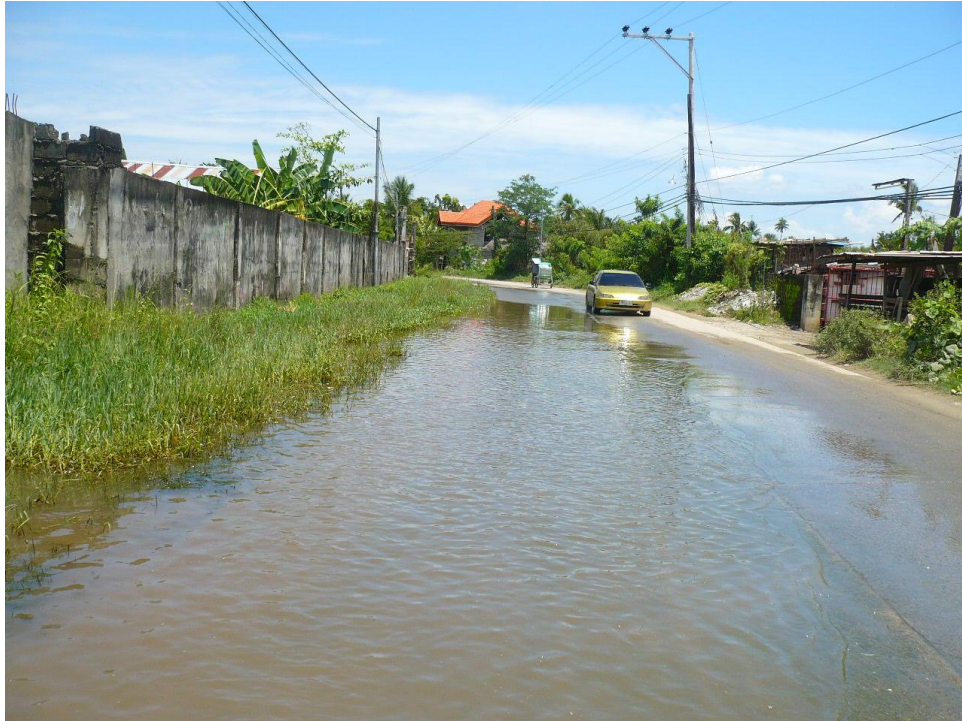
Excessive surface run-off from Brgy. Kauswagan perennially floods Zone 6, Brgy. Bayabas.

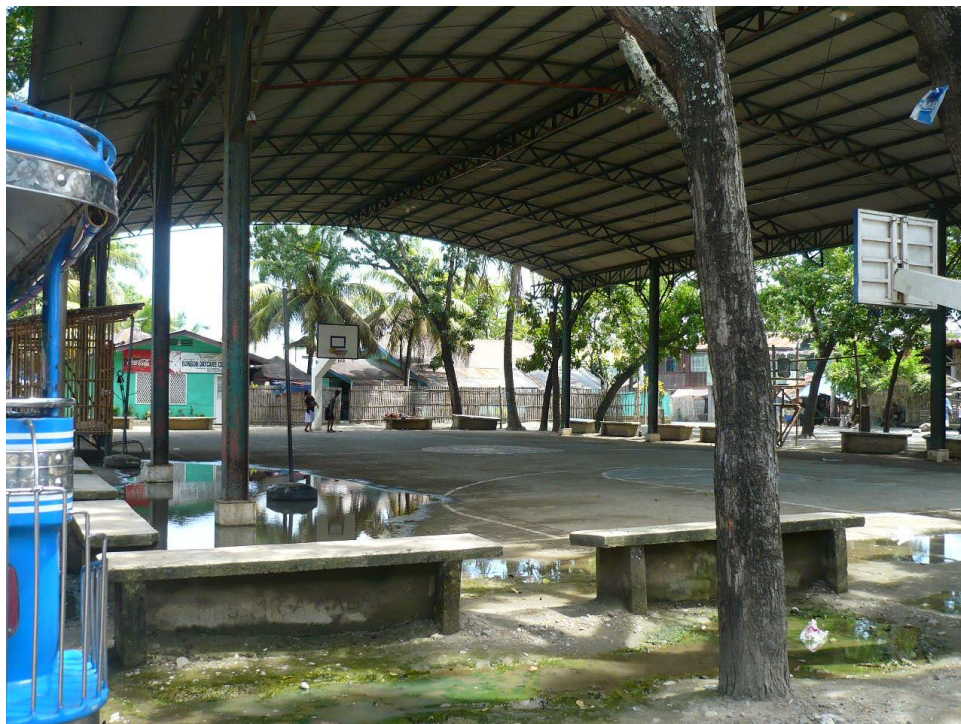
Heavy rainfall and the simultaneous occurrence of high tide events cause flooding in Brgy. Bonbon, particularly in this covered basketball court.

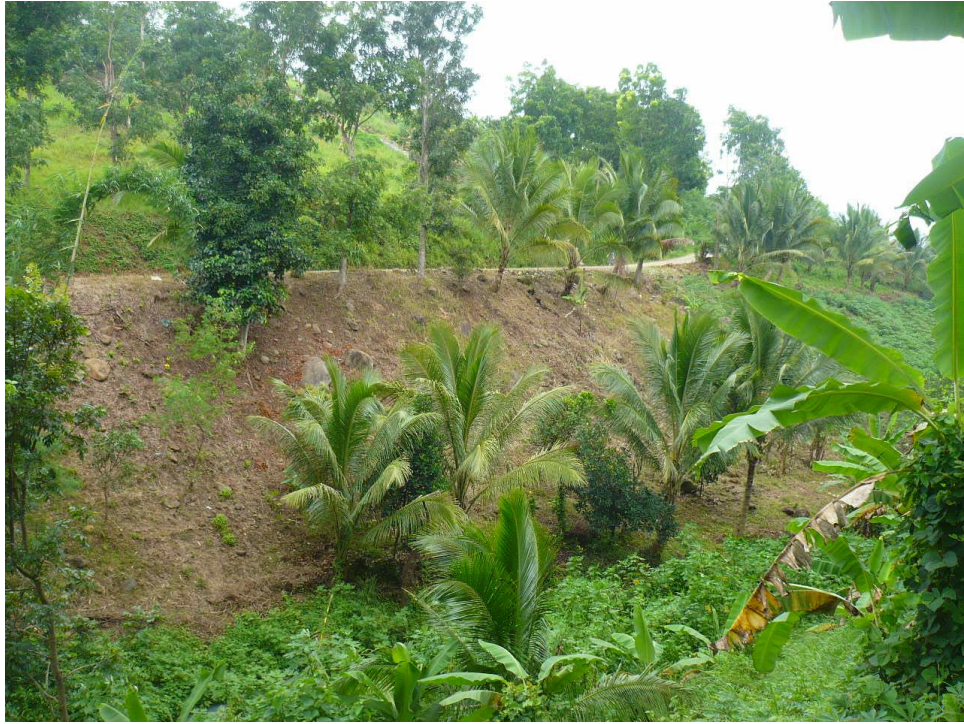
Unstable slopes along the road to Brgy. Balubal as manifested by the tilted coconut trees
