RESULTS OF THE MGB LANDSLIDE AND FLOOD ASSESSMENT (1:10,000 SCALE) OF PARTS OF MONKAYO IN COMPOSTELA VALLEY PROVINCE

The Mines and Geosciences Bureau-Department of Environment and Natural Resources Regional Office No. 11 (MGB-DENR XI) conducted a landslide assessment and mapping (1:10,000 scale) of areas within the municipality of Monkayo, Compostela Valley Province on May 14, 2012 until June 8, 2012. The assessment is in line with the government's efforts aimed at reducing, if not, totally mitigating the destructive effects and impacts of natural hazards on the populace. Comprising the geohazard assessment team are Ms. Beverly Mae M. Brebante and Ms. Abigail June L. Agus, geologists from the MGB regional office.

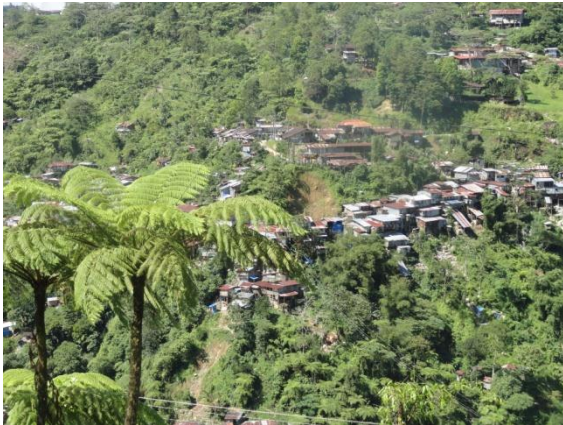
Photo 1. Landslide scar of the December 2011 landslide in Po. Nang, Brgy. Mt. Diwata

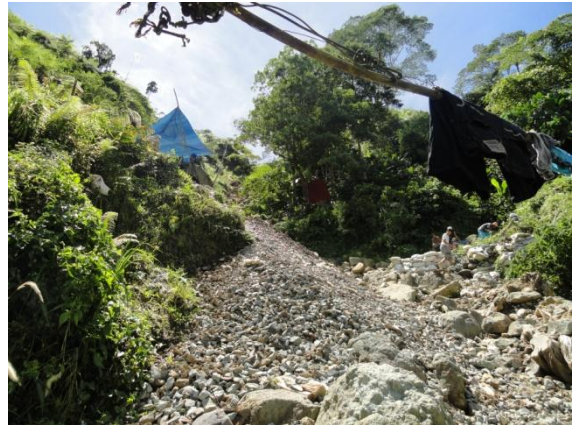
Photo 2. Landslide debris in Po. Bardown, Brgy. Mt. Diwata

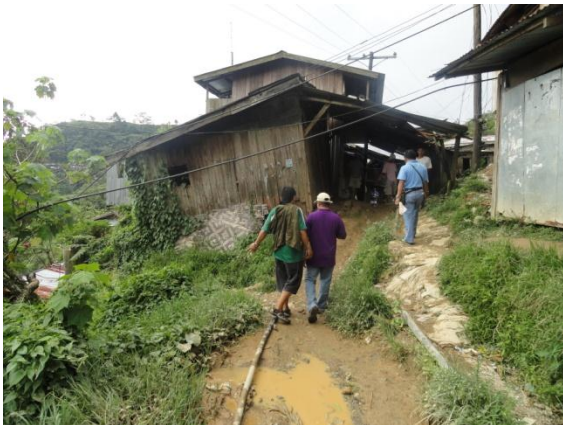
Photo 3. Tilted houses erected at the edge of steep slopes prevalent in Brgy. Mt. Diwata

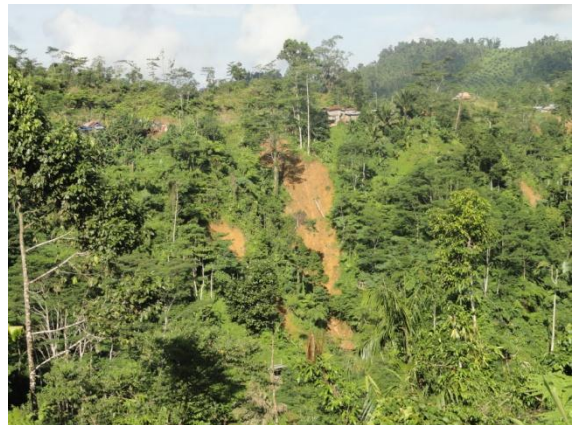
Location	Landslide Susceptibility Rating	Remarks/ Recommendations
21	Po. Depot	High	Observe for and/or monitor for presence of mass movement (e.g. landslide, tension cracks); Report situation to MGB office and the municipal/city authorities; Observed for saturated ground/; Report situation to MGB office and the municipal/city authorities;

Photo 4. Active landslides near houses in road going to Po. Depot, Brgy. Upper Ulip

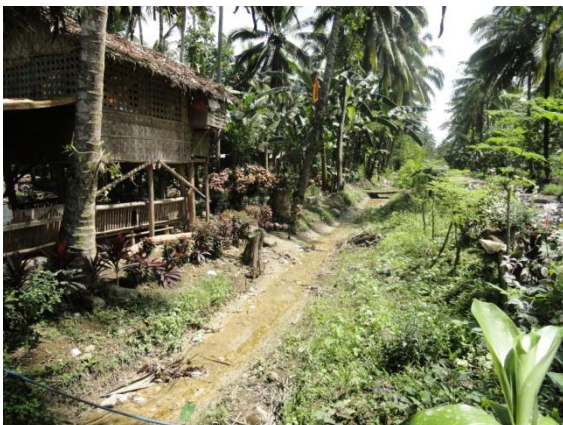
Photo 5. P6, Brgy. Naboc which experience regular flooding due to canal overflows.

Location	Flood Susceptibility Rating	Remarks/ Recommendations
5		High	Monitor rapid increase/decrease in creek/river water levels as well as irrigation canals close to the area; Develop an early warning device/system (e.g. signages) and communication network with upland barangays;

Constant communication and updates with the barangay officials on geohazard situation;
--	--	--	--

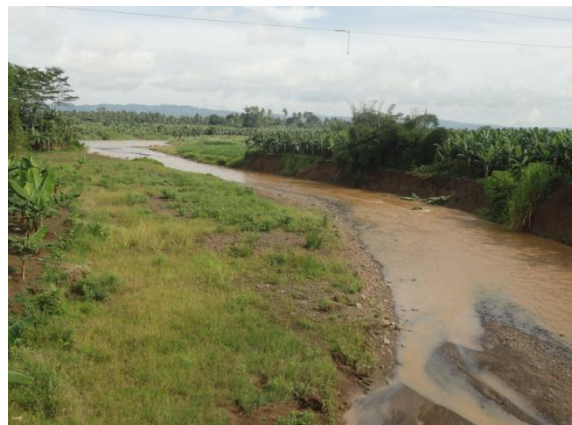
Photo 6. Active riverbank erosion of Mamonga River

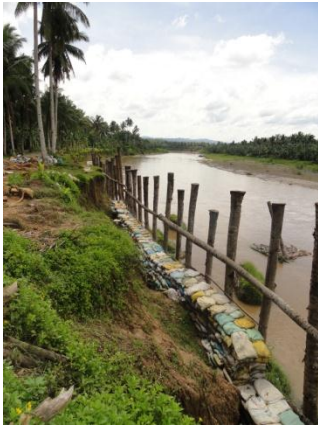
Photo 7. River bank protection against active river scouring located at Brgy. Inambatan

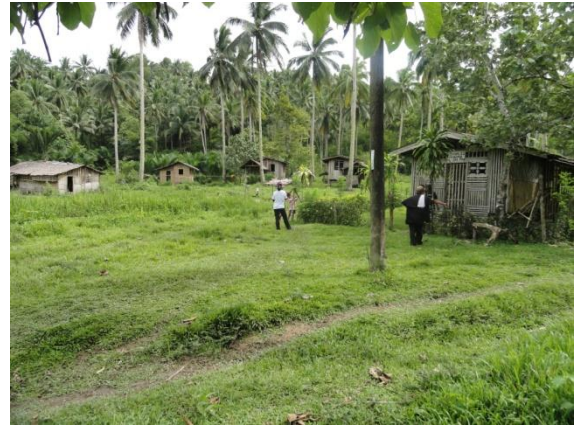
12		Moderate	Monitor rapid increase/decrease in creek/river water levels, possibly accompanied by increase turbidity (soil content); Constant communication and updates with the barangay officials on geohazard situation.
13		Moderate	Monitor rapid increase/decrease in creek/river water levels, possibly accompanied by increase turbidity (soil content); Constant communication and updates with the barangay officials on geohazard situation.
1 2 3 4		None	High susceptibility in area near Agusan River. Monitor rapid increase/decrease in creek/river water levels, possibly accompanied by increase turbidity (soil content).

Photo 8. Po. 12, Brgy. Pasian which regularly experience floods from runoff waters of surround intermittent creeks

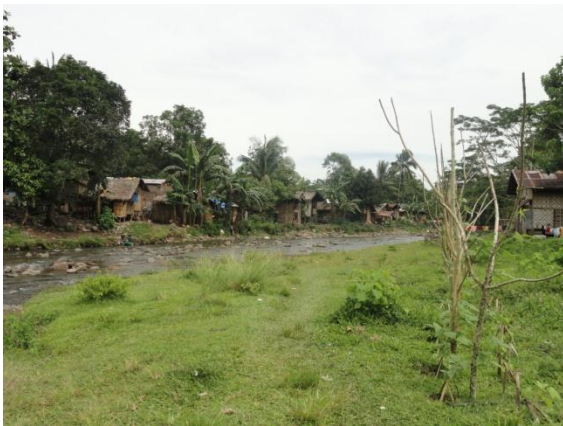
Location	Flood Susceptibility Rating	Remarks/ Recommendations
1A		High	Monitor rapid increase/decrease in creek/river water levels as well as irrigation canals close to the area; Develop an early warning device/system (e.g. signages) and communication network with upland barangays; Constant communication and updates with the barangay officials on geohazard situation; For relocation of residents located very close to the main river channel.
10		Moderate	Monitor rapid increase/decrease in creek/river water levels, possibly accompanied by increase turbidity (soil content); Constant communication and updates with the barangay officials on geohazard situation.

Photo 9. Houses very close to main river channel in po.1A, Brgy. Pasian

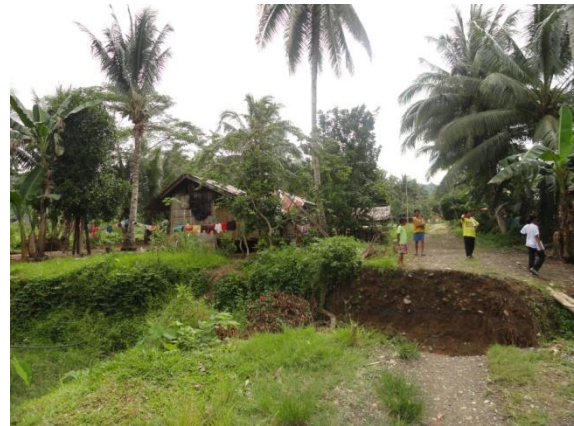
Photo 10. Destroyed culverts in Po. 3, Brgy. Haguimitan due to high stream discharge

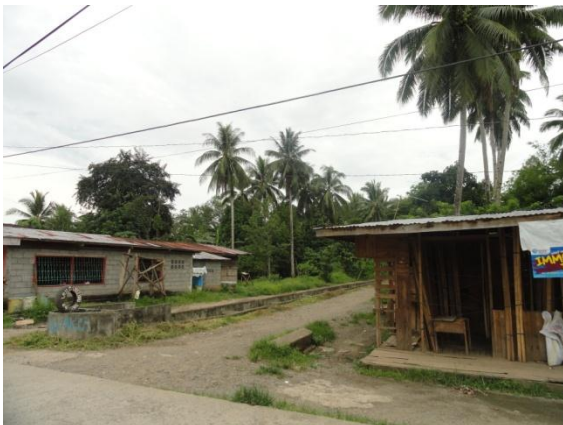
Photo 11. Canal within Brgy. Poblacion that regularly overflows causing flooding in the area

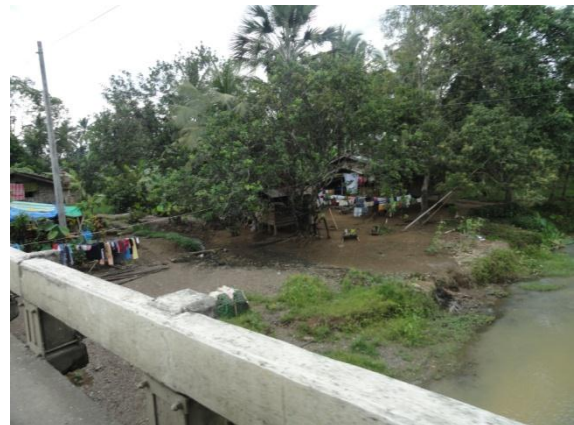
2C	Libuton	High	Monitor rapid increase/decrease in creek/river water levels, possibly accompanied by increase turbidity (soil content); Develop an early warning device/system (e.g. signages) and communication network with upland barangays; Constant communication and updates with the barangay officials on geohazard situation; Report situation to MGB office and the municipal/city authorities
2D	Resettlement	High	Monitor rapid increase/decrease in creek/river water levels, possibly accompanied by increase turbidity (soil content); Develop an early warning device/system (e.g. signages) and communication network with upland barangays; Constant communication and updates with the barangay officials on geohazard situation; Report situation to MGB office and the municipal/city authorities
3		Moderate	Monitor rapid increase/decrease in creek/river water levels, possibly accompanied by increase turbidity (soil content); Constant communication and updates with the barangay officials on geohazard situation.

Photo 12. Houses near Libuton Creek, Brgy. Poblacion
