Title: Static water penetration testing of the Barracuda brick slip system

Report No: N950-22-18406

**Title:** Static water penetration testing of the Barracuda brick slip system

**Customer:** James & Taylor Ltd,  
Sixty-Two, Barwell Business Park,  
Leatherhead Road, Chessington, Surrey KT9 2NY.

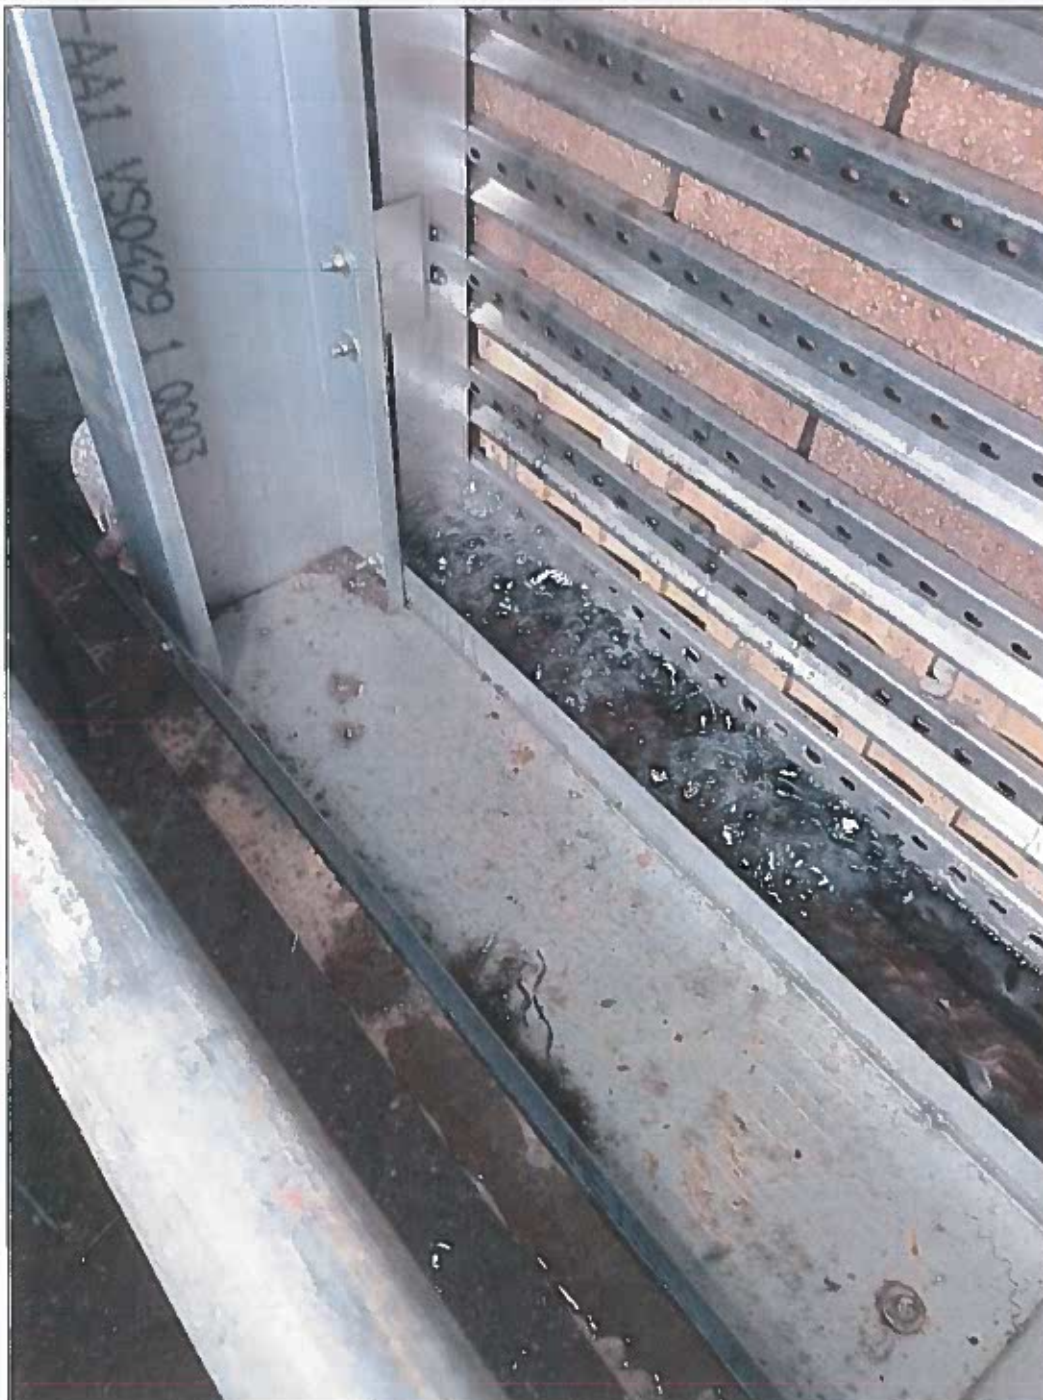
PHOTO 085845

At zero pressure minor water leakage was observed seeping through some of the brick slips and running down the rails.

The water leakage rate and area increased with increased pressure and was across all the brick types. The water was confined to the back of the bricks and rails and ran down to the base of the sample where it would drain out through a ventilated cavity.

INTERNAL VIEW DURING WATER TEST

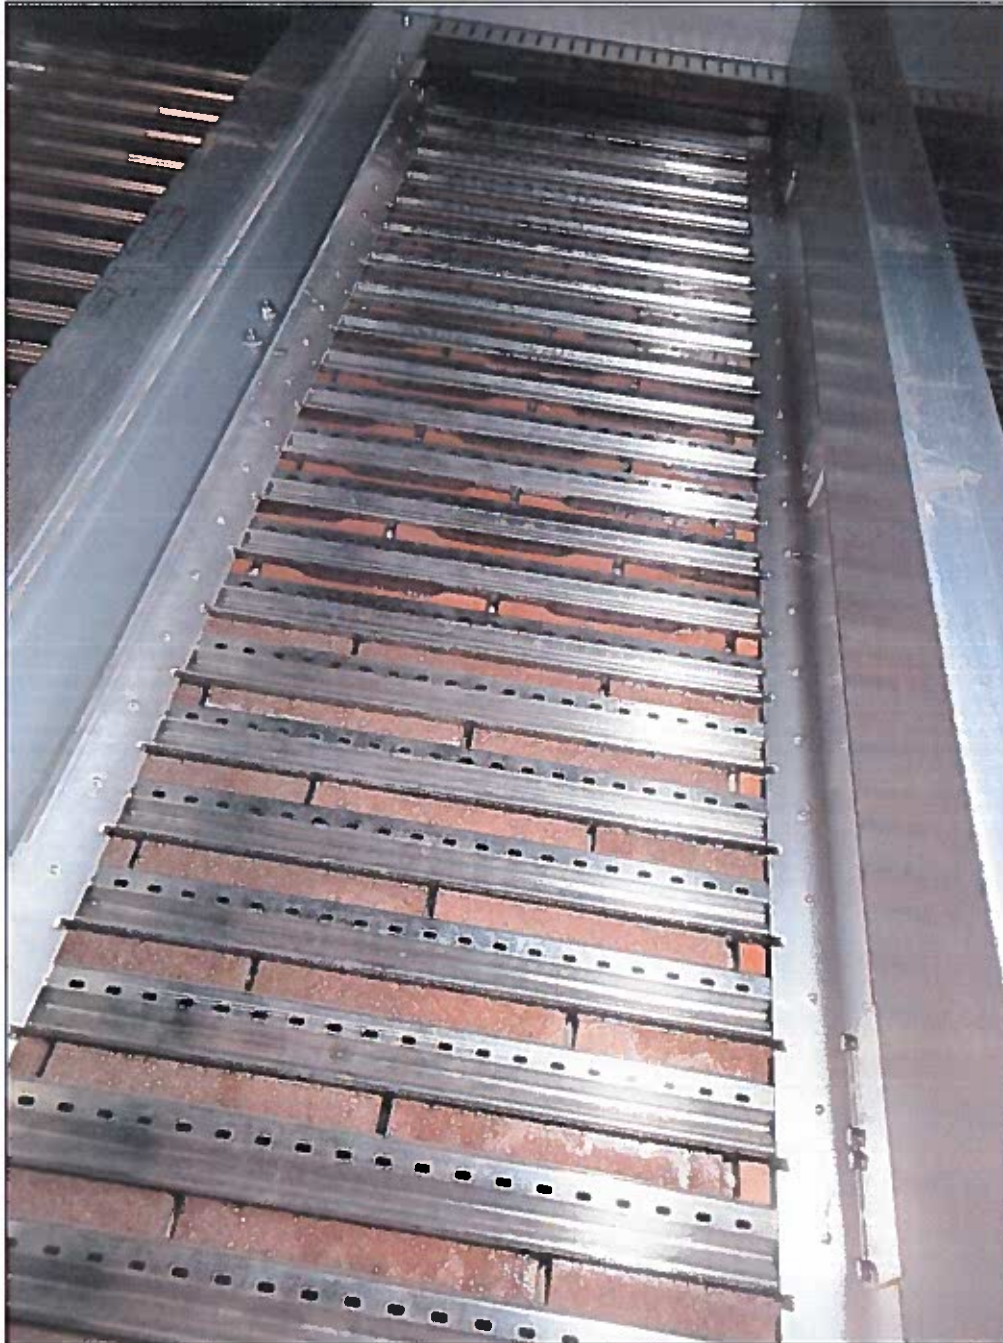
PHOTO 5156

After 1 minute into the test, slow dripping was observed down the back of the bricks/rails.

During the test period the amount of water leakage remained constant and was confined to the back of the tiles and support rails. The water drained out at the base of the sample through drainage holes.

INTERNAL VIEW DURING TEST

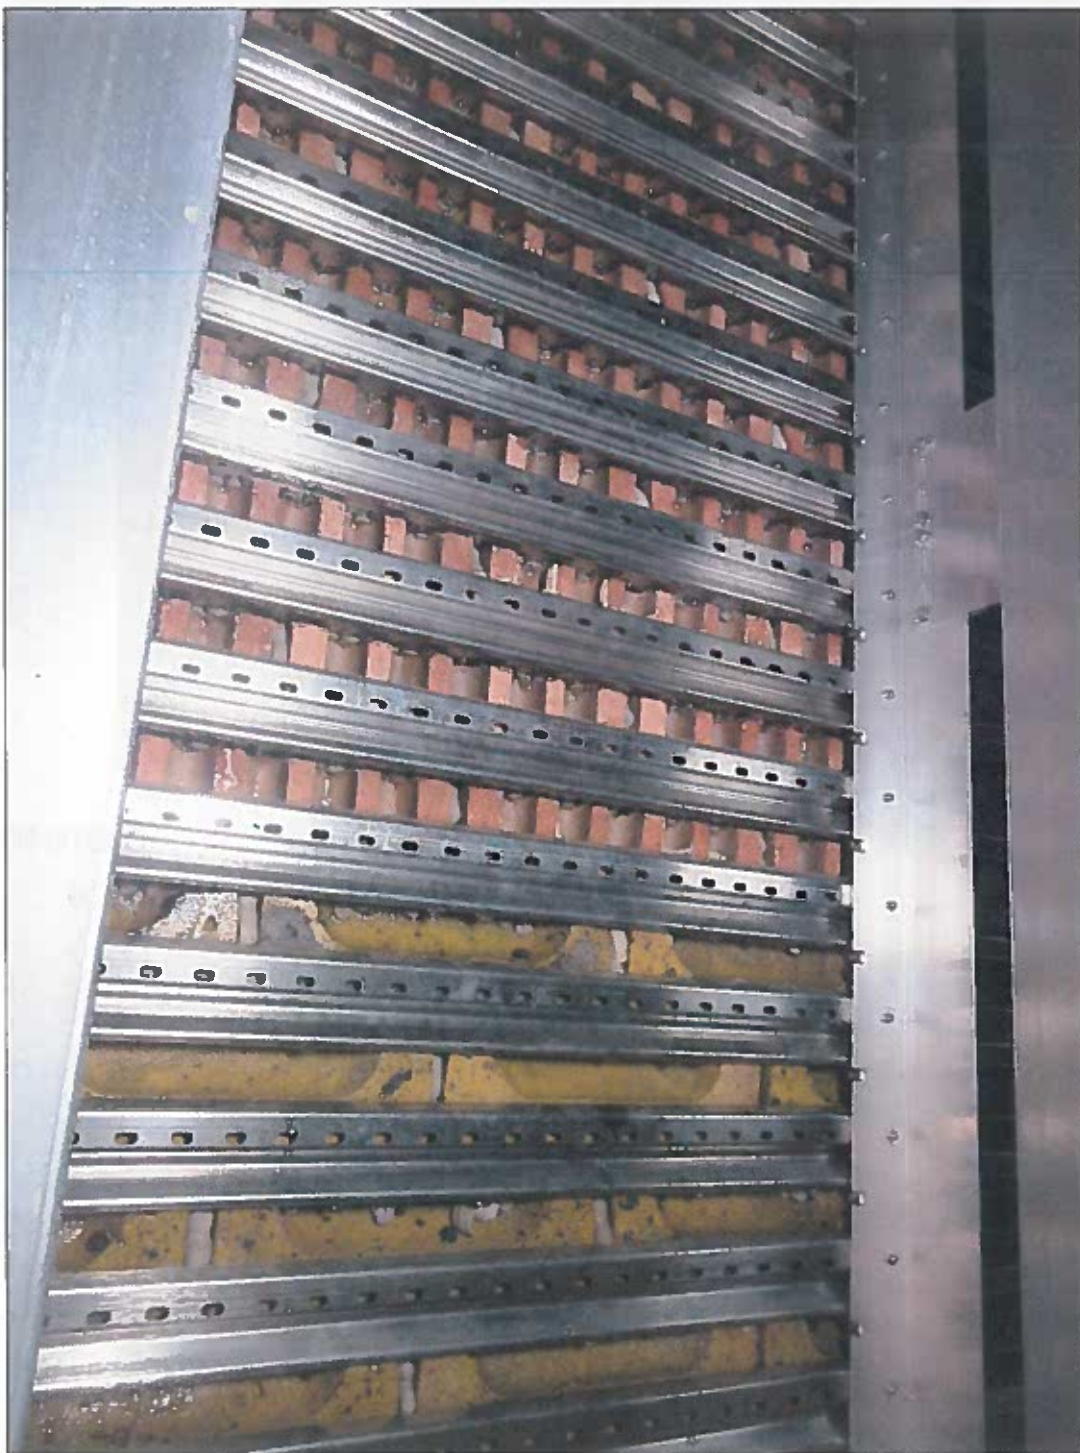
PHOTO 5157

INTERNAL VIEW DURING TEST

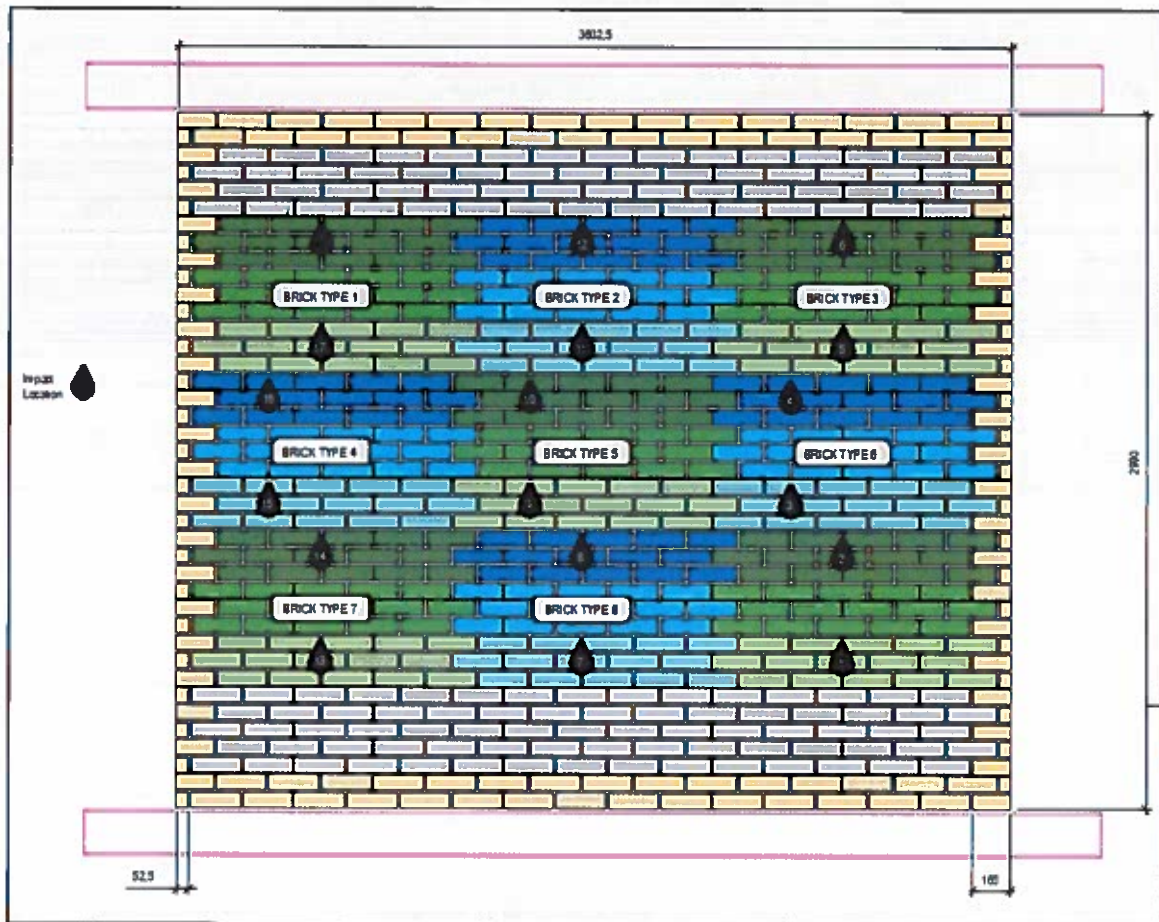
FIGURE 2

HARD BODY IMPACT LOCATIONS

| Location | Impact energy (J) | Observations | Classification |
|---|---|---|---|
| 1 | 10 | Crack through full height of tile | Low risk |
| 3 | 10 | Crack through full height of tile.<br>Small chip to corner of brick | Low risk |
| 8 | 10 | Crack through full height of tile.<br>Small chip to corner of brick (4 g) | Low risk |

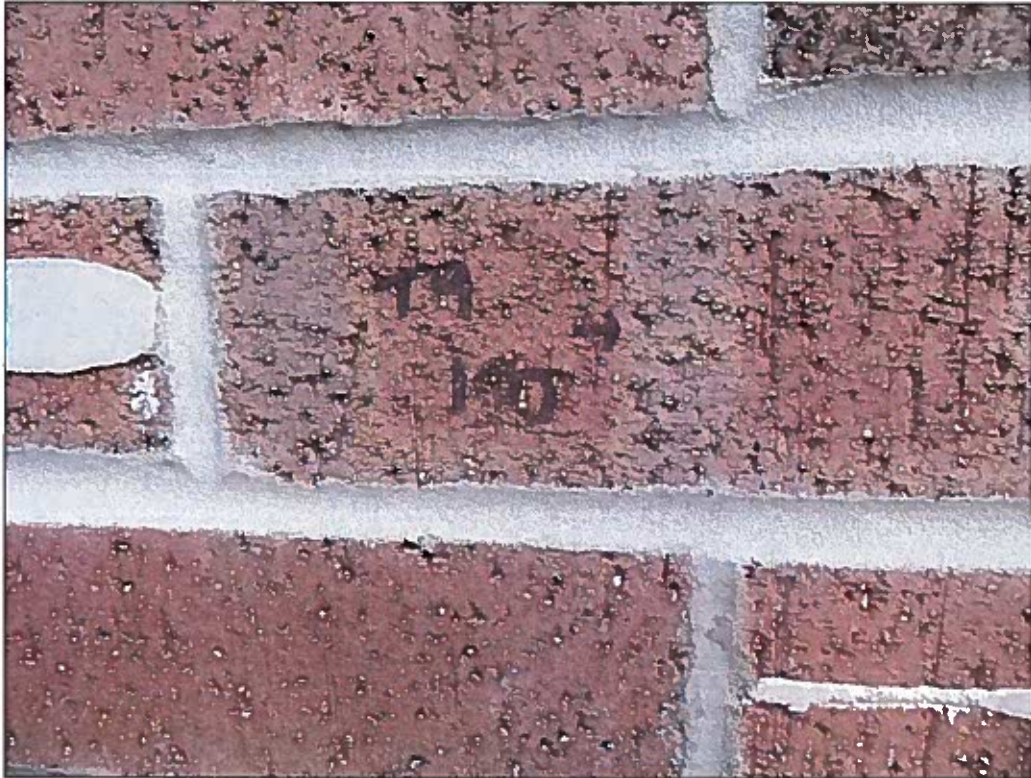
PHOTO 4072

10 J HARD BODY IMPACT

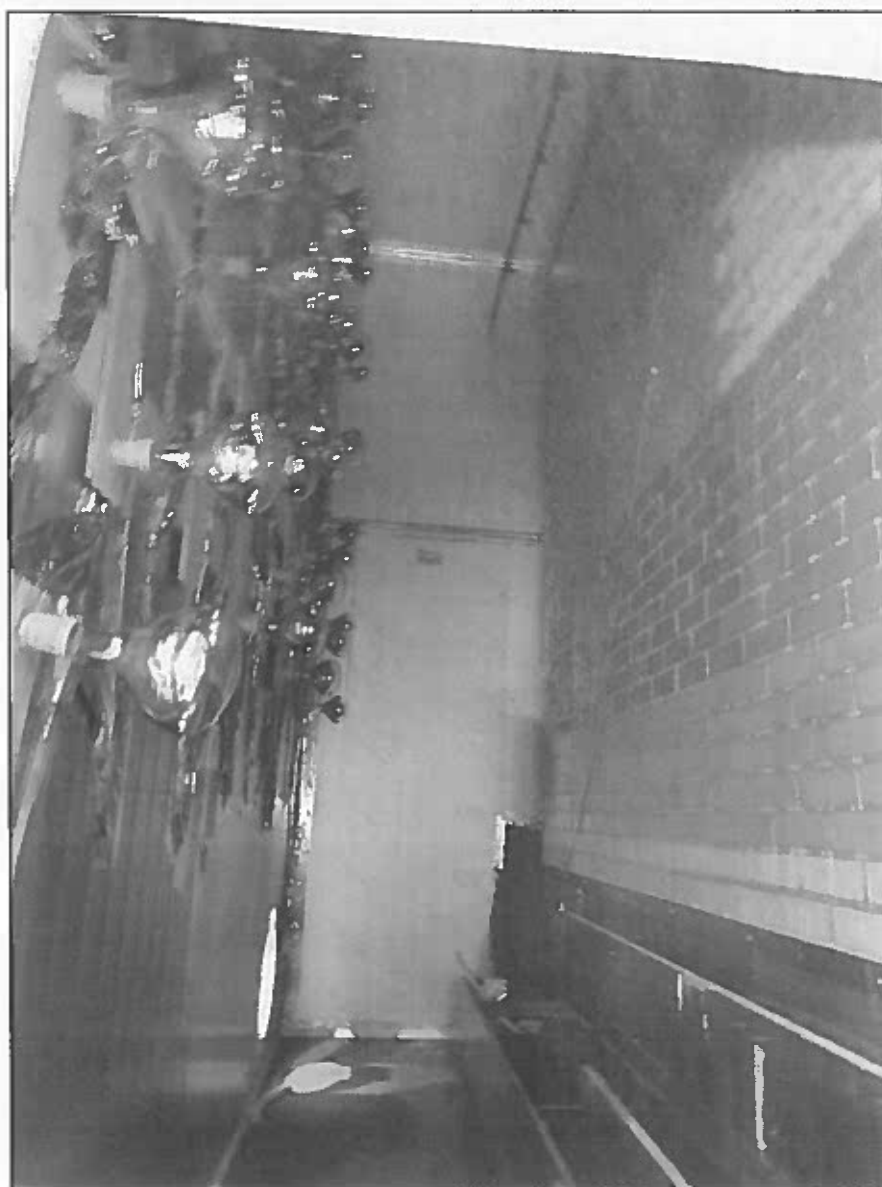
PHOTO 20221123\_132854

No damage or degradation was observed to any of the brick slips or supporting elements during and after the completion of the testing.

TEST SETUP AND WATER SPRAYING OCCURING

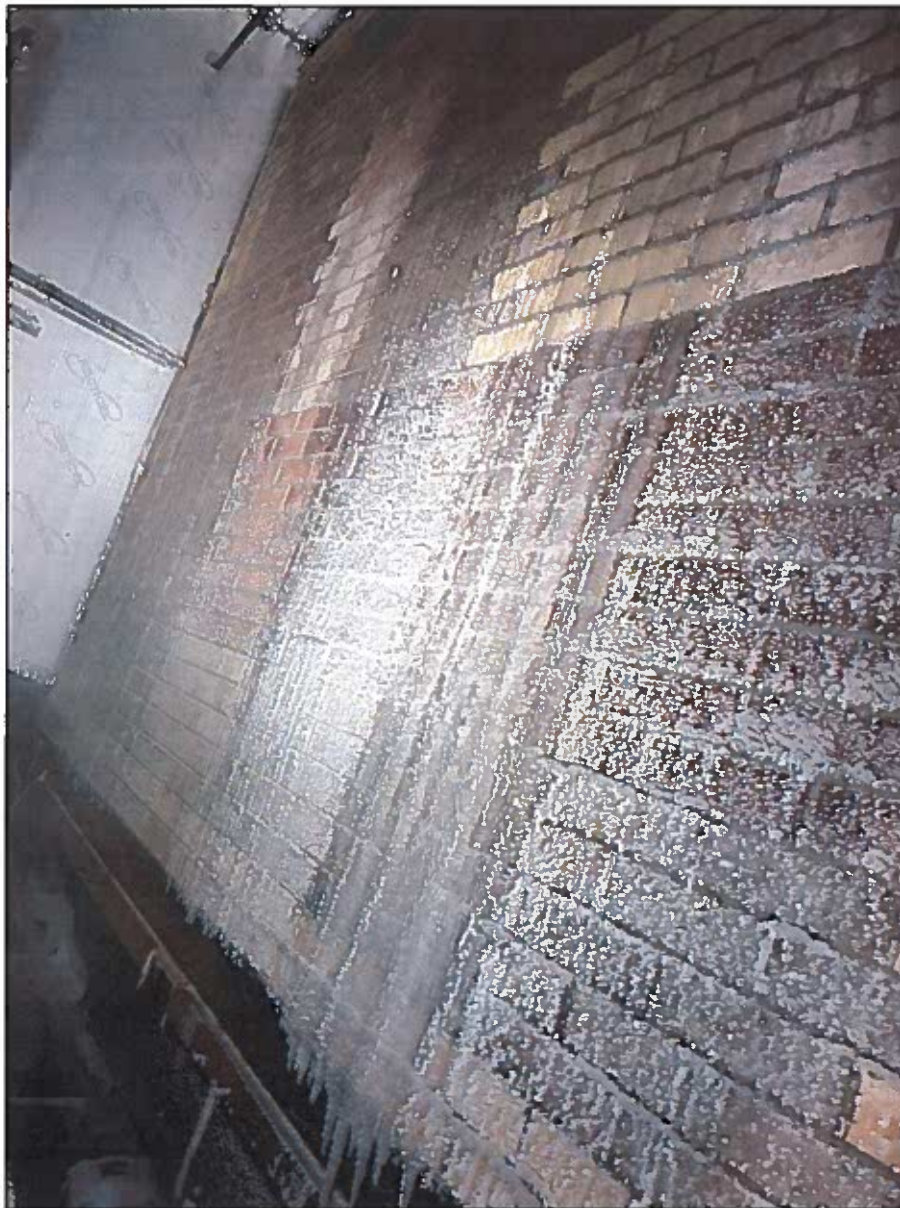
PHOTO IMG\_56422

No damage or degradation was observed to any of the brick slips or supporting elements during and after the completion of the testing.

ICE BUILD UP ON FACE OF BRICKS SLIPS BEFORE THAWING
