1 and 3-7 Stamford Street: Existing Condition

5.0.1 Introduction  
Vision

As part of the site analysis and design process, in 2022 DIA completed a detailed desktop study and visual audit of both of the on-site listed buildings. The following pages discuss the buildings' current condition.

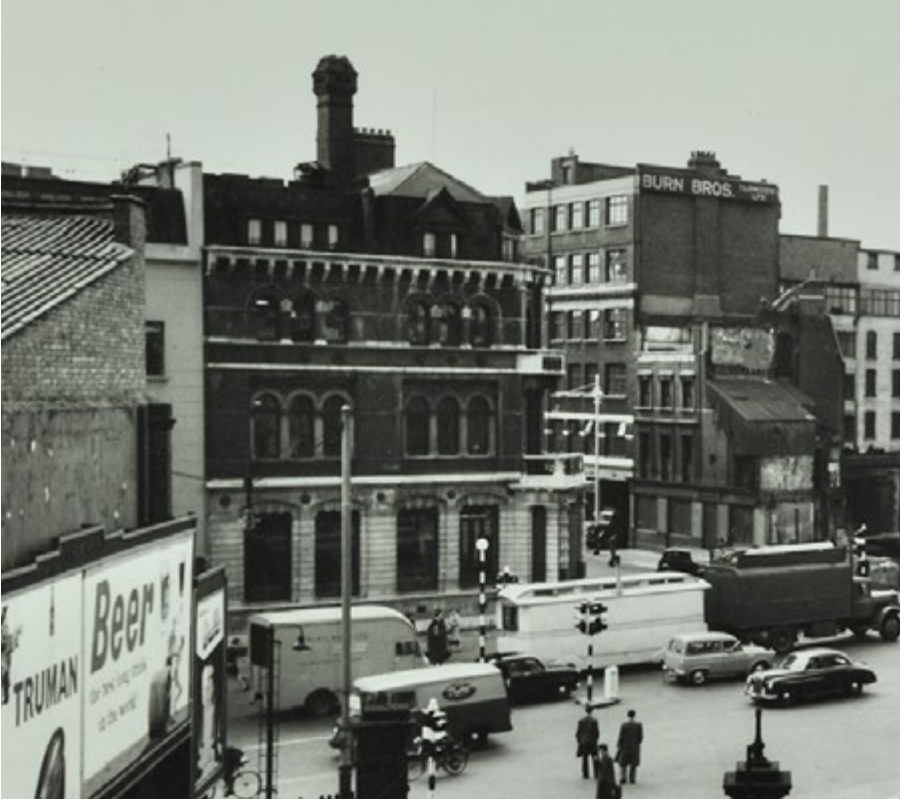
**Top Right:**  
Corner of Blackfriars Road and Southwark Street - 1957  
**Bottom Right:**  
Photograph of 1 and 3-7 Stamford Street - 1979  
**Left:**  
Drawing of Central Bank of London at 1 Stamford Street - 1875

*“1 Stamford Street is shown as suffering serious damage, along with the neighbouring terrace buildings along Blackfriars Road. A 1957 photograph taken at the corner of Blackfriars Road and Stamford Street shows the east elevation of 1 Stamford Street, which appears to be in a good condition despite the noted bomb damage“.*

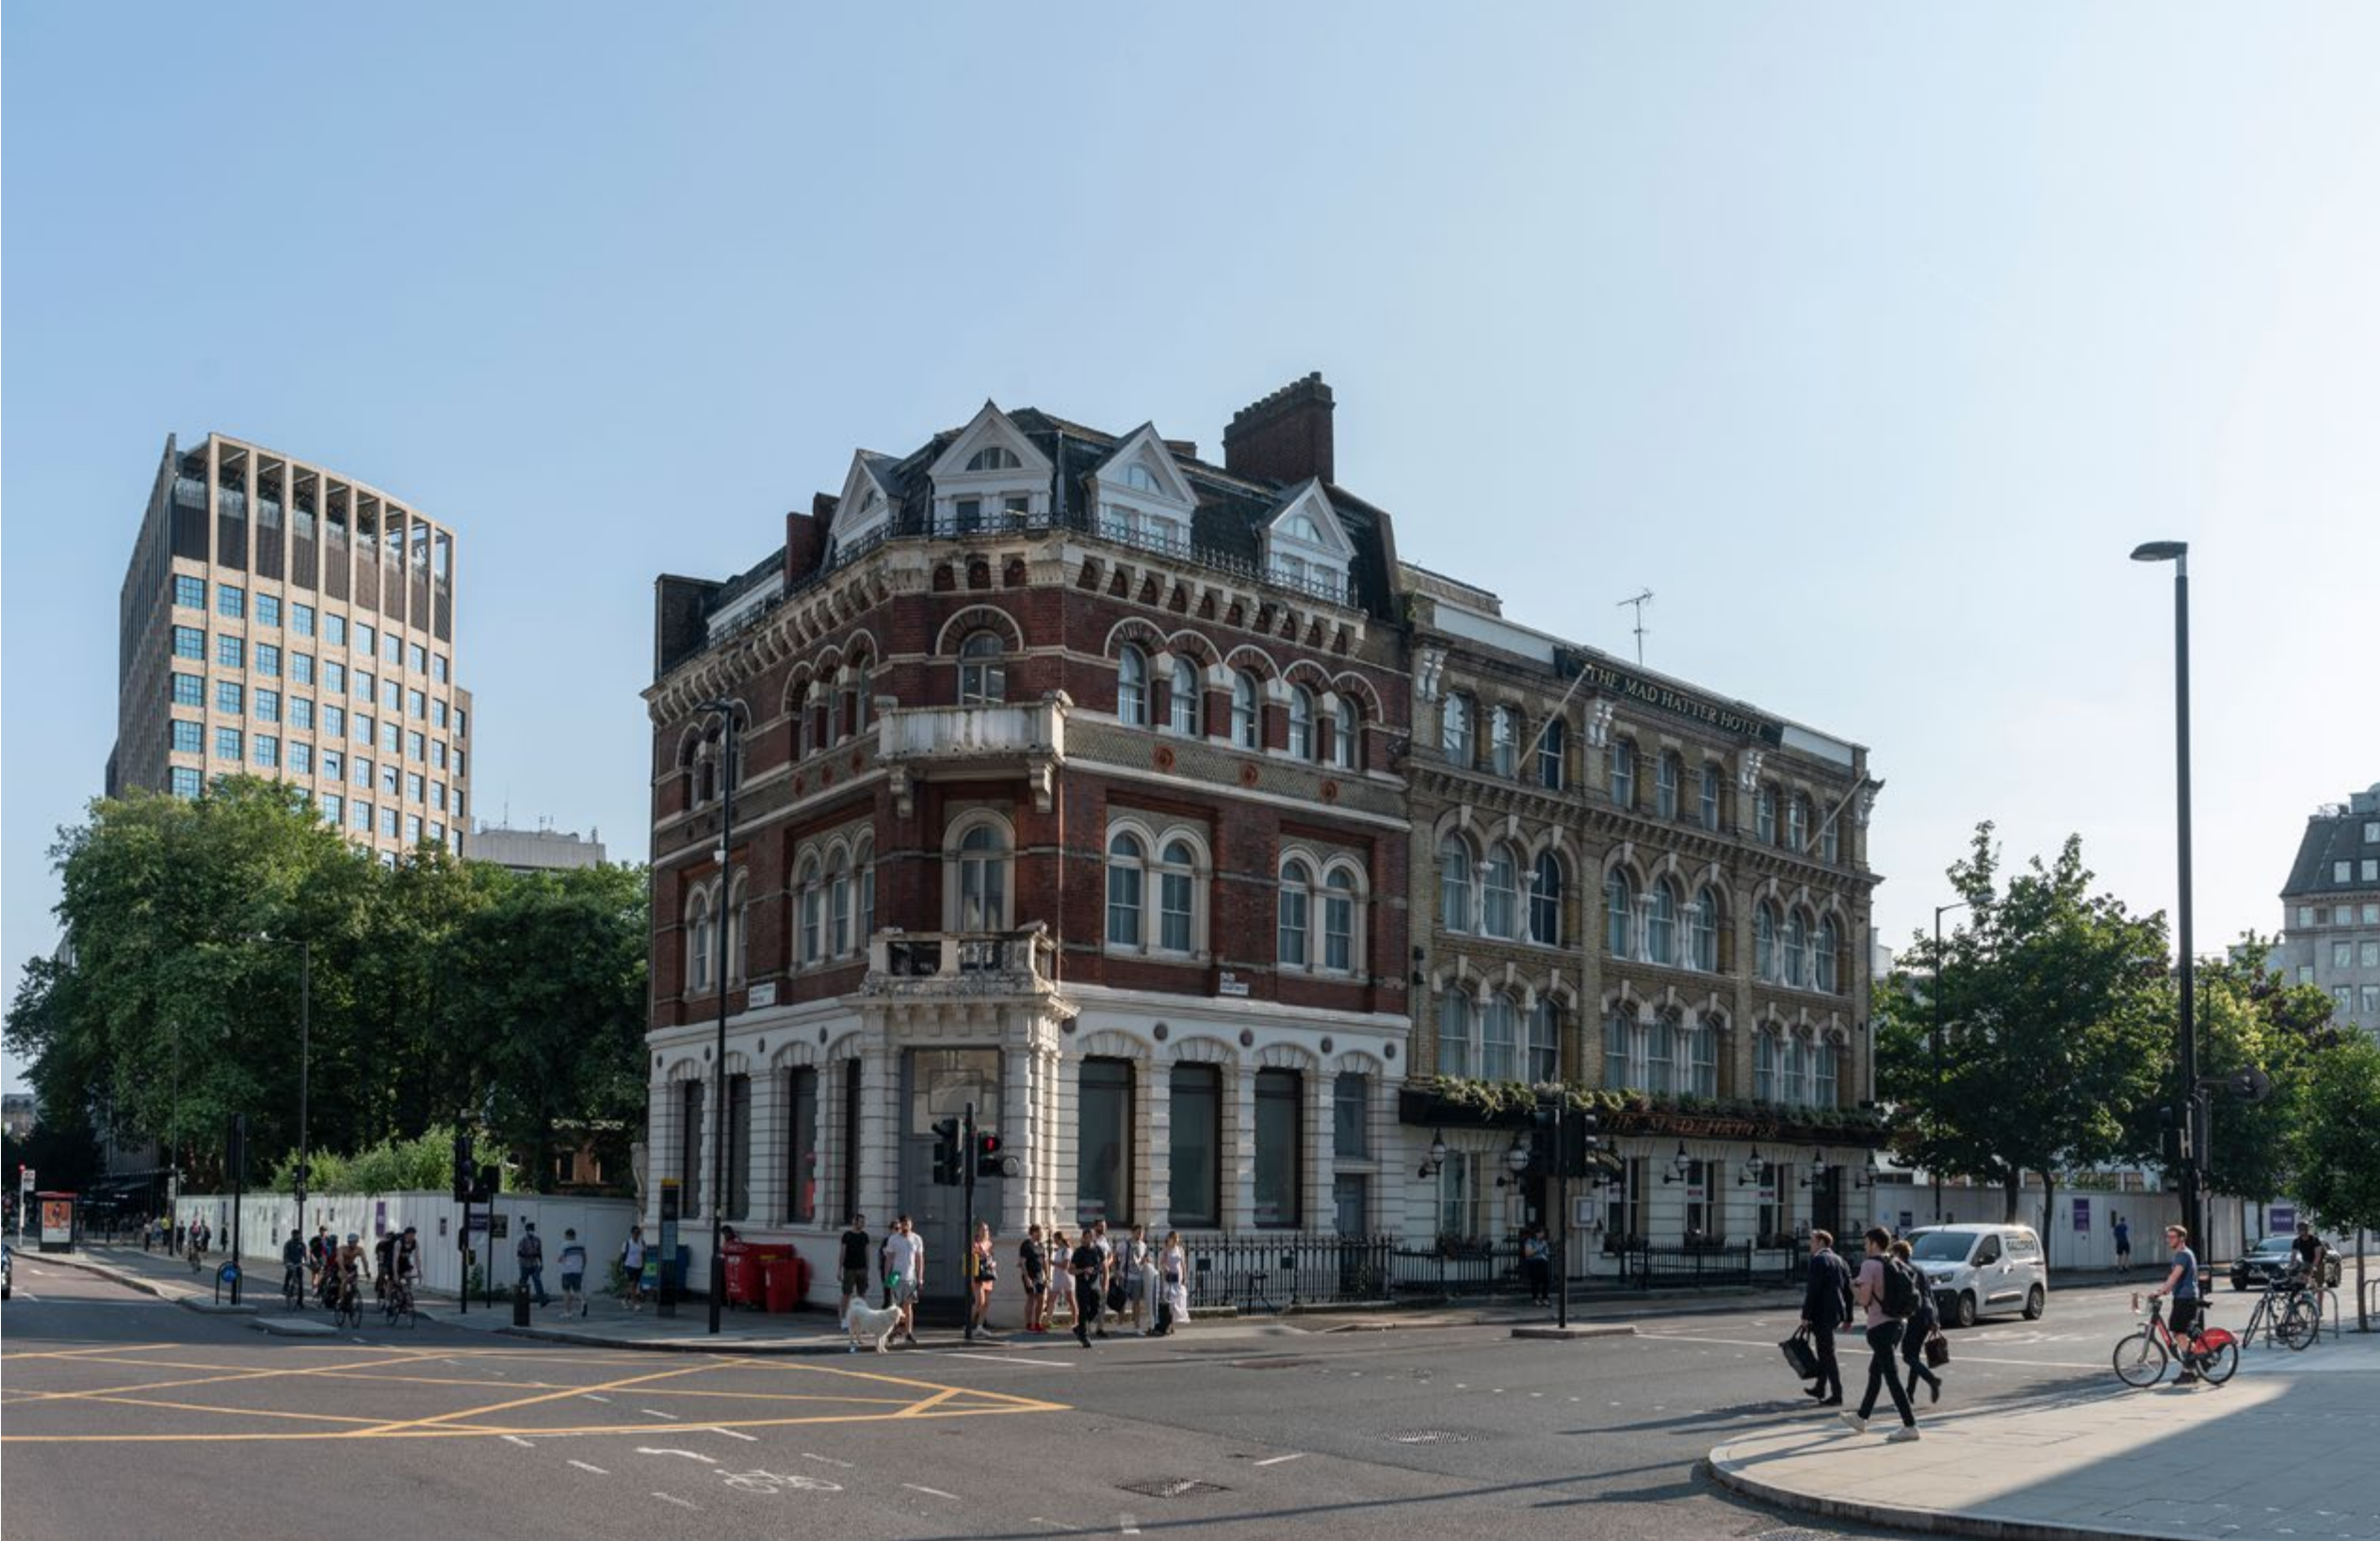
**Right:**  
Photograph of 1 and 3-7 Stamford Street - 2021

The main access to the building is through modern principal double entrance doors located on the canted corner. There is a second entrance located on Stamford Street elevation, which was historically a window.

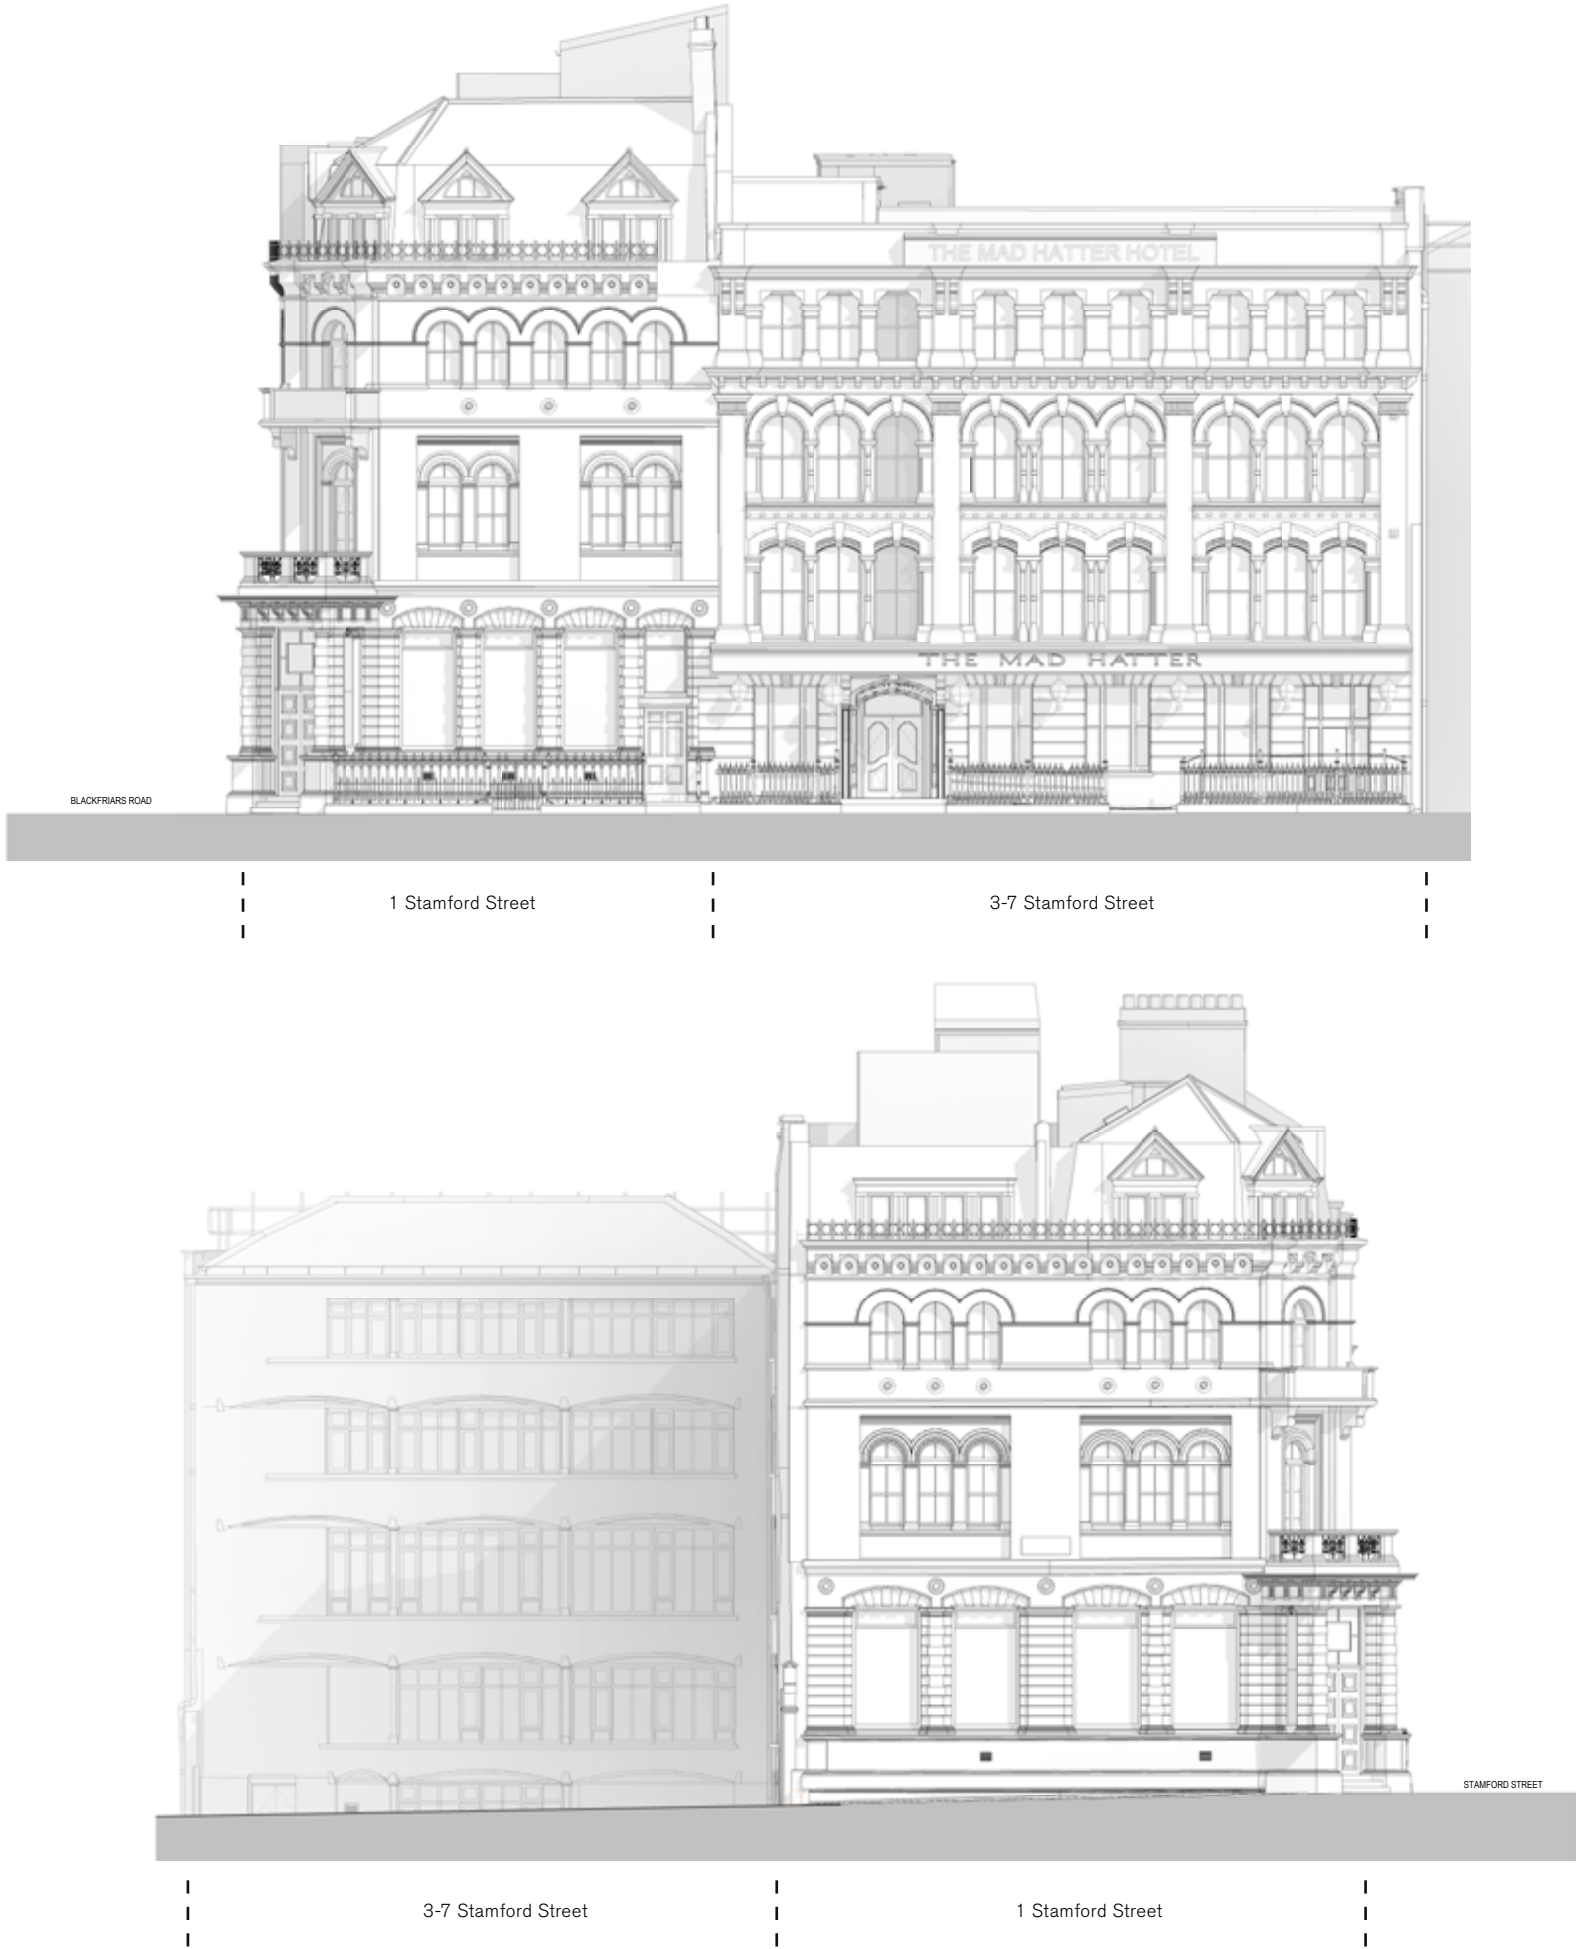
**Top:**  
Drawing of existing 1 and 3-7 Stamford Street north elevation DIA survey, 2022  
**Bottom:**  
Drawing of existing 1-7 Stamford Street east elevation based on DIA survey, 2022

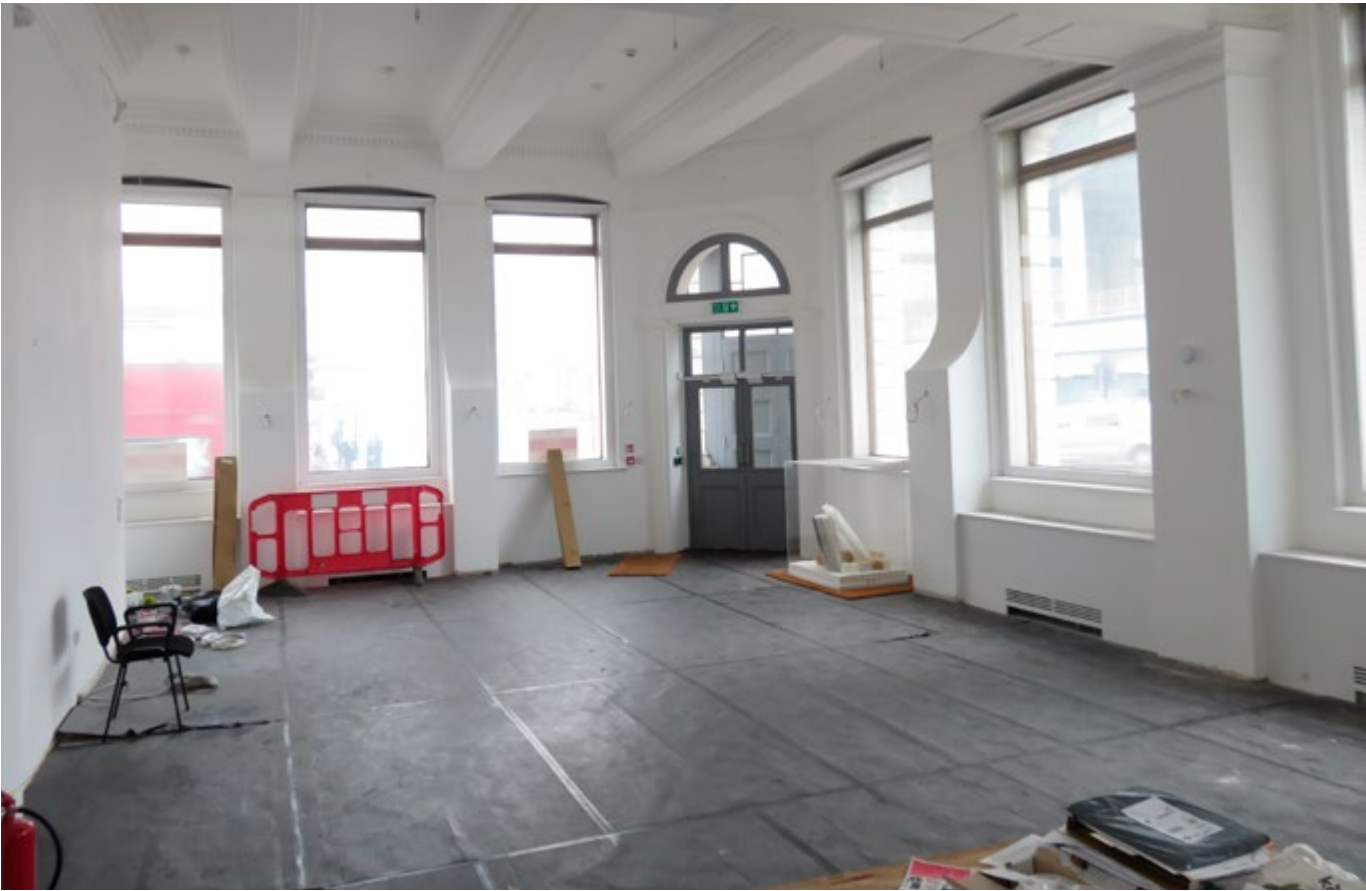
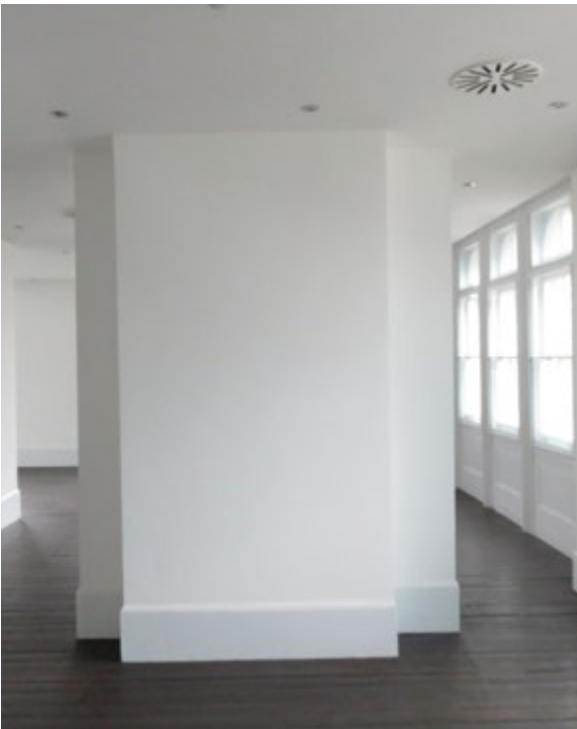
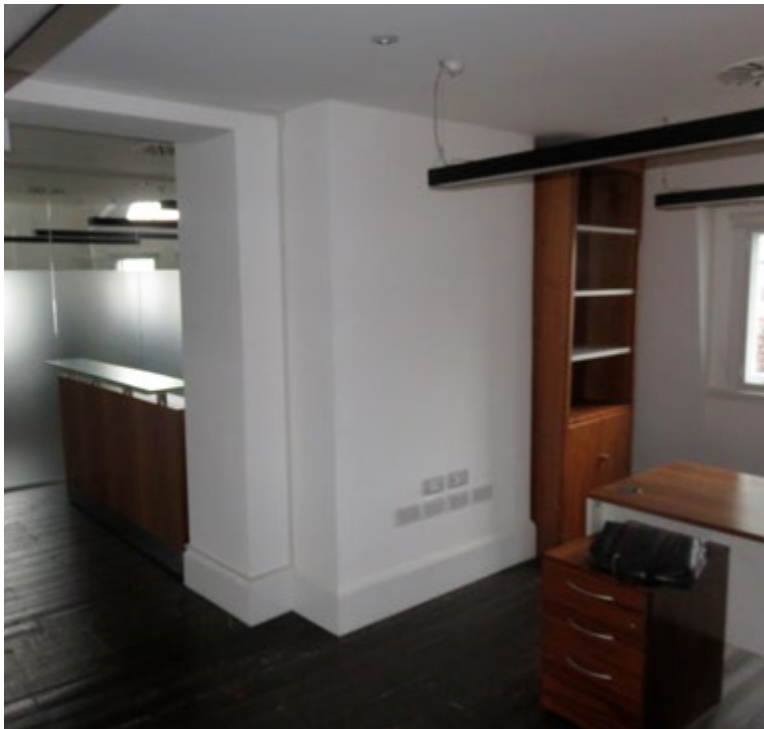
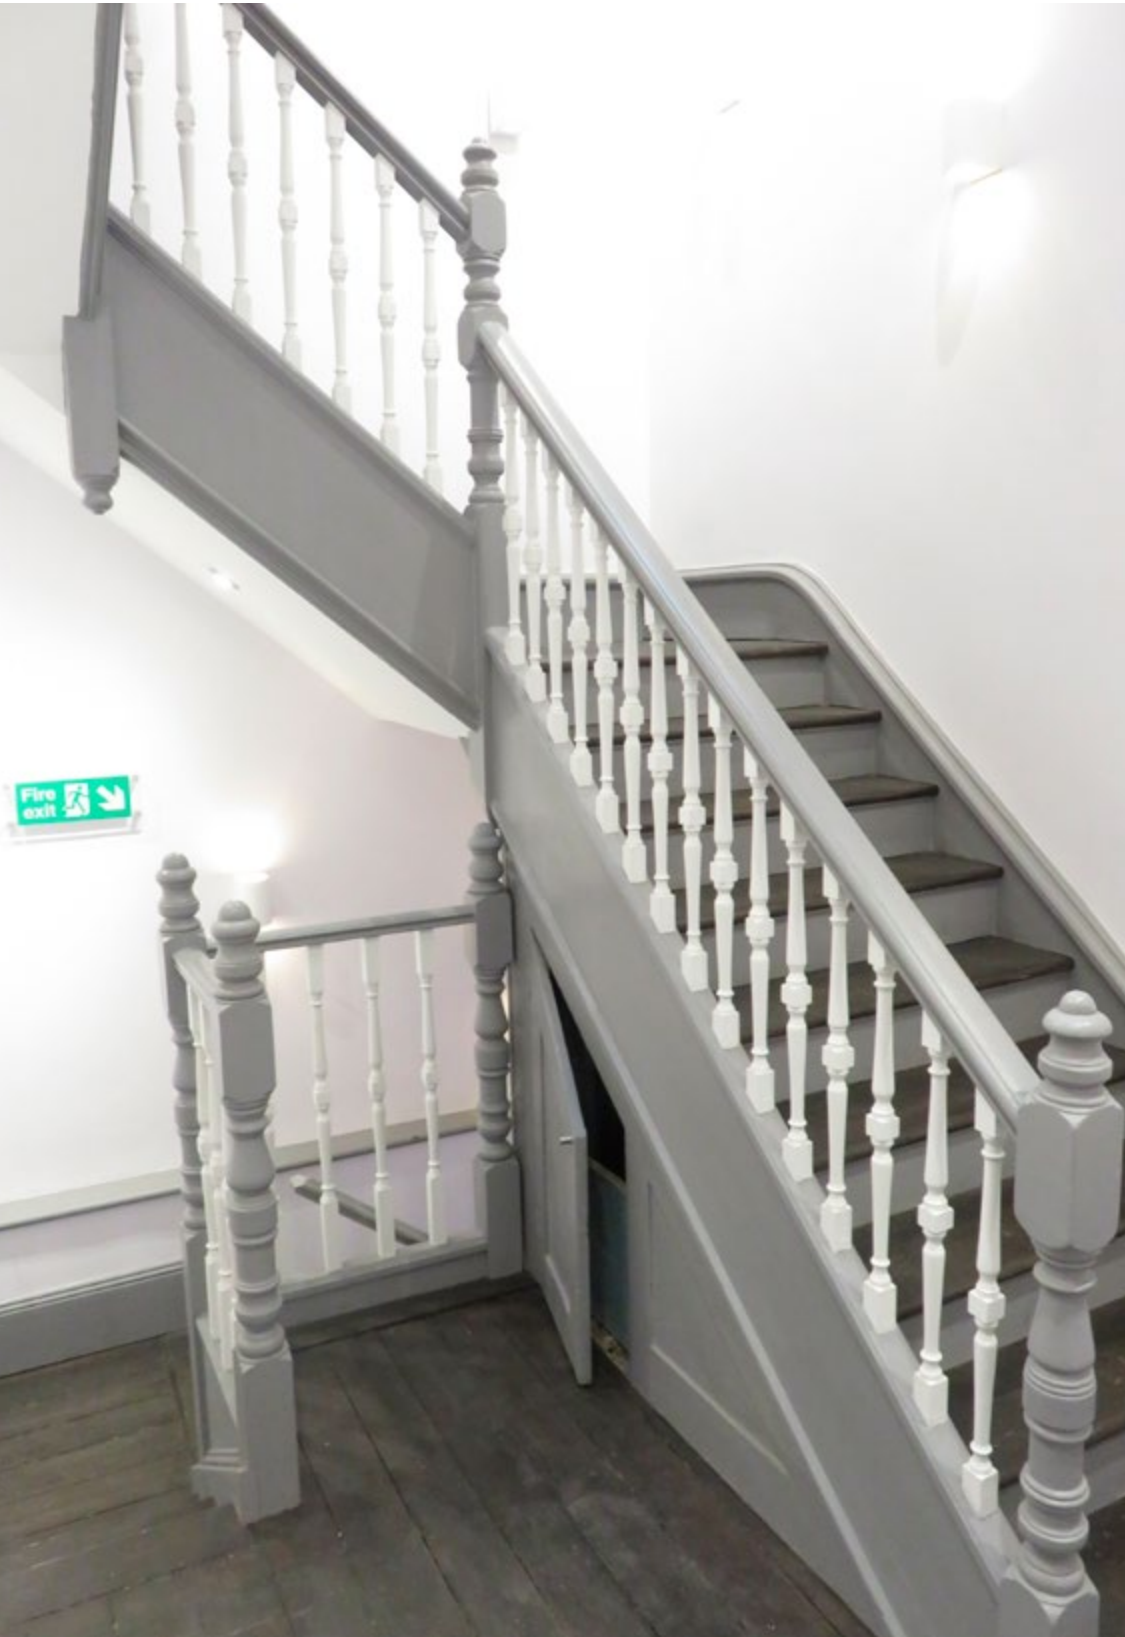
Internally there is a modern foyer featuring contemporary timber stairs leading to the first floor and a modern corridor that leads to the principal Ground Floor space. Above the Ground Floor, an original timber winder staircase with stick balusters and a timber handrail leads from the first floor to the upper floors.

As noted by DIA, overall, very few of the original features and only some of the plan form survive. *"Only the Ground Floor coffered ceiling and plasterwork, original chimney breasts, the timber stair from first to third floor level and historic timber floorboards survive, and are considered to be of high significance. The Ground Floor plan retains its likely-original open floor plan, which is also of high significance. The floor plans of the upper floors have been altered, as demonstrated by the stand-alone chimney breasts and the insertion of modern corridors".*

**Bottom Left:**  
1 Stamford Street - Level 01- 2023  
**Bottom Right:**  
1 Stamford Street - Level 03 - 2023  
**Top Left:**  
1 Stamford Street - Ground Floor - 2023  
**Right:**  
1 Stamford Street Staircase - Level 01/02 - 2023

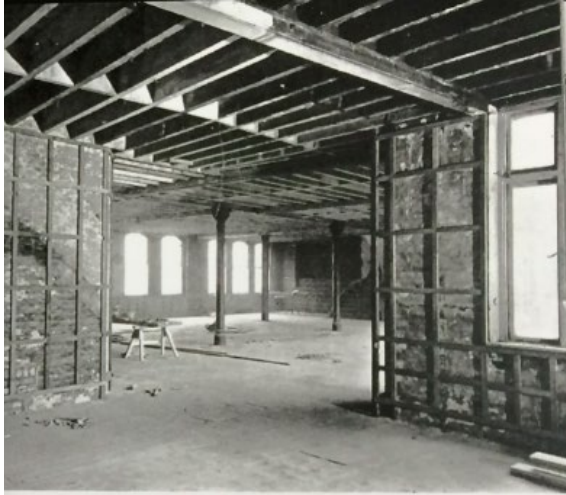
**Top Left:**  
The Tress & Co Hat Factory at 3-7 Stamford Street - 19th Century  
**Top Middle:**  
Internal photograph of 3-7 Stamford Street -1955  
**Top Right:**  
Ordinance Survey map from 1981  
**Bottom Left:**  
Tress House at 3-7 Stamford Street - 1975  
**Bottom Right:**  
Aerial view of Stamford Street - 1929

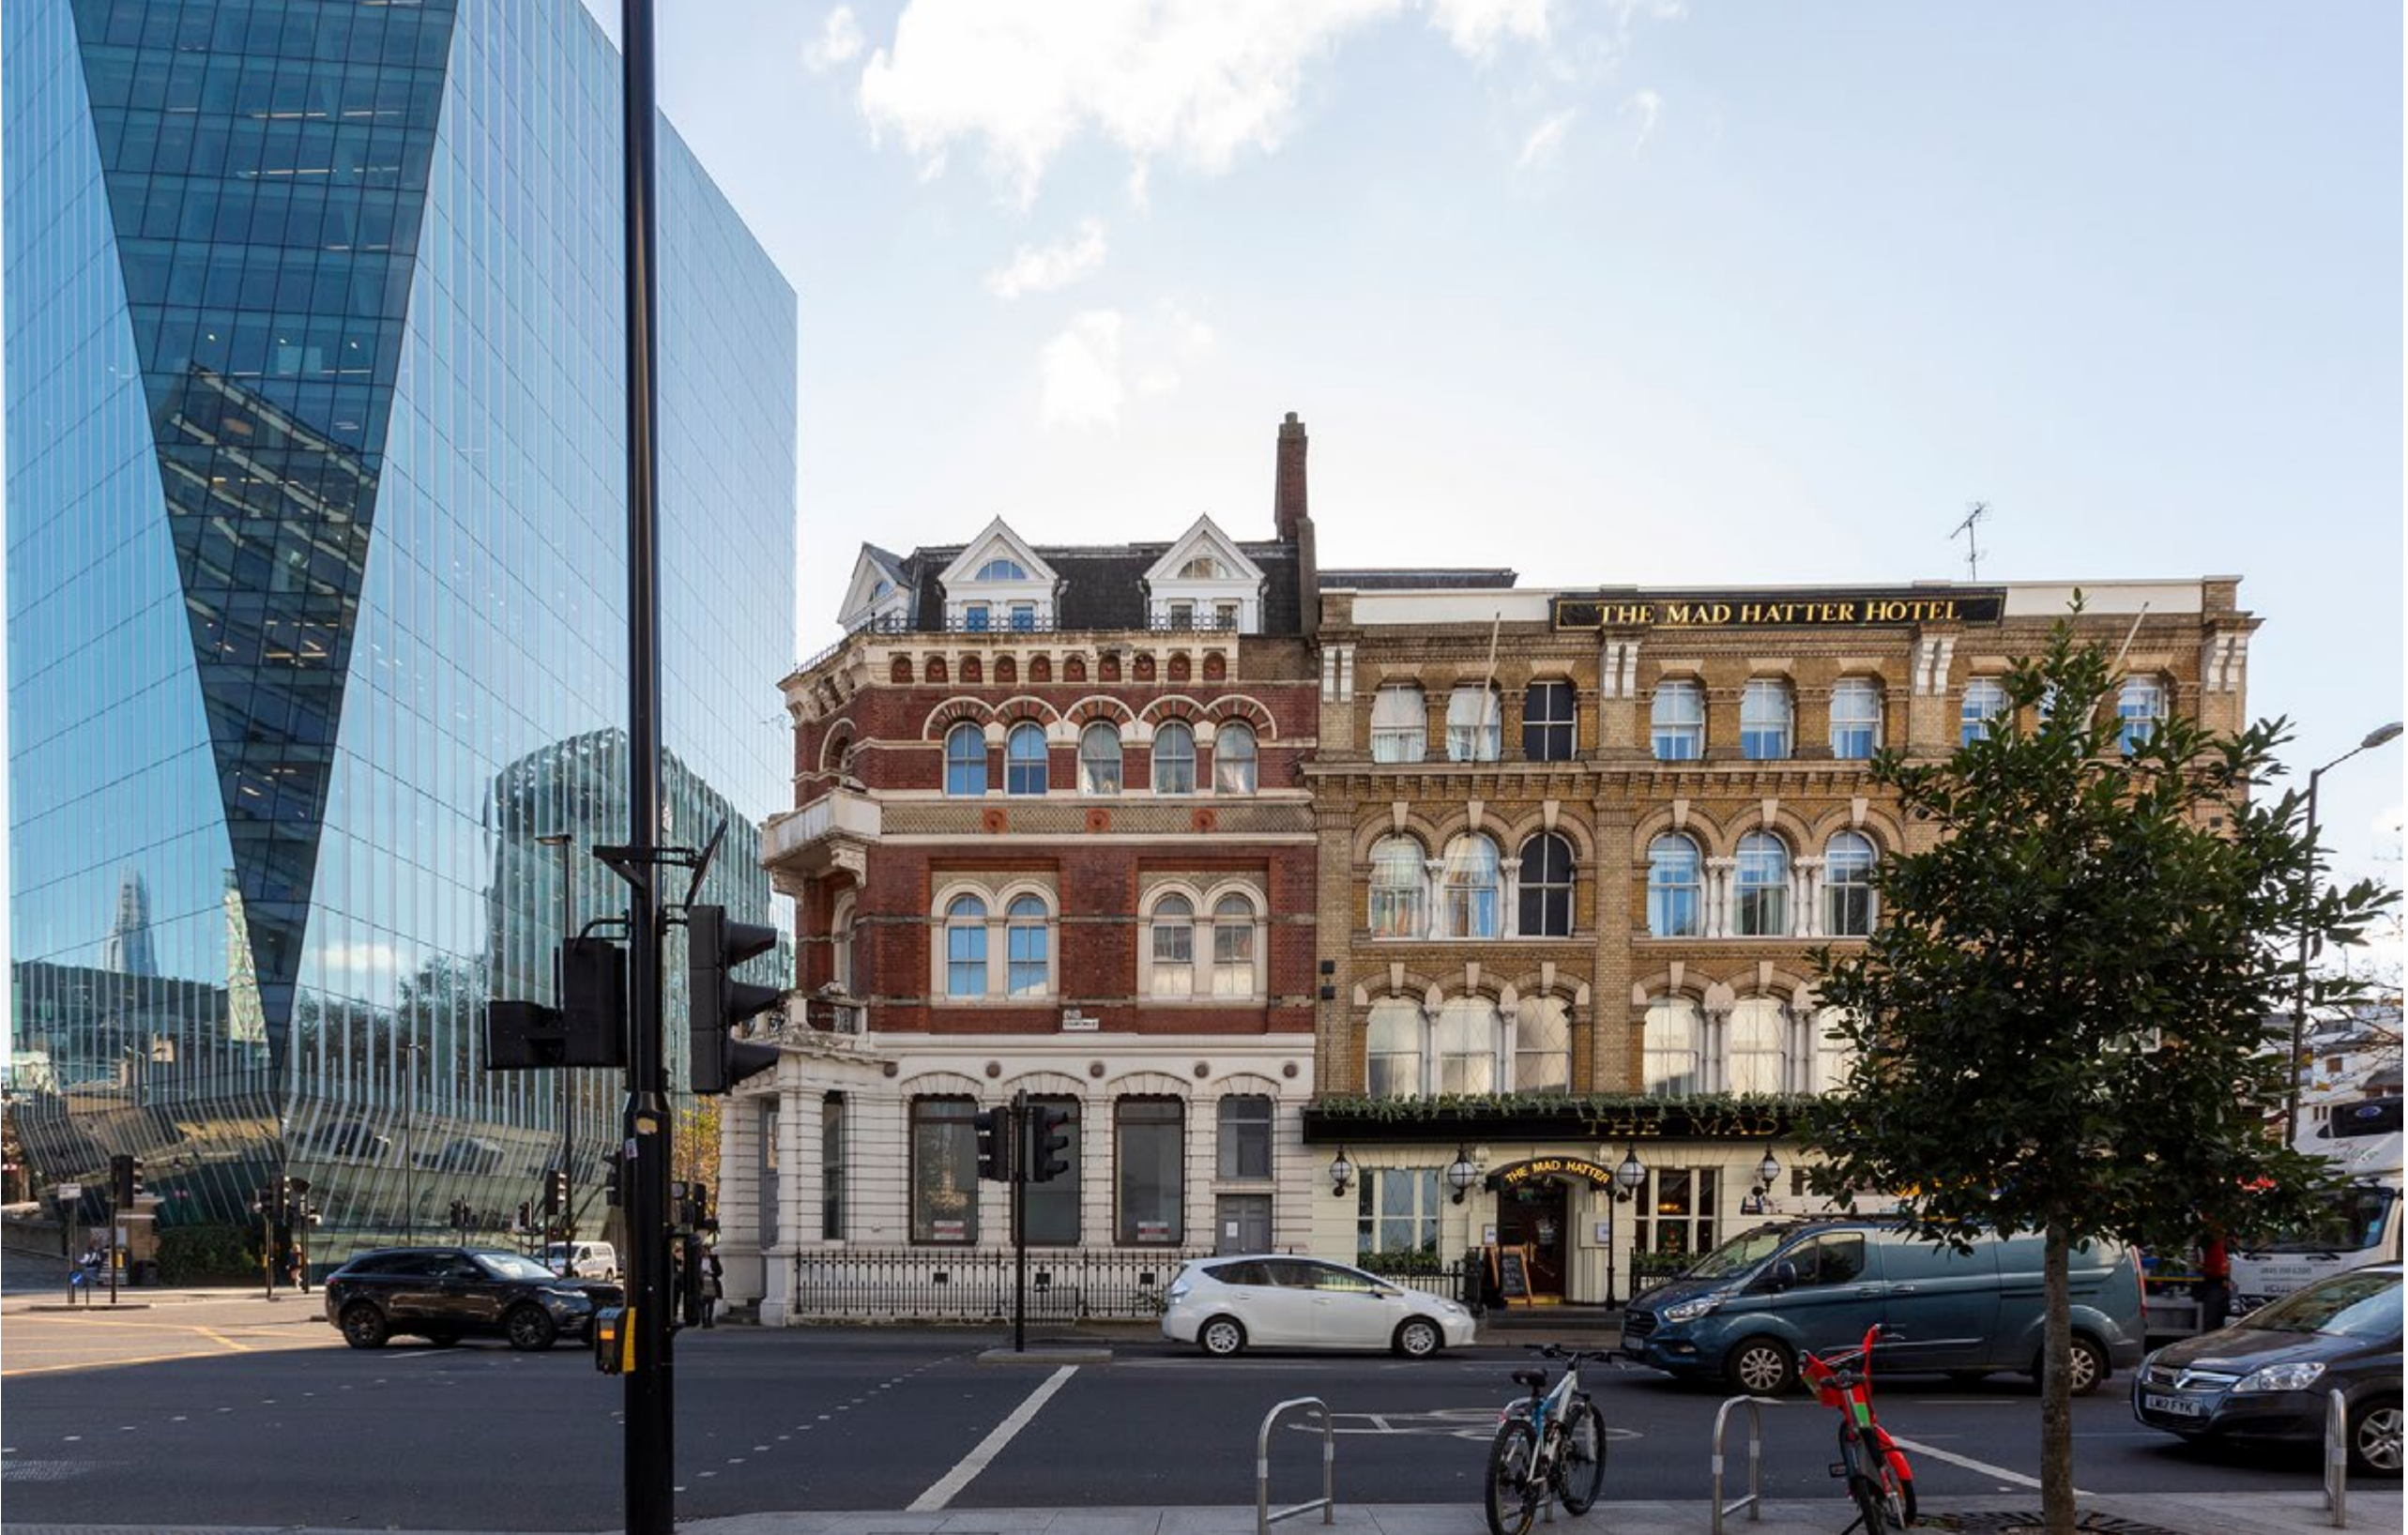
**Right:**  
Photograph of 1 and 3-7 Stamford Street - 2021

DIA note that *“the primary significance of 3-7 Stamford Street lies in its external aesthetic value, with its principal brick façade, which remains largely unaltered. The rear elevation has been heavily altered in conjunction with the rear return, and subsequently both are considered to be of lesser significance. Whilst the brick arches are likely original, the fenestration has been replaced with modern uPVC windows, large areas of brickwork have been replaced and openings to both the rear elevation and the east elevation of the rear return have been partially infilled”*.

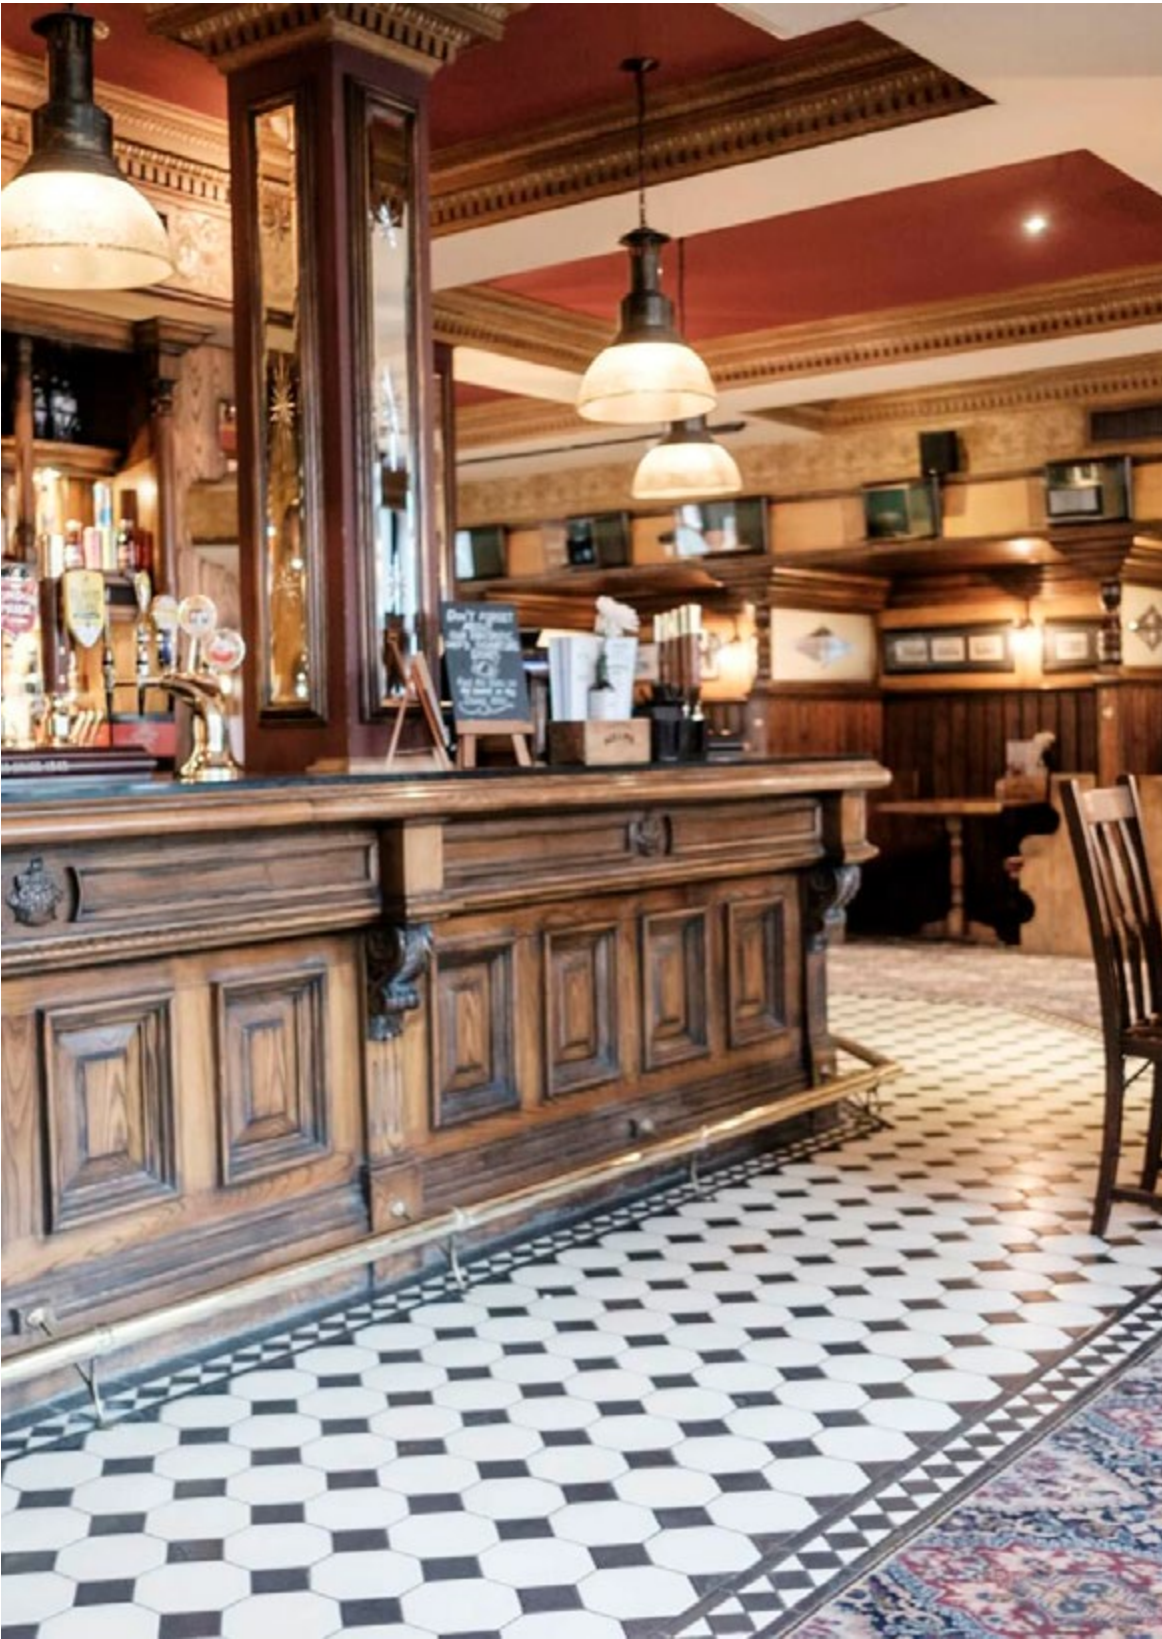
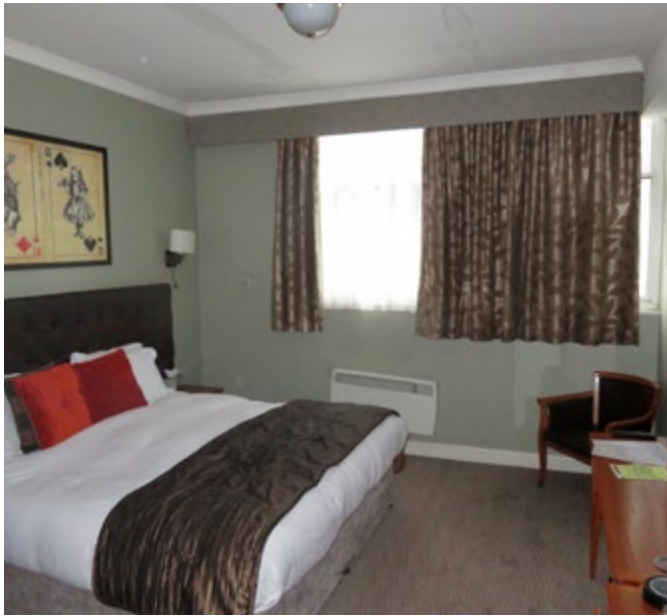
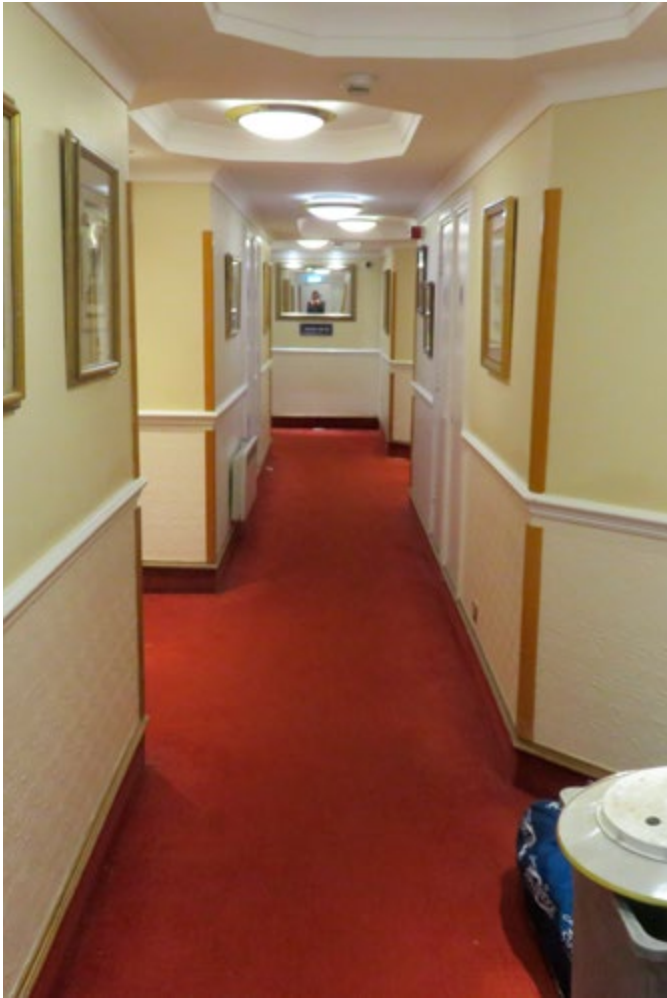
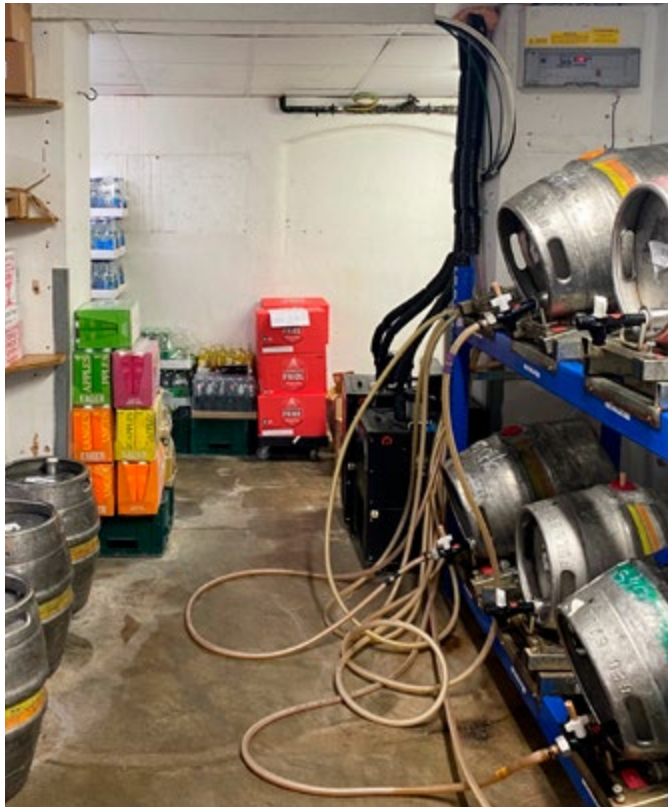
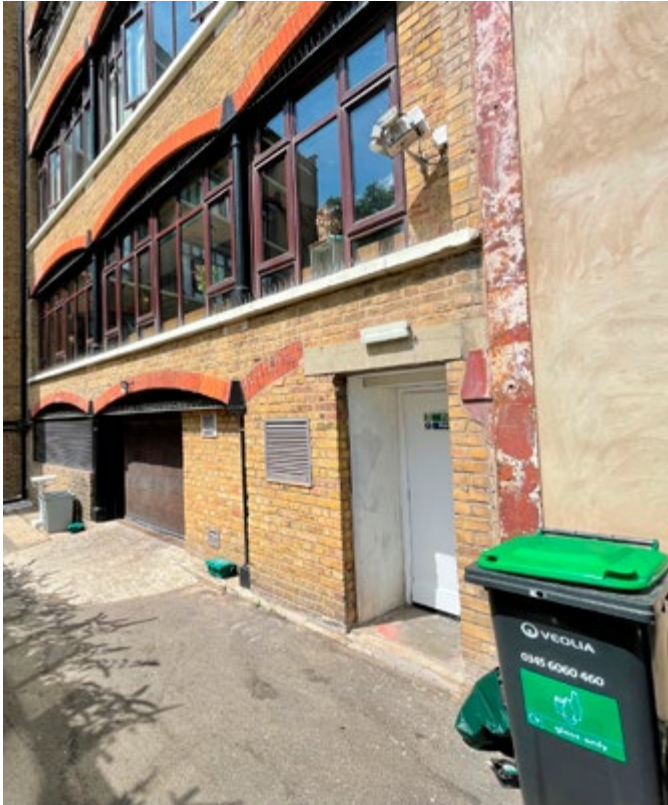
Modern incongruous ventilation grilles and plant equipment have also been fixed to both elevations. The consequence of these unfortunate alterations have resulted in patchwork elevations, which whilst displaying a remnant of their former industrial appearances, appear mostly untidy and incoherent.

**Left:**  
3-7 Stamford Street -  
Mad Hatter Public House  
- 2023  
**Top Middle:**  
3-7 Stamford Street  
- Typical Hotel Room  
- 2023  
**Bottom Middle:**  
3-7 Stamford Street -  
Typical Hotel Corridor  
- 2023  
**Top Right:**  
3-7 Stamford Street -  
Mad Hatter Basement  
- 2023  
**Bottom Right:**  
3-7 Stamford Street  
- Mad Hatter Rear  
Elevation - 2023
