**Staffin Community Harbour Development  
Environmental Impact Assessment Report  
Volume 3: Appendices  
September 2021**

# **Appendix A1: The Environmental Impact Assessment Team**

## **Staffin Community Harbour Development**

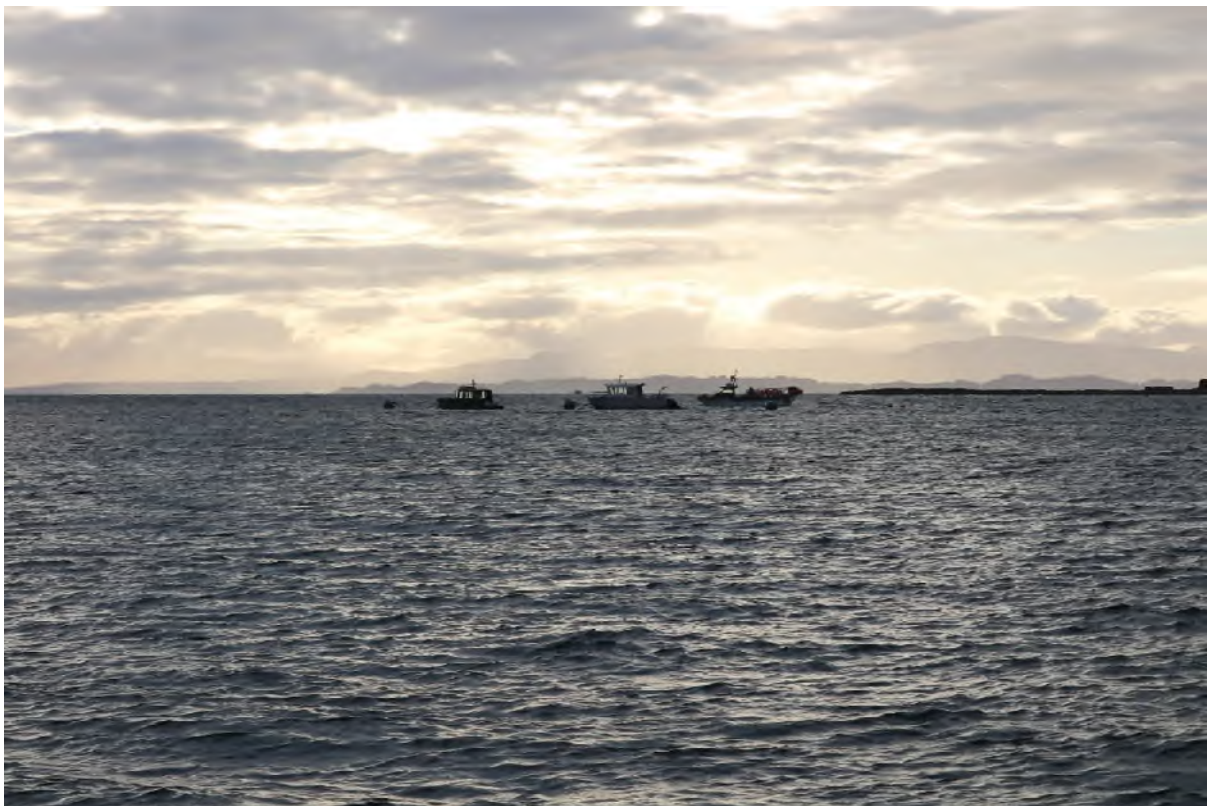
**Figure 11.1.2: Boats Moored between Staffin Island and the Staffin Slipway**

Currently boats, that are not removed from the water daily, are moored between the slipway and Staffin Island (located approximately 600m north of the existing slipway) (Figure 11.1.2). Small dinghies are used to ferry people from the slipway to their boats and back. However, when the sea is too rough, the dinghies cannot leave slipway area, preventing access to anchored vessels.

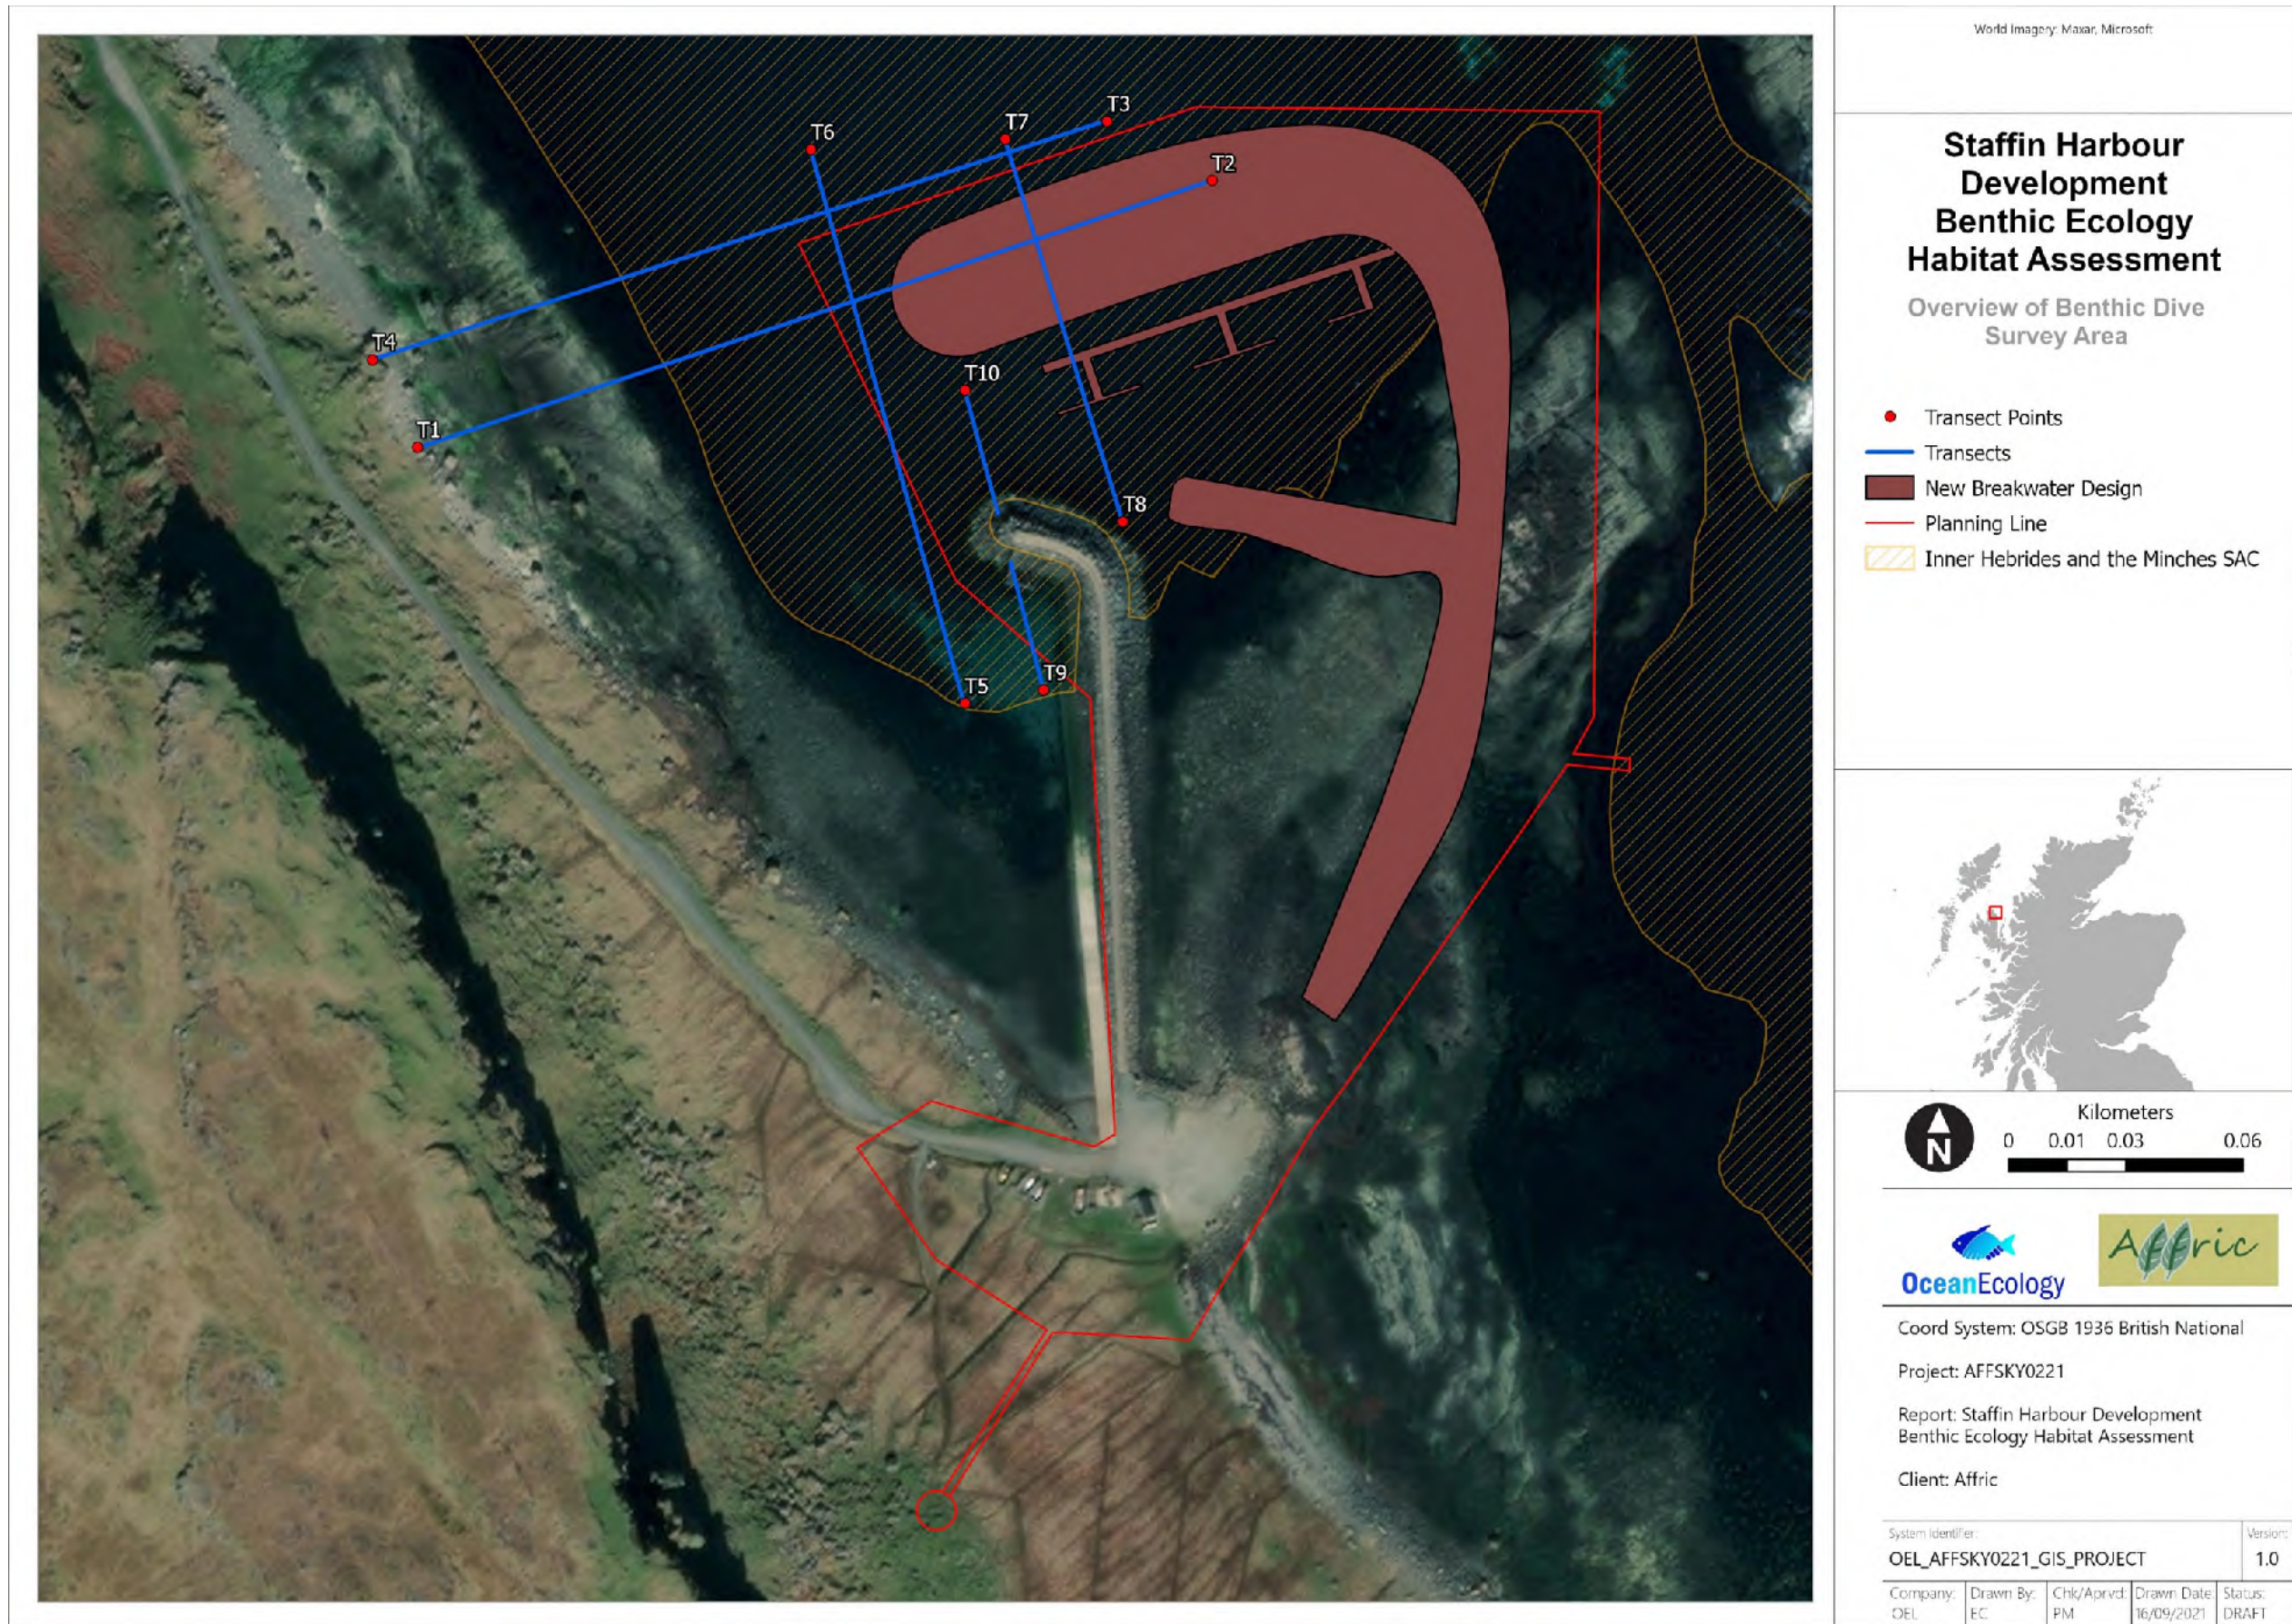
**Figure 1** Overview of the Staffin Harbour survey area covered by the video footage collected across 5 transects and new slipway and breakwater designs.

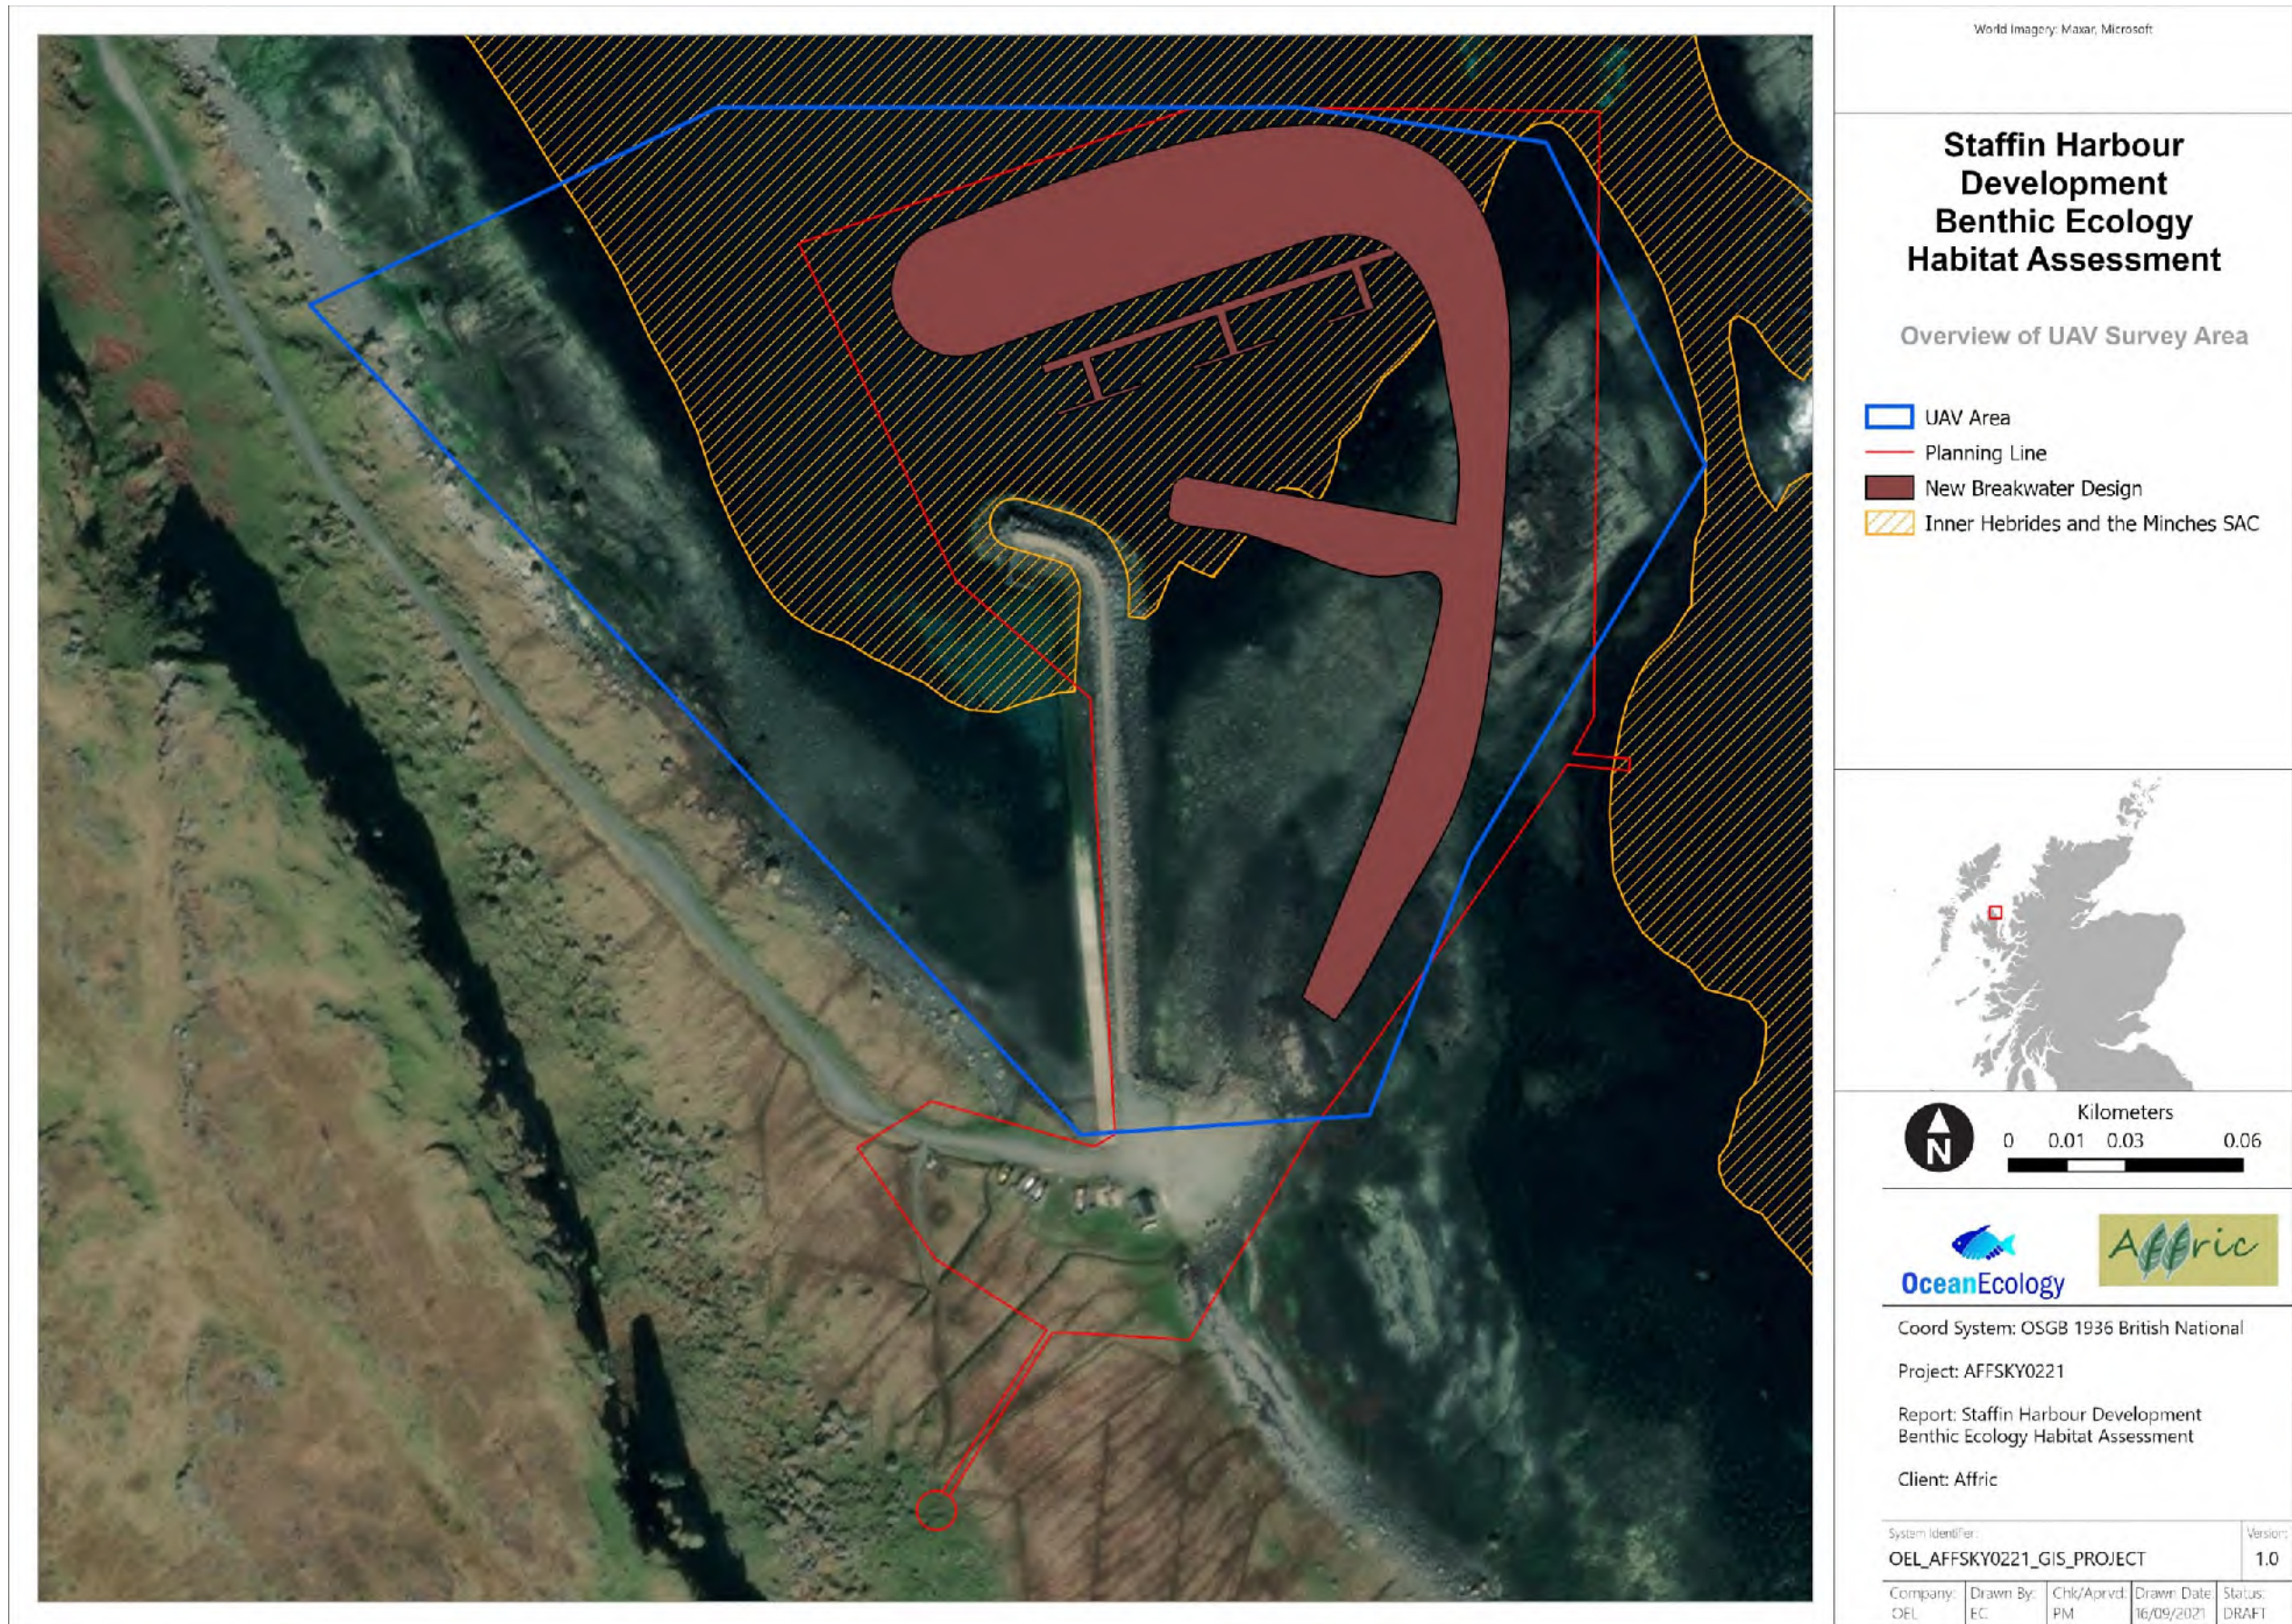
**Figure 2** Overview of the Staffin Harbour survey area covered by the UAV flight and new slipway and breakwater designs.

The UAV mapping was by Tracks Ecology Ltd in accordance with the Civil Aviation Authority (CAA) regulations. Tracks Ecology Ltd holds a Certificate of Competency for flights within the A2 subcategory and a General Visual Line of Sight Certificate. The UAV used was a DJI Phantom 4 Professional. Two flights were necessary to adequately cover the survey area to the appropriate resolution and were pre-planned using the Pix4DmapperPro software to achieve an orthomosaic Ground-Sampling Distance (GSD) of 1-5 cm/px. Appendix II includes the full UAV survey report.

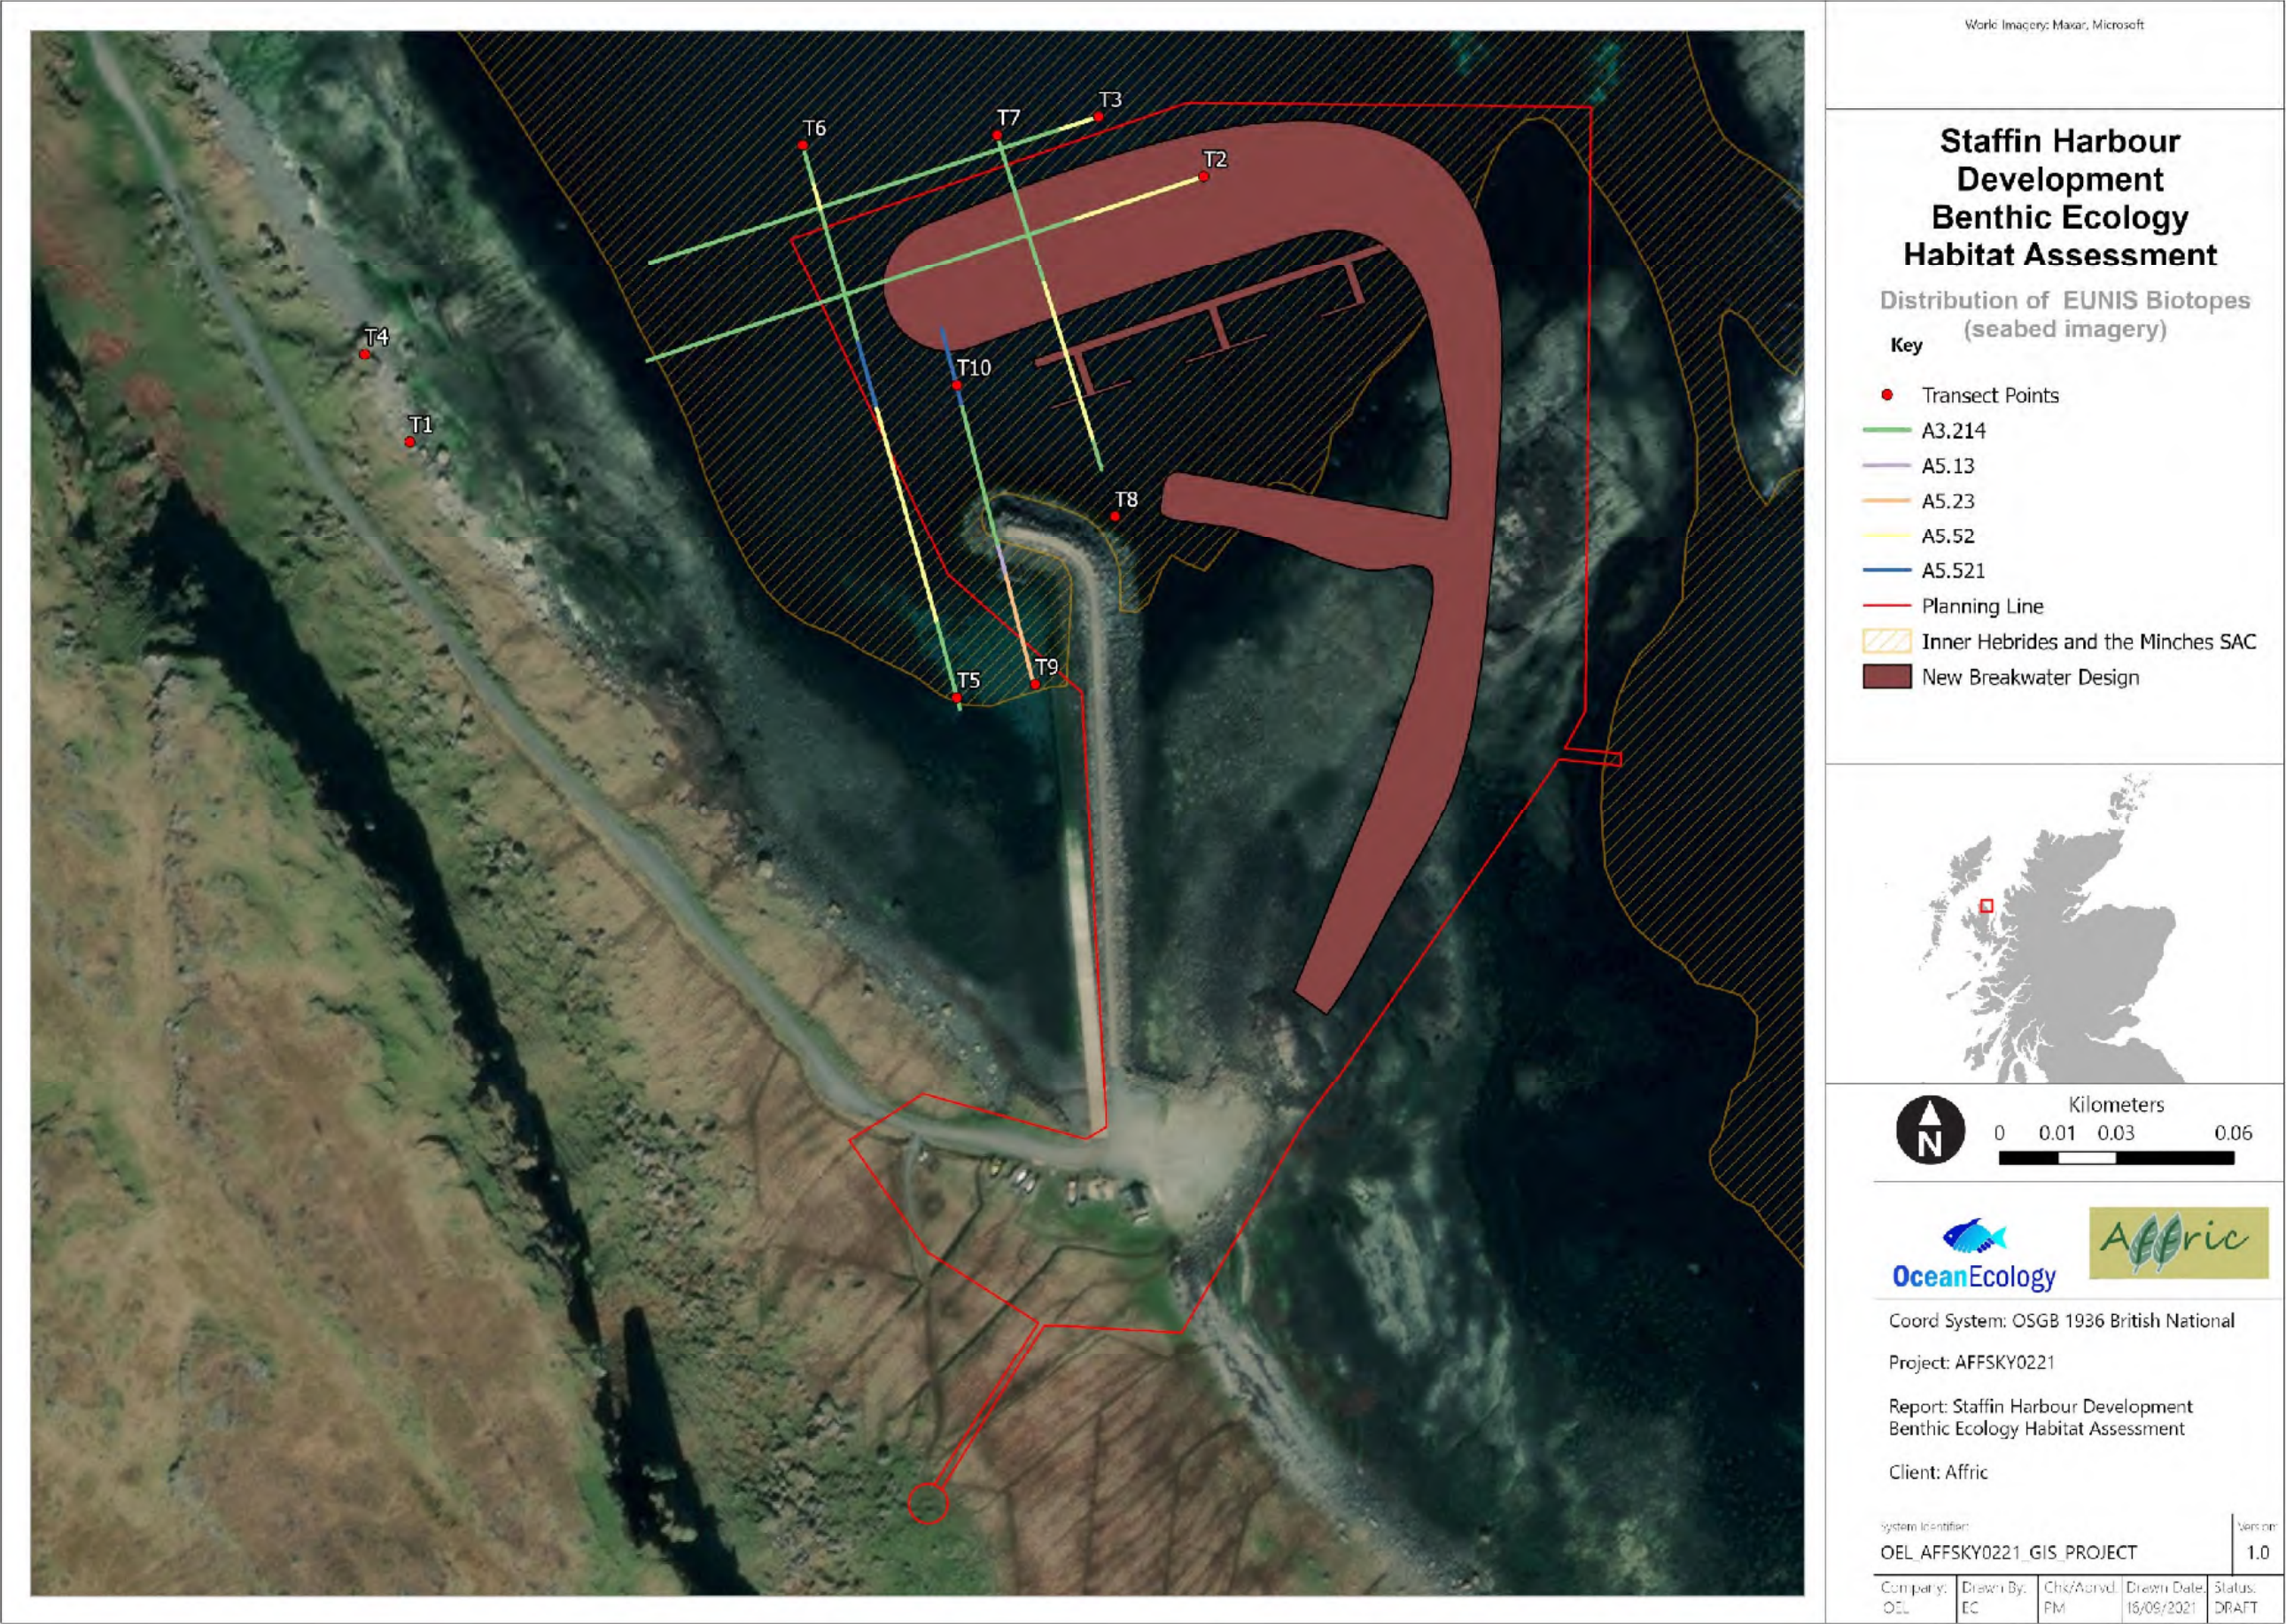
Figure 4 EUNIS classifications assigned to video footage along each of the transects sampled across the Staffin Harbour survey area.

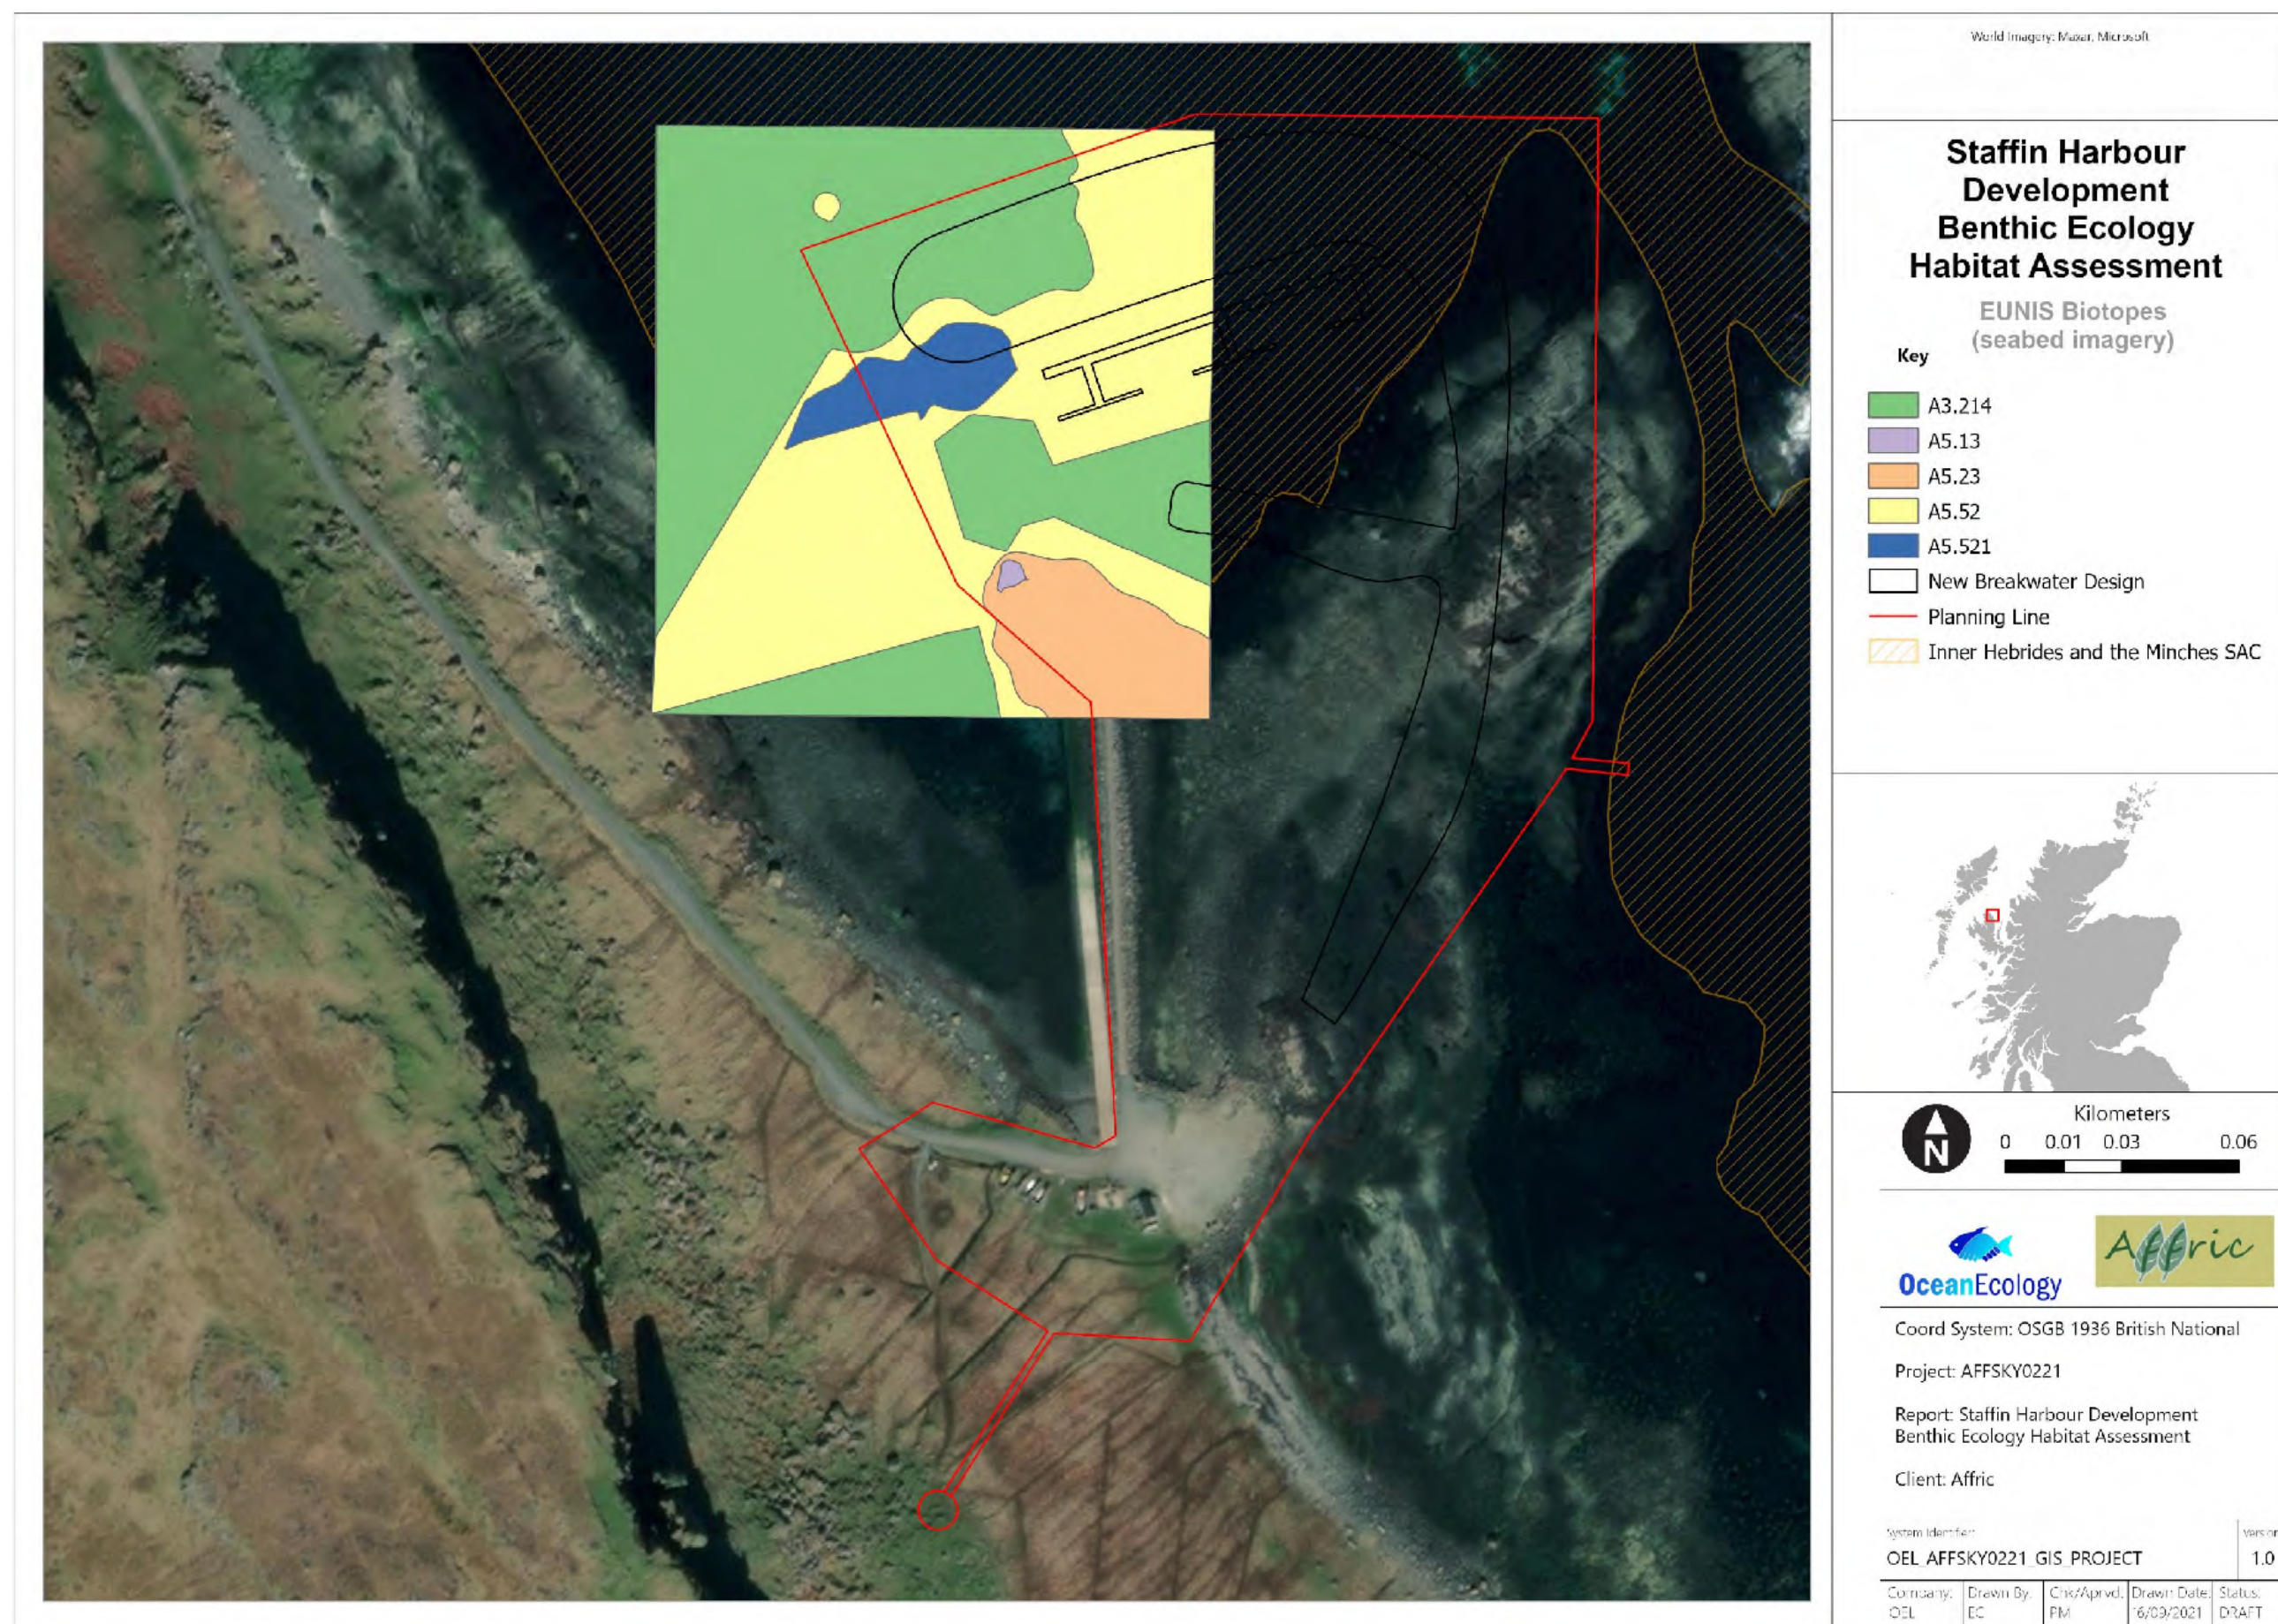
**Figure 5** Predicted EUNIS habitats/biotopes for the Staffin Harbour survey area based on video footage data.

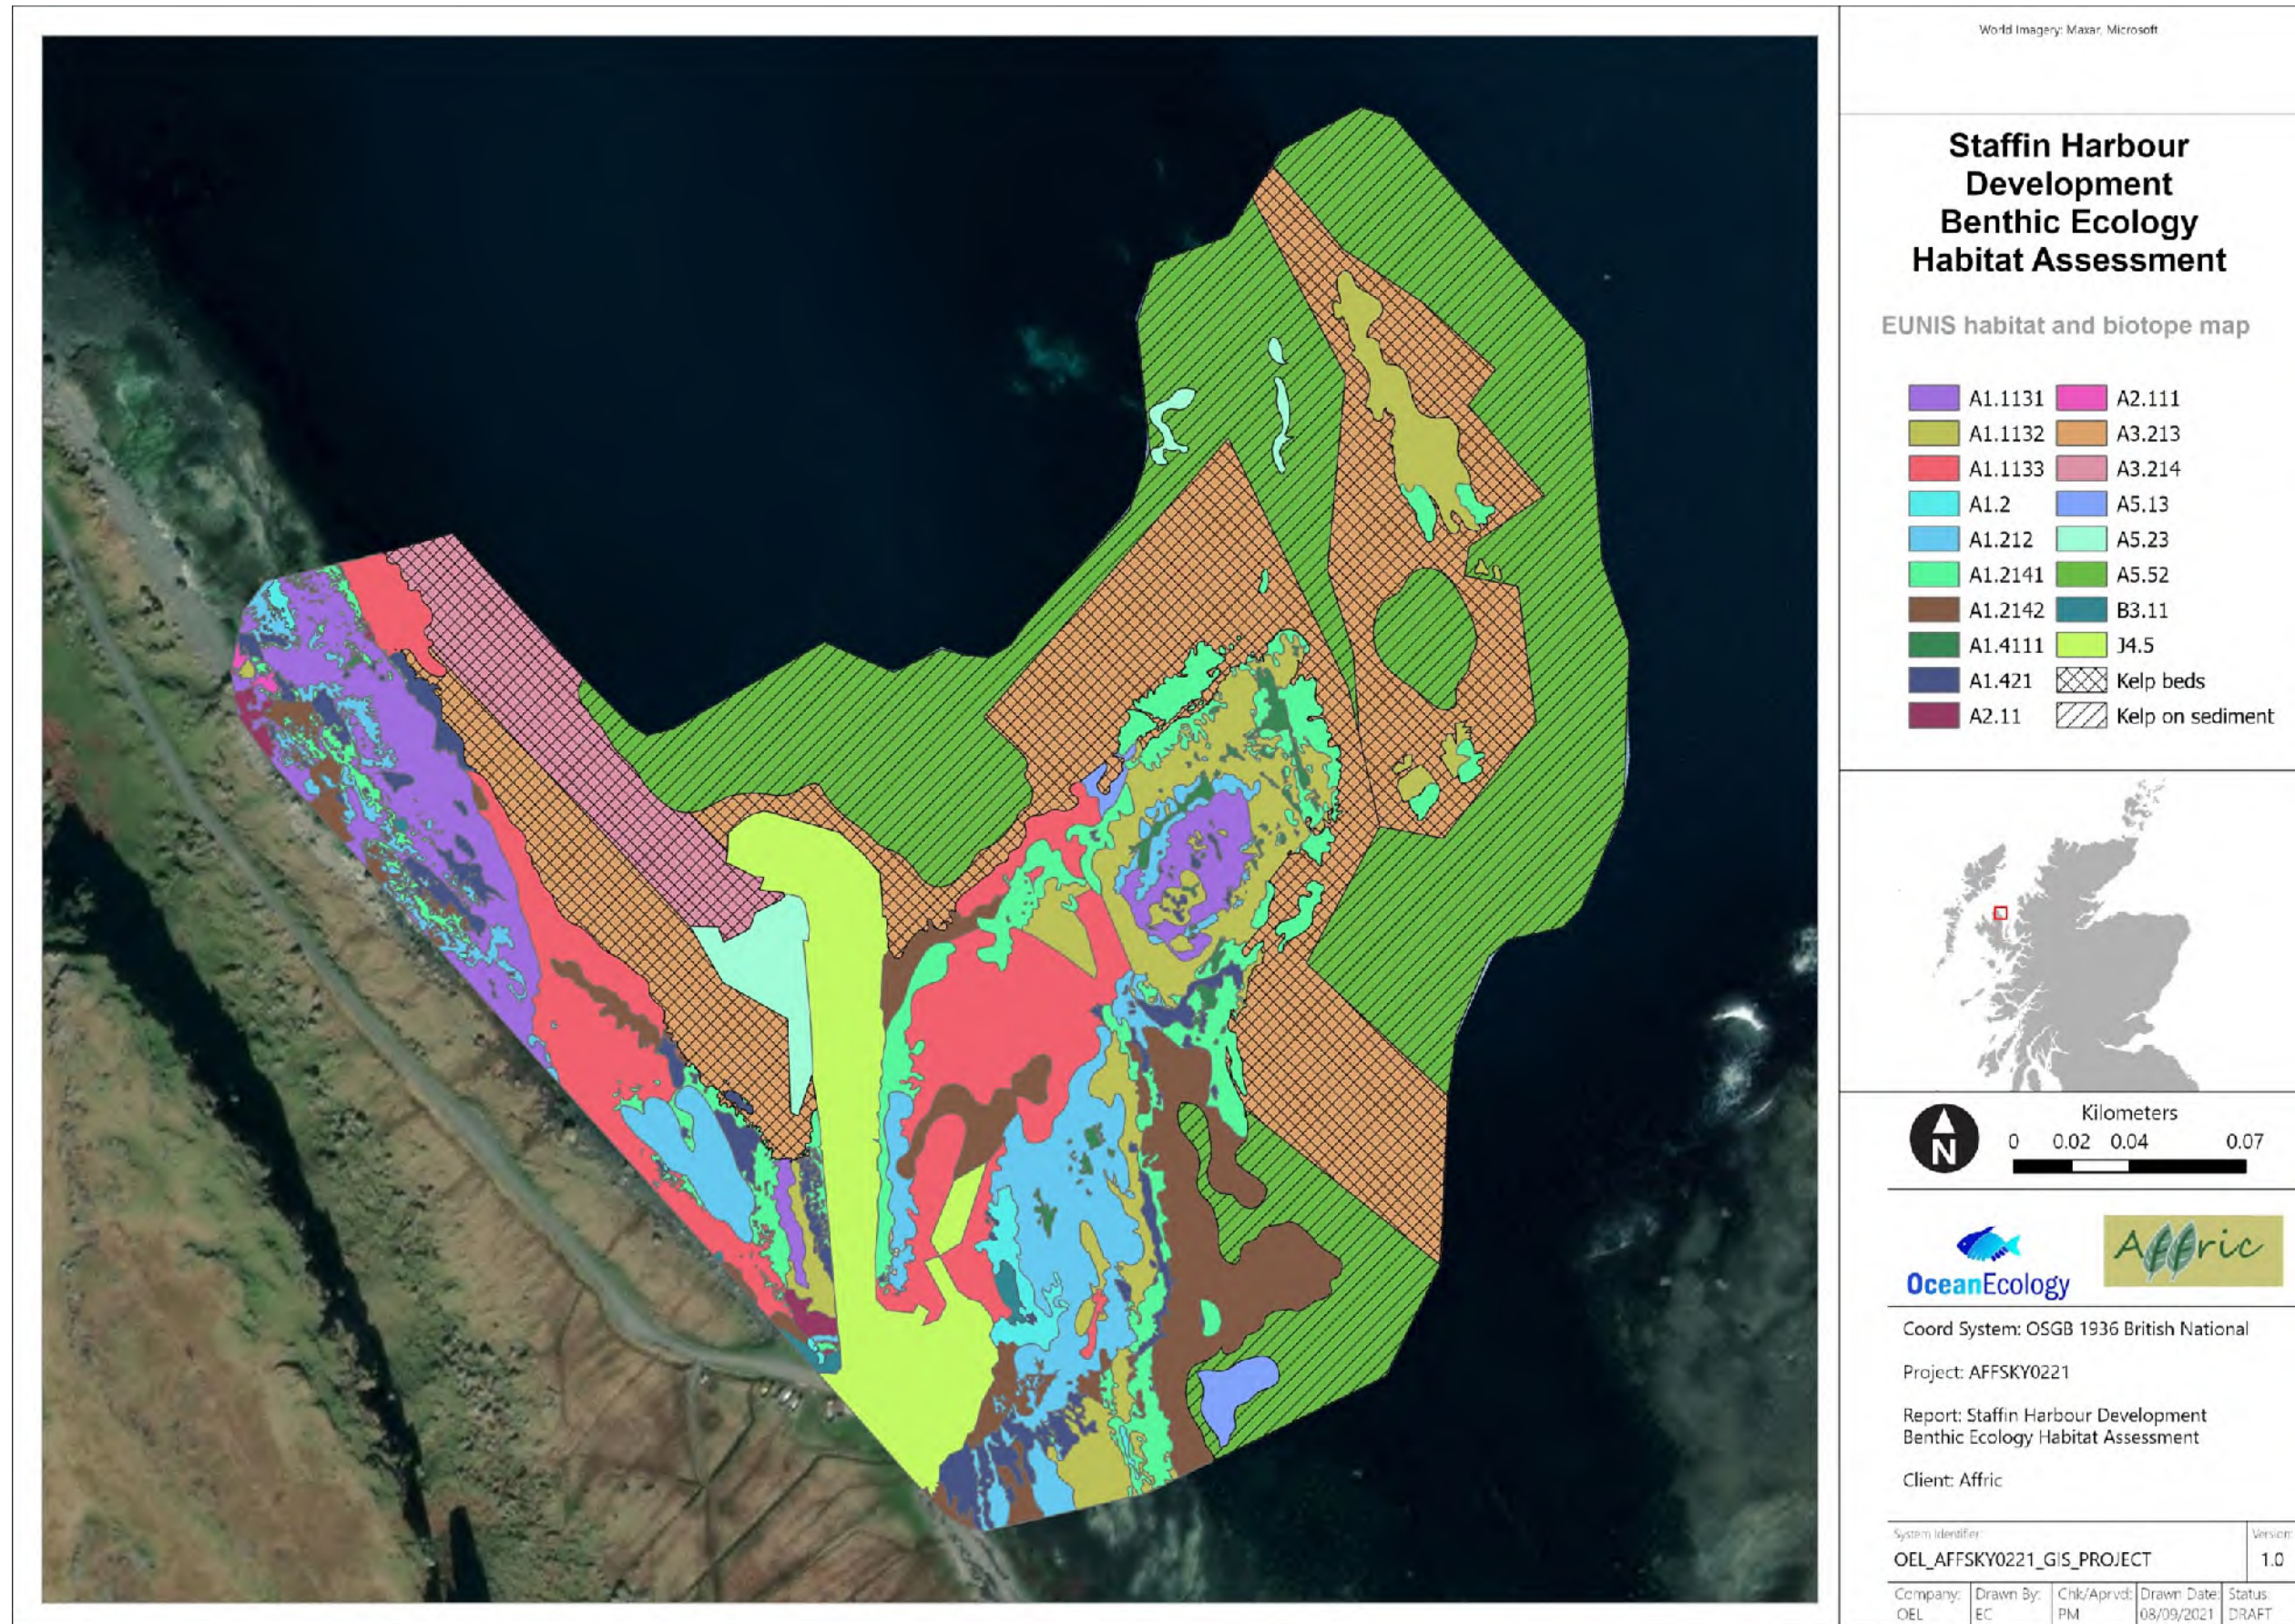
**Figure 6** EUNIS habitats/biotopes for the Staffin Harbour survey area based on UAV imagery.
