**Staffin Community Harbour Development  
Environmental Impact Assessment Report  
Volume 3: Appendices  
September 2021**

# **Appendix A1: The Environmental Impact Assessment Team**

## **Staffin Community Harbour Development**

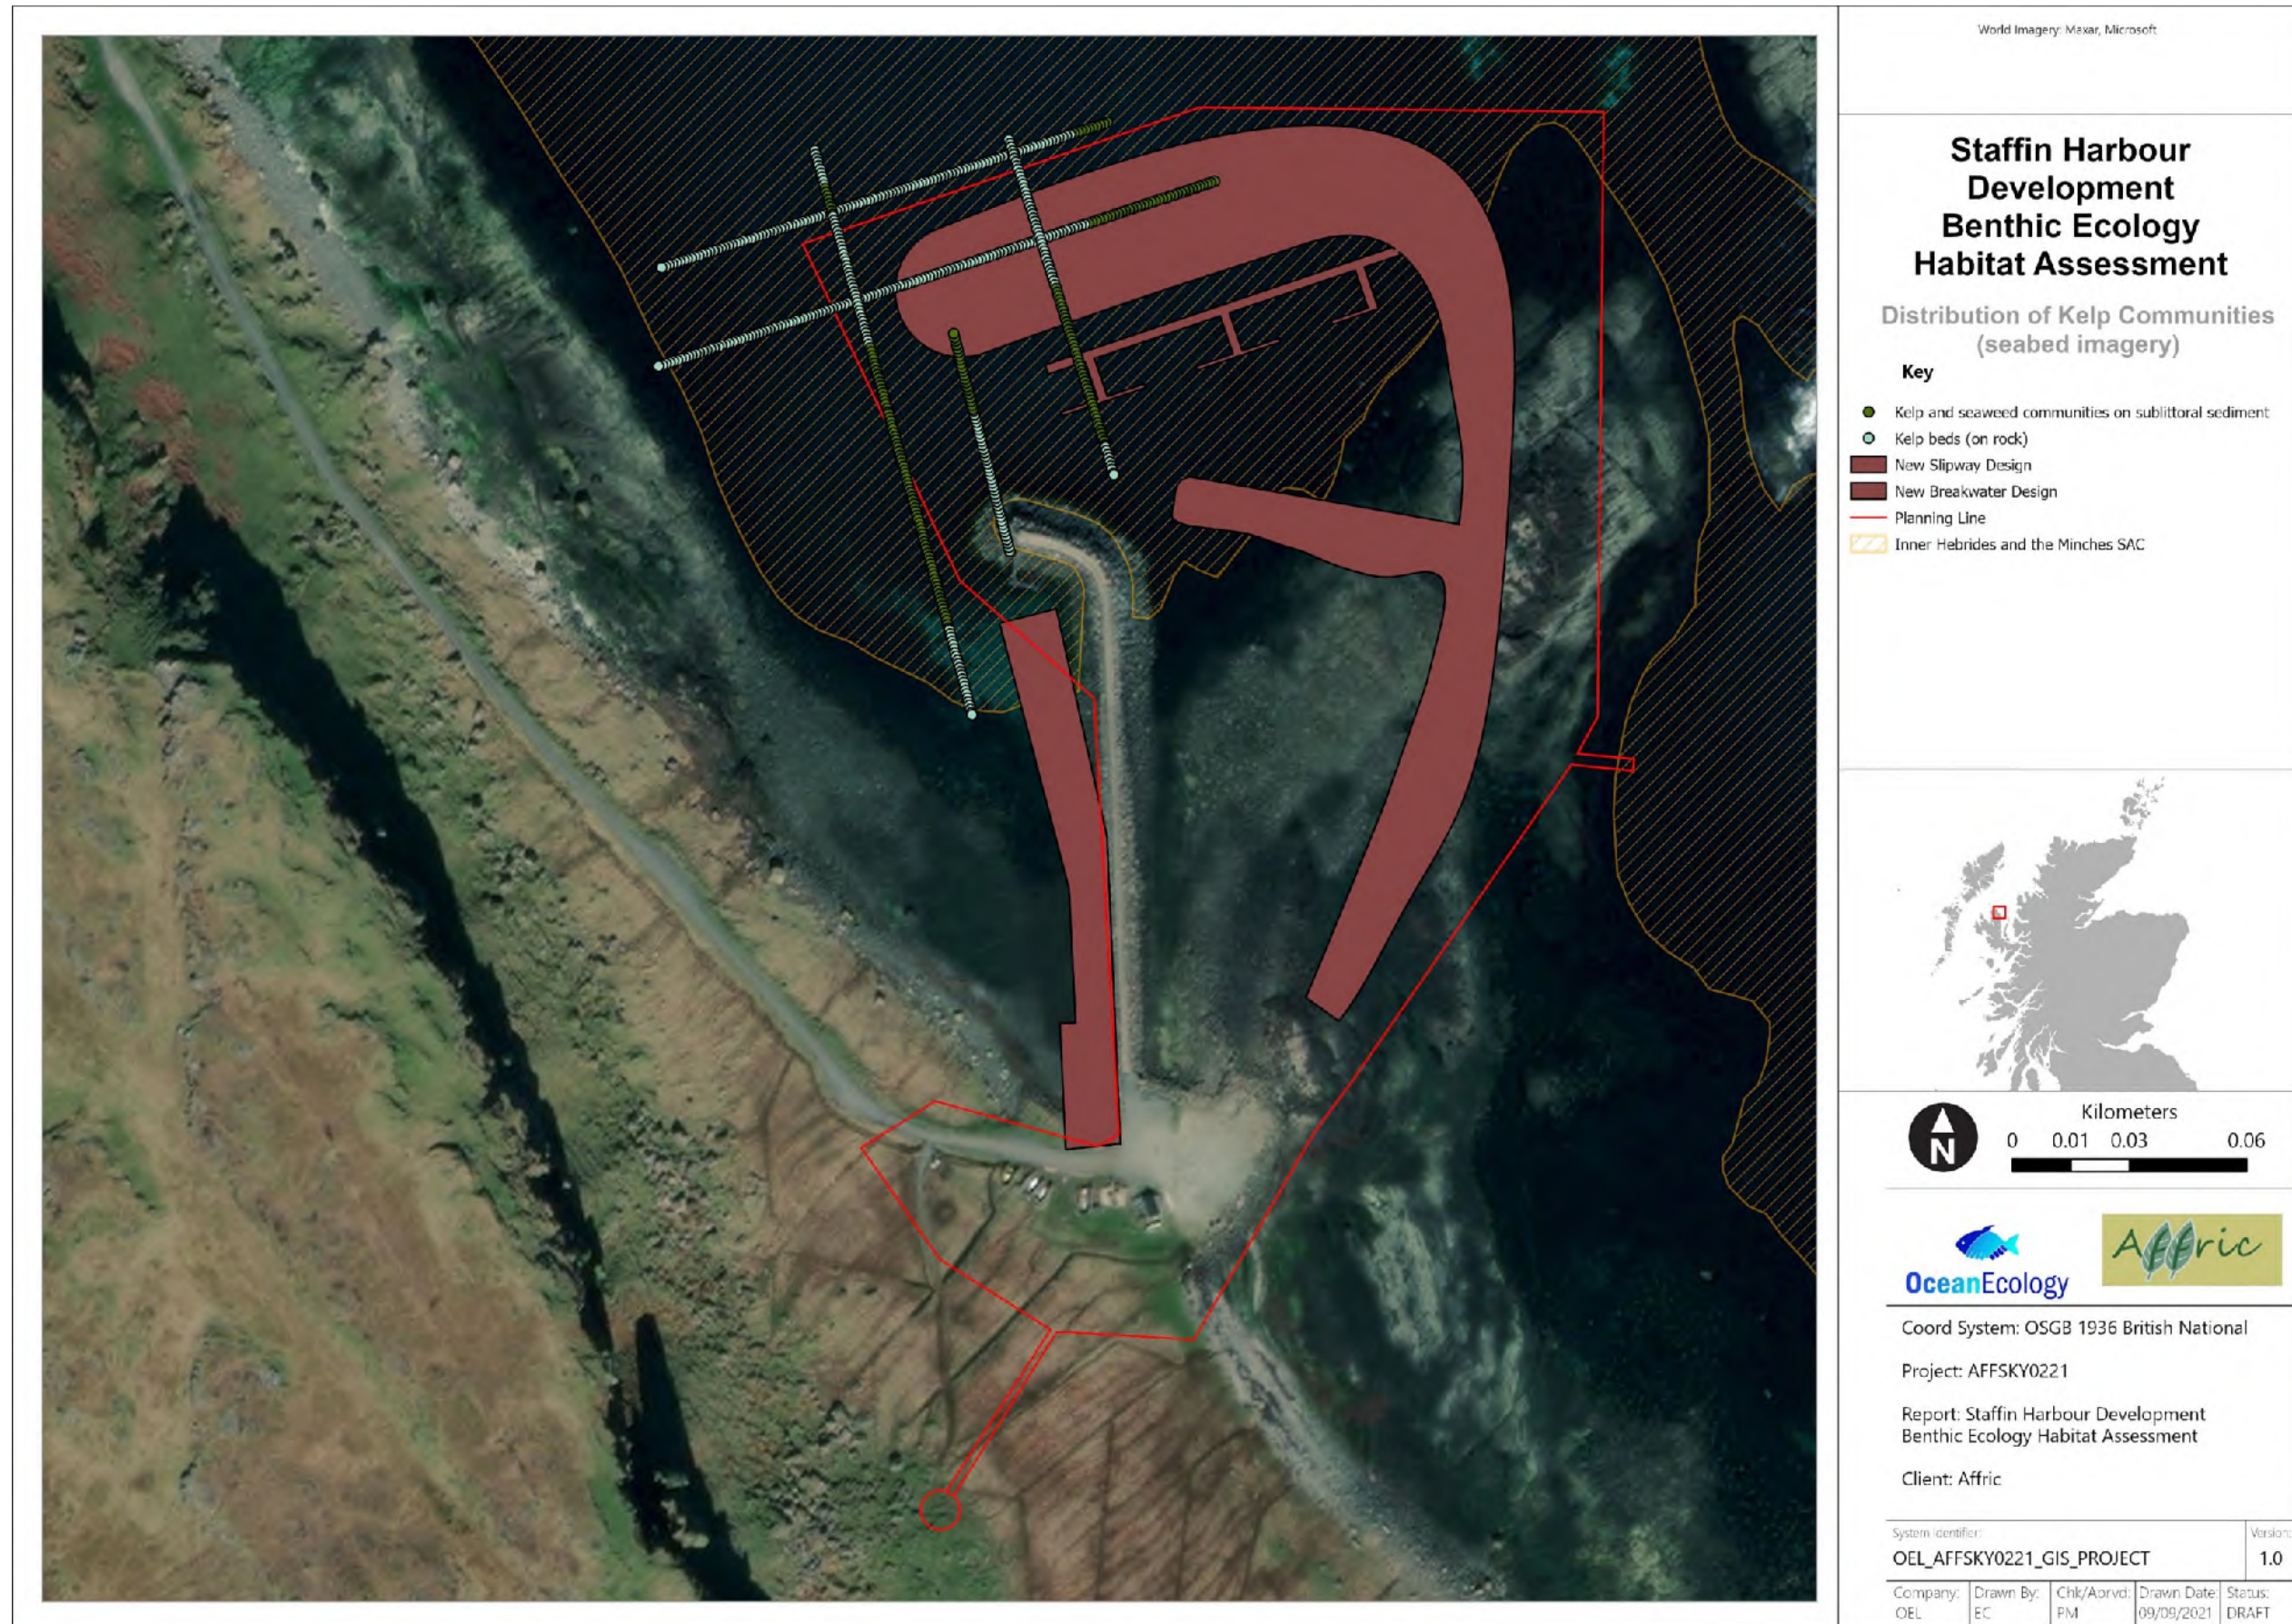
**Figure 7** Distribution of kelp and seaweed communities and kelp beds observed in videos along each of the transects sampled across the Staffin Harbour survey area.

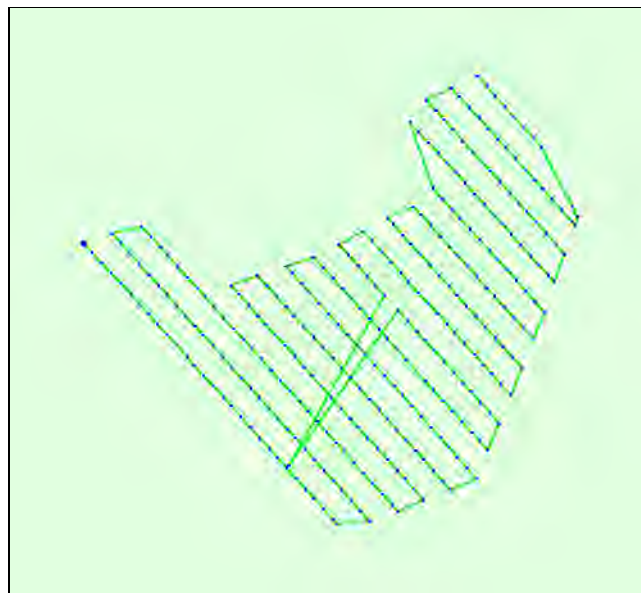
Figure 2: Top view of the initial image position. The green line follows the position of the images in time starting from the large blue dot.

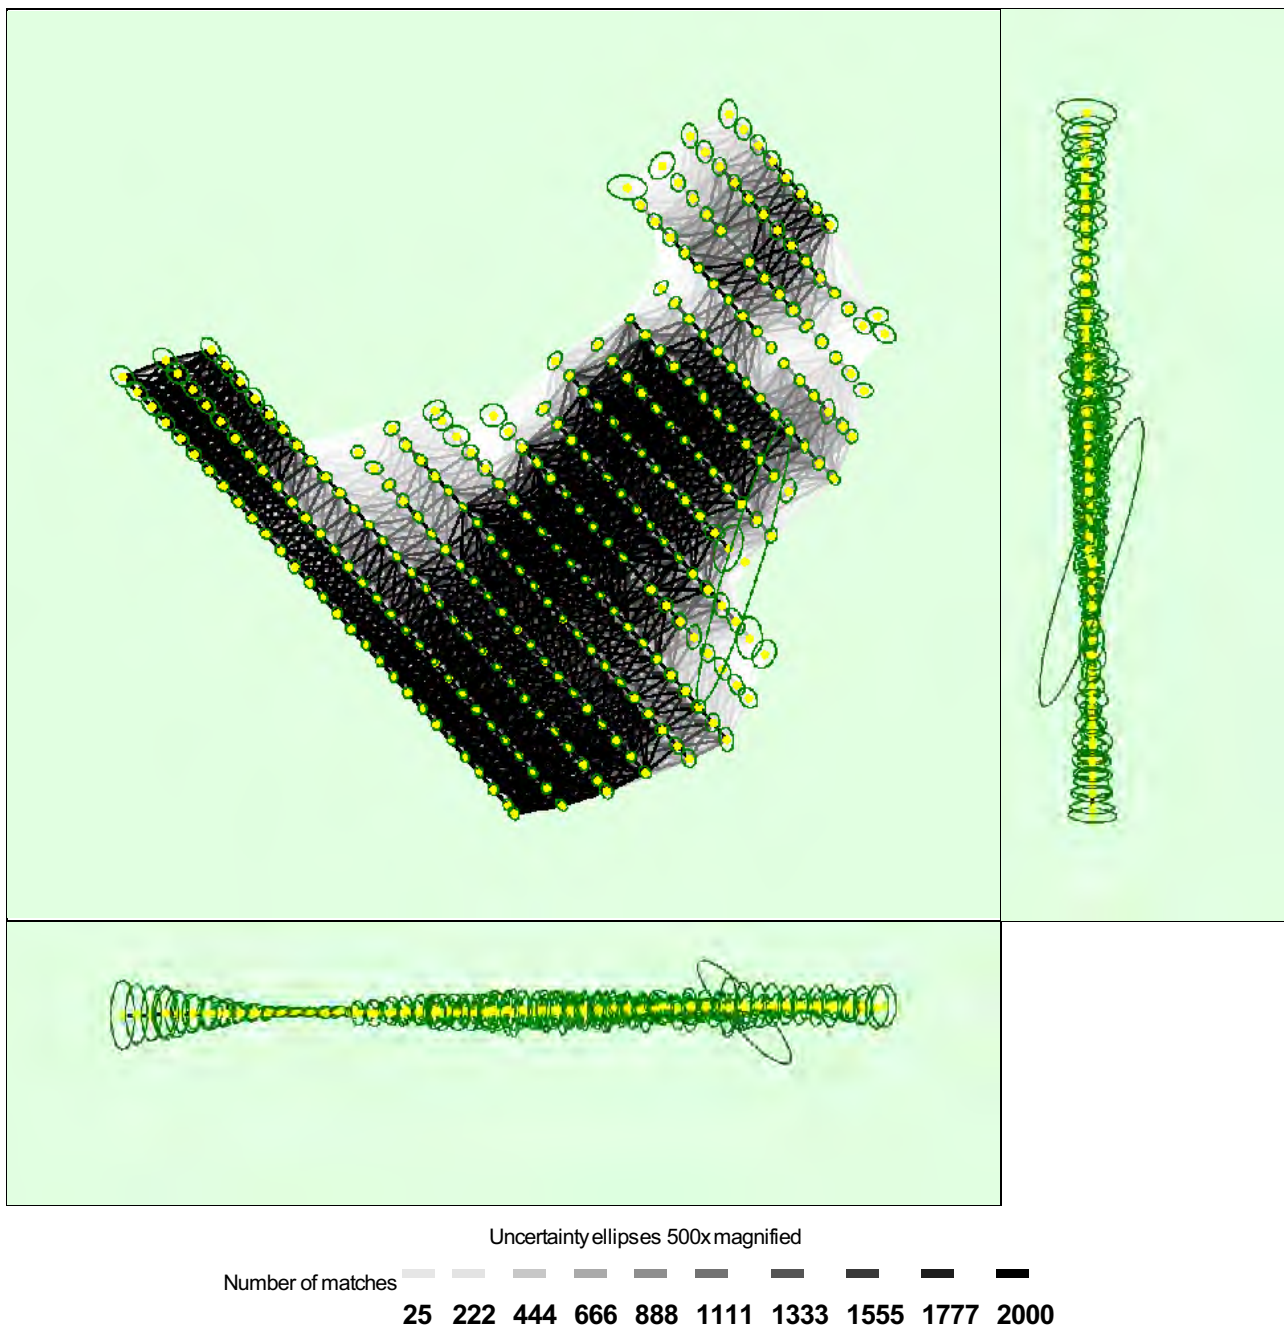
Figure 5: Computed image positions with links between matched images. The darkness of the links indicates the number of matched 2D keypoints between the images. Bright links indicate weak links and require manual tie points or more images. Dark green ellipses indicate the relative camera position uncertainty of the bundle block adjustment result.

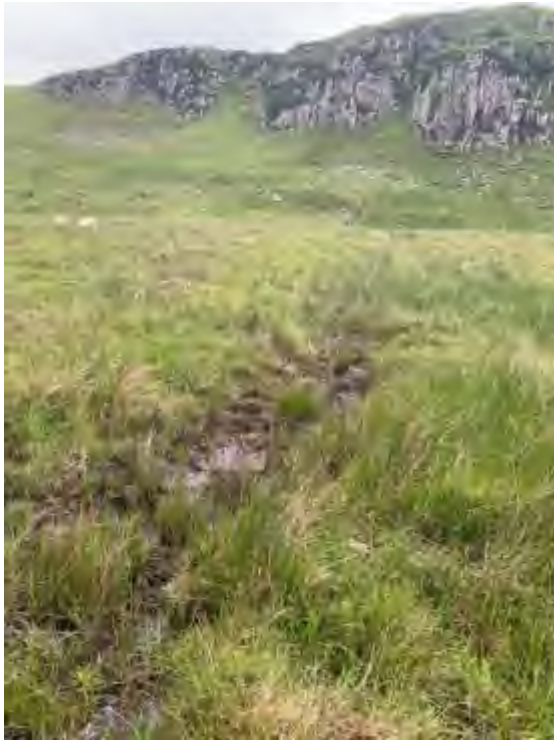
Plate 5: Drainage channels are shallow but frequent across flatter areas of the Harbour Survey Area.

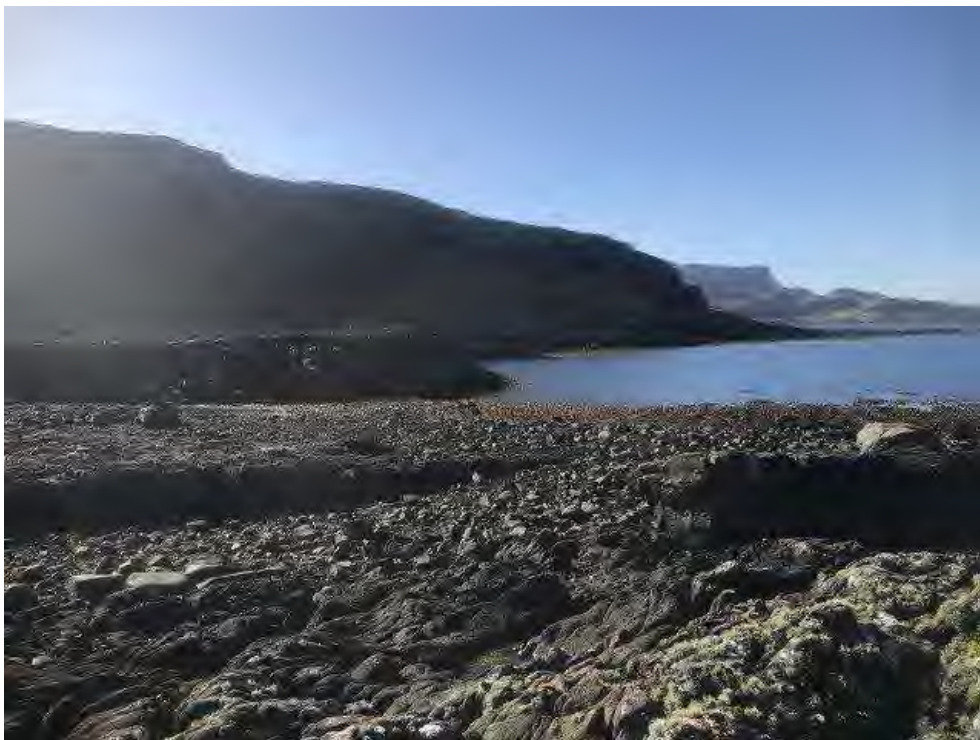
Plate 8: Typical section of rocky shoreline at low tide showing exposed bedrock near to existing breakwater.

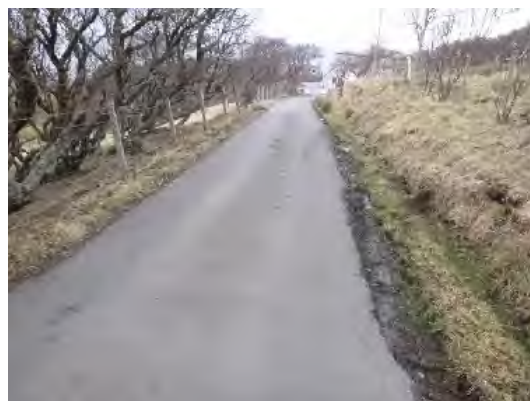
### 4.2 Ch 250 and bend

Surface in poor condition, some holes and patches.

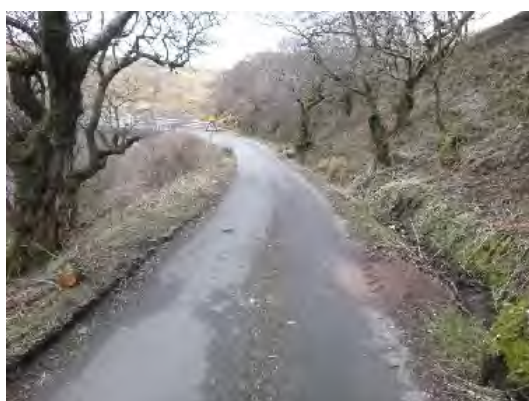
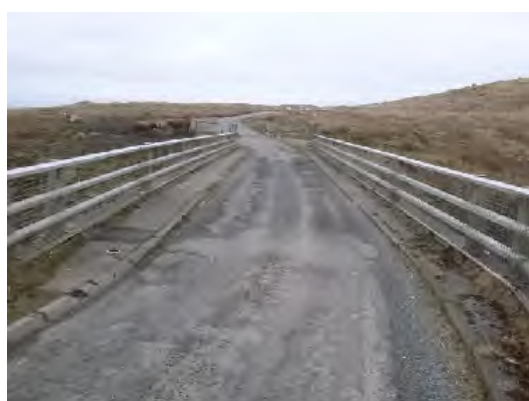
### 4.3 Ch 300-392

Good condition, narrow soft verge and ditch to right, trees close on right. Widening at bend leading on to bridge ch 376-392. Bridge 3.3m clear between kerbs, with 1.0m footpath left and 0.6m edge strip right. One hole in bridge surfacing, through to waterproofing. *Fill hole approx. 0.8x0.5m*

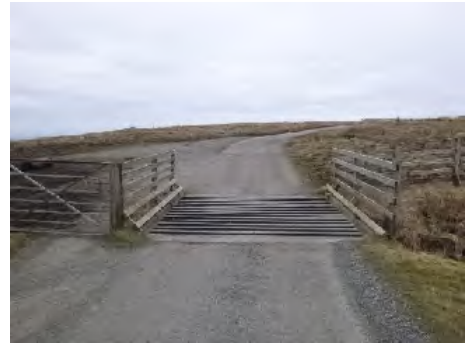
#### 4.4 Ch 410

Cattle grid 3.3m clear between kerbs, good condition. Hard area (unsurfaced) just beyond to ch 430 – allows for passing.

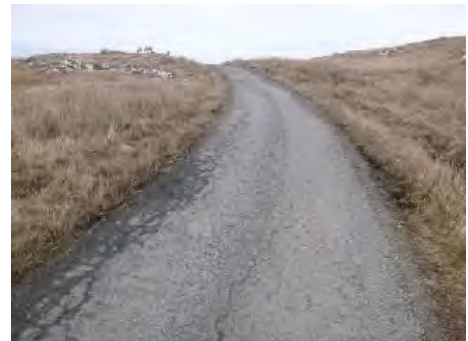
#### 4.5 Ch 490-505

Cracking to left edge, although bedrock outcrops close by. Possible settlement. *Edge strengthening 15m long.*

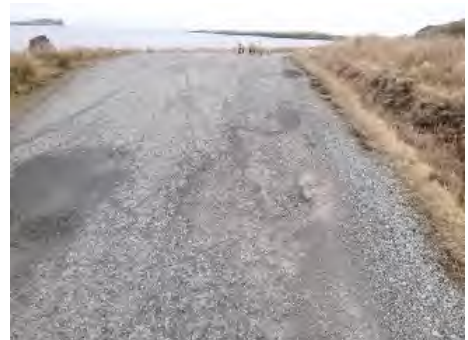
#### 4.6 Passing place ch 533

Cracking and patches.  
*Resurface/reconstruct R edge 10m*

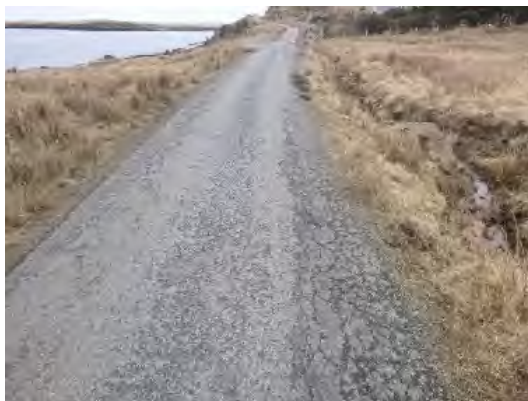
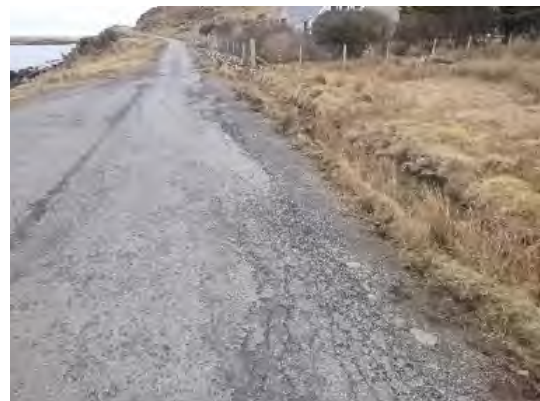
#### 4.7 Ch 615 – 633 passing place

Cracking along right edge, some settlement. Ditch close on right.  
*Edge strengthening 25m long*

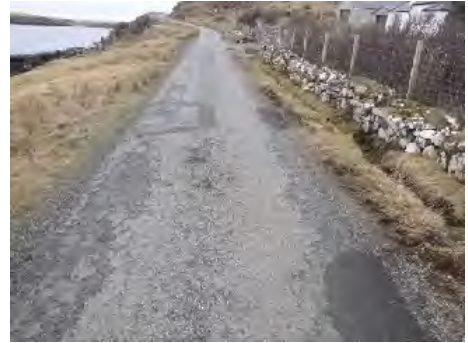
#### 4.8 Ch 659

Settlement over culvert left side (300 diameter plastic pipe, with 0.45m cover).  
*Repair/replace pipe section, place and compact fill and repair road edge 2m*

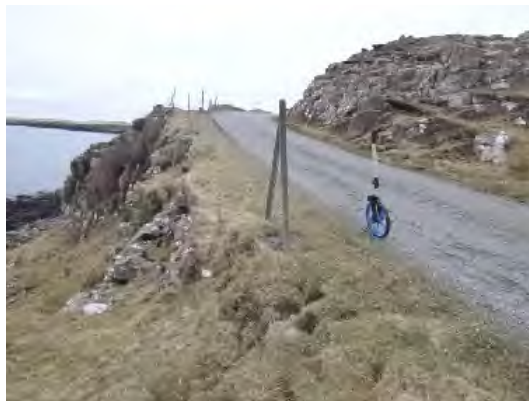
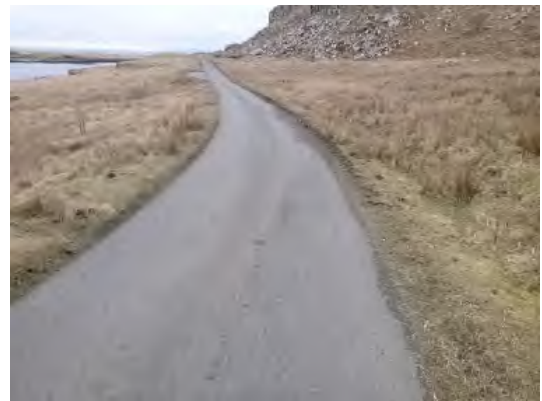
#### 4.9 Ch 740 – 800

Patchy, wider round bend. Rock outcrops close to right side; steep drop on left side. From ch 800 generally good condition but narrow.

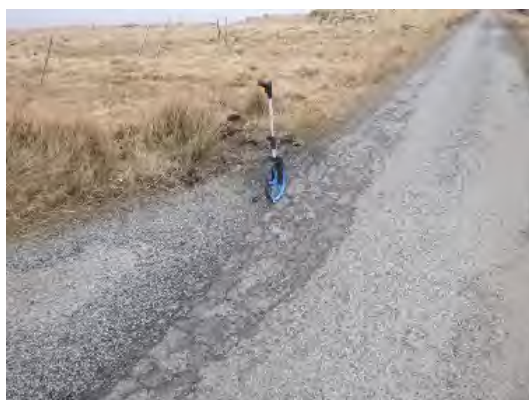
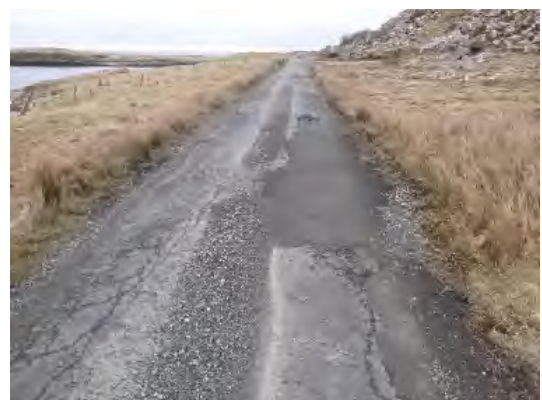
#### 4.10 Ch 845 – 930

Cracking to right edge. Soft verges, some patches and holes towards parking area at ch 935 to 955. *Edge reconstruction 85m long.*

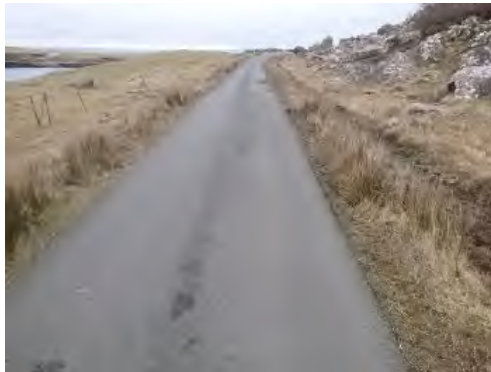
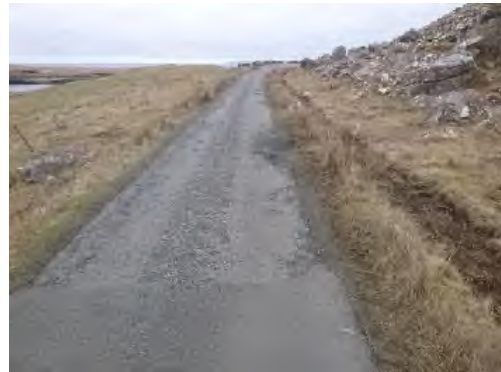
#### 4.11 Ch 960 – 1030

Generally in good condition, narrow but straight.

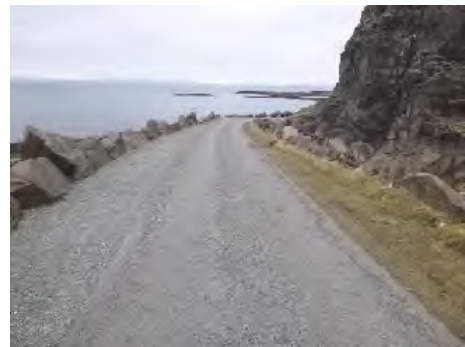
#### 4.12 Ch 1040 – 1190

Widens to left, gravel strip on left edge, line of stones both sides. Adequate width.

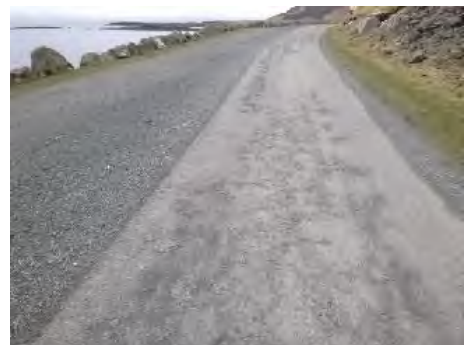
#### 4.13 Ch 1190 – 1300

Fair condition, patchy. Gravel parking area left, stone edge left.

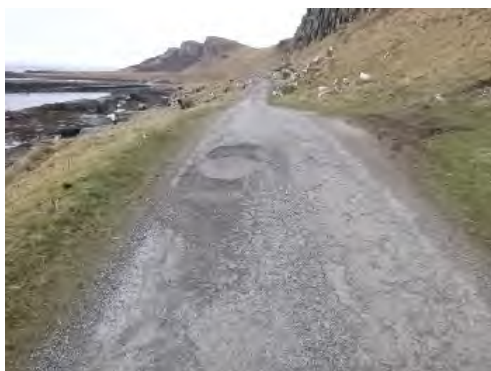
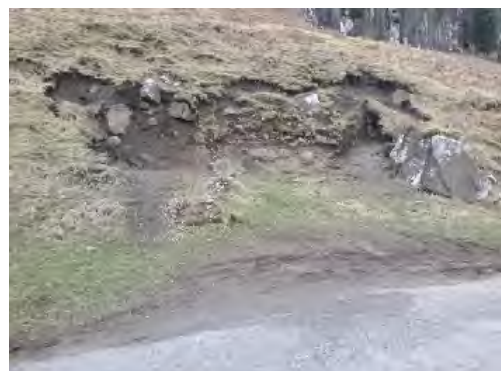
#### 4.14 Ch 1340 – 1350

Holes and patch including in passing place. Slip to bank above but not close enough to encroach onto road. *Reconstruct 6 sq.m*

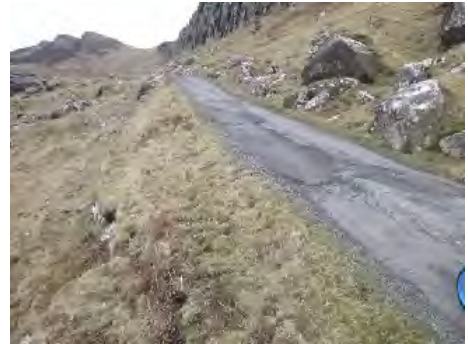
#### 4.15 Ch 1380 – 1390

Patch to left edge, steep bank to left. *Repair 10m x 1.5m*

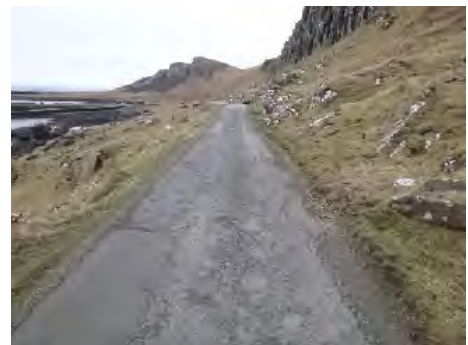
#### 4.16 Ch 1390 – 1450

Right edge collapsed and cracked, verge? *Edge reconstruction 60m long*

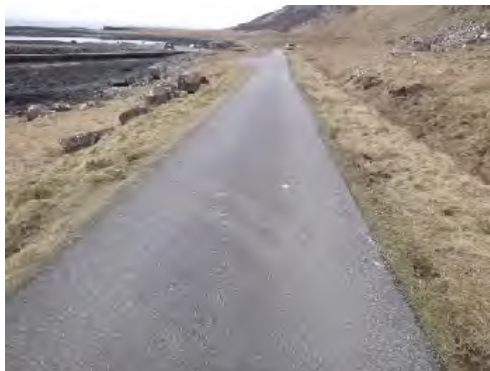
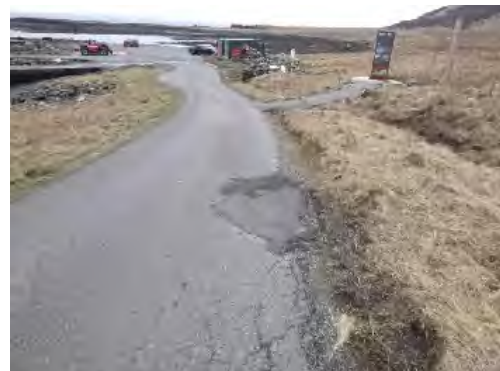
#### 4.17 Ch 1450 – 1740

Generally in good condition, recent surface with no defects. Patch and edge cracking around ch 1690.

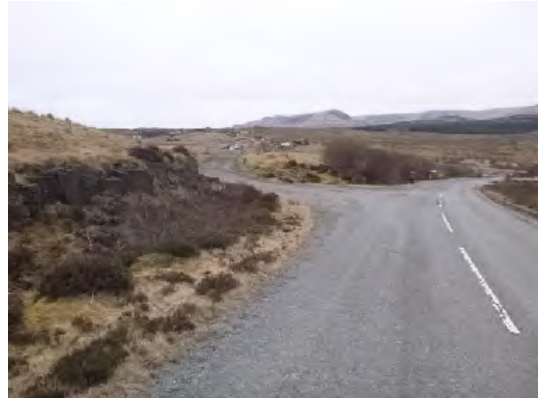
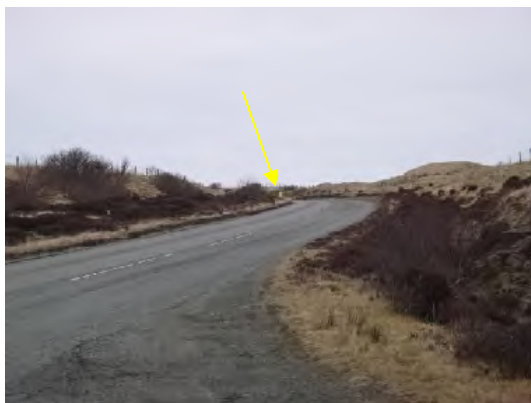
Visibility has been measured from a point 4.5 metres back from the edge of the main road, along the road edge to both north and south. This is shown in the photographs below (yellow jacket at the point of measured visibility).

*150m visibility to north*

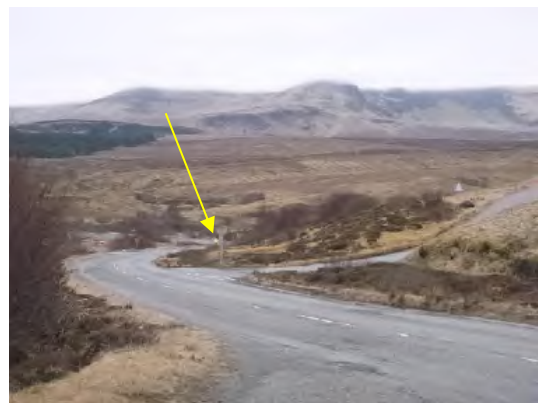
*210m visibility to south*

The proposed quarry is located about 8.7 km to the south of the start of the slipway access road, at approximate grid reference NG 518 606. The A855 is a two lane road at this point, with a speed limit of 60mph.

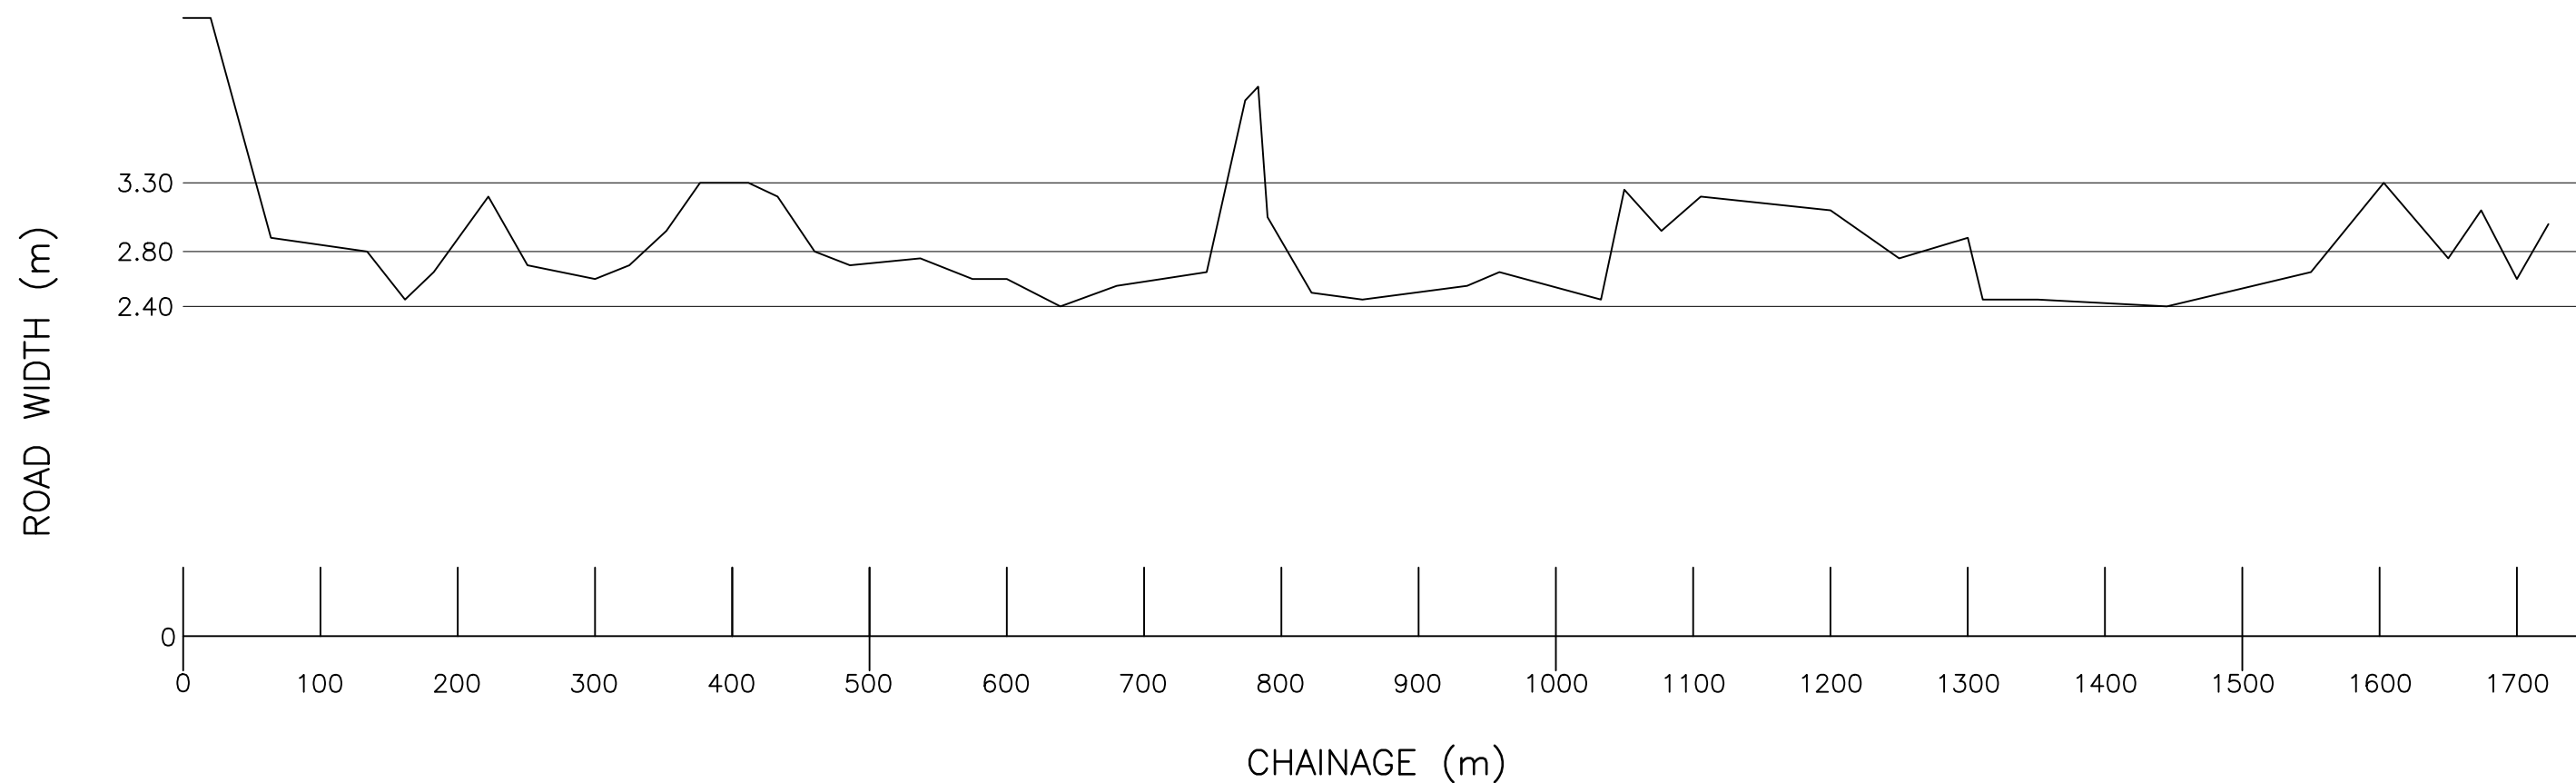
## ROAD WIDTH COMPARISON

VERTICAL SCALE 1:50  
HORIZONTAL SCALE 1:5000

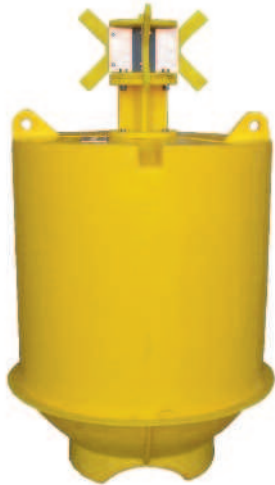
Lifting eyelets

316 Stainless steel Serial Number Plate

JFC Can/Cone navigation Buoy is designed as per IALA recommendations. All Buoys are manufactured from UV-stabilised virgin polyethylene material

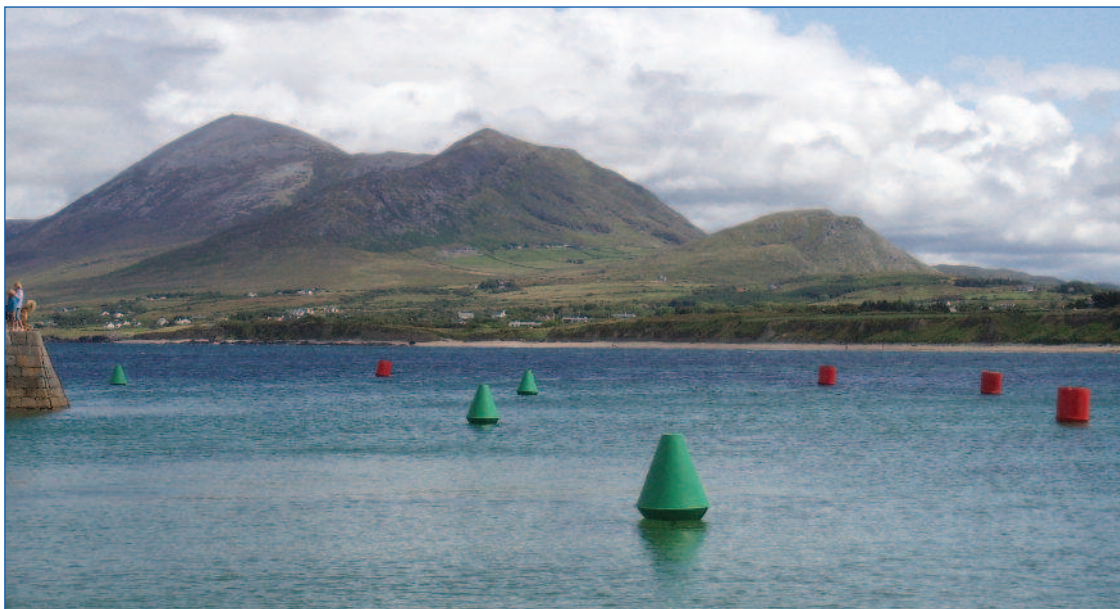
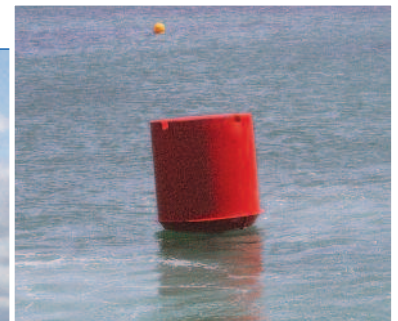
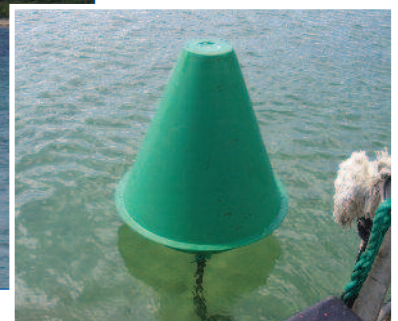
- These buoys are small and light weight
- Easy to Handle
- Excellent buoyancy & stability
- Fitted with high lifting eyes for ease of maintenance
- All steel used is 316 grade stainless steel
- Made from UV stabilised virgin polyethylene
- No painting or sand blasting required
- Designed to fit Navigation Lanterns
- Each section can be coloured to suit IALA specifications, cardinal, danger marks etc.

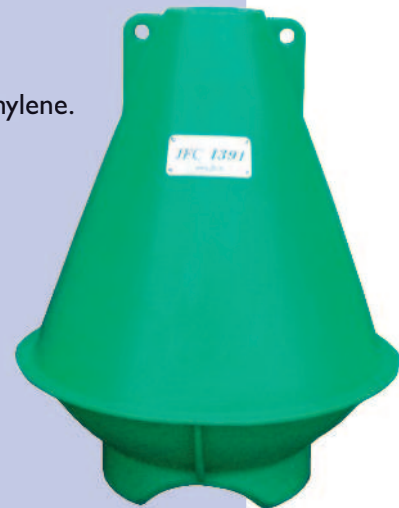
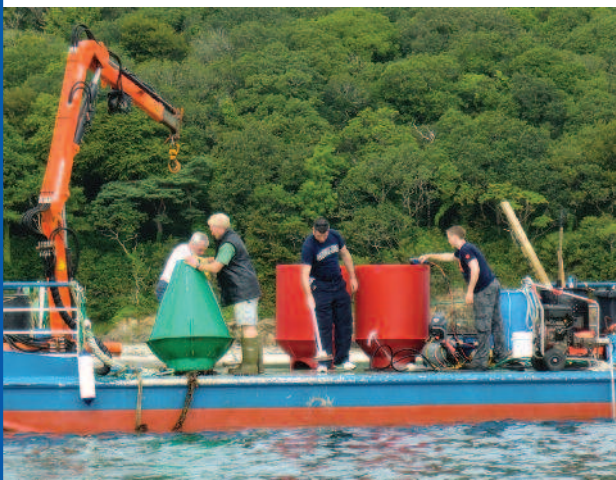
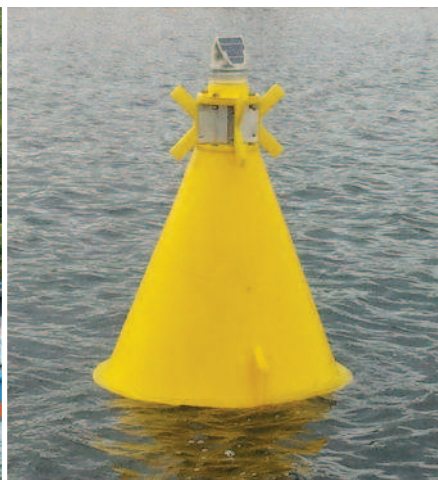
Rotationally Moulded UV-Stabilised Virgin Polyethylene.  
Steel all 316 Stainless Steel

Radar Reflector

Top Marks

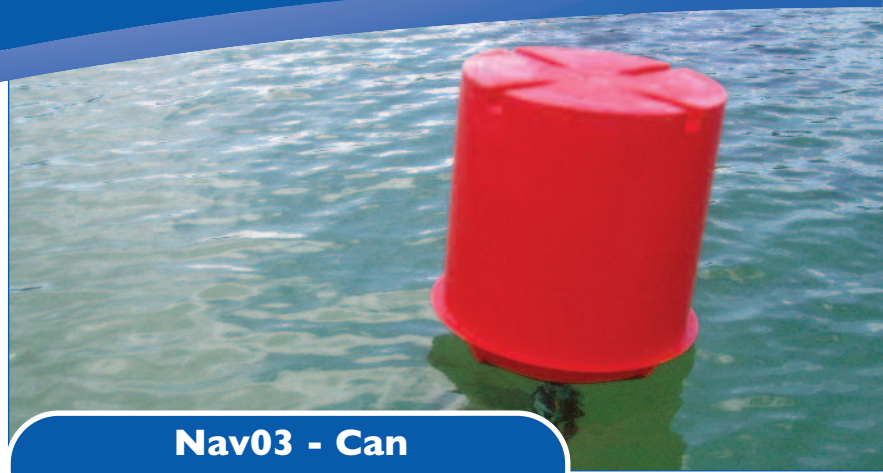
# JFC Marine Can

### Nav03 - Can

Green, Red, Yellow as per IALA recommendations  
870mm (Without Top Mark)

Rotationally Moulded UV-Stabilised Virgin Polyethylene.  
Steel all 316 Stainless Steel

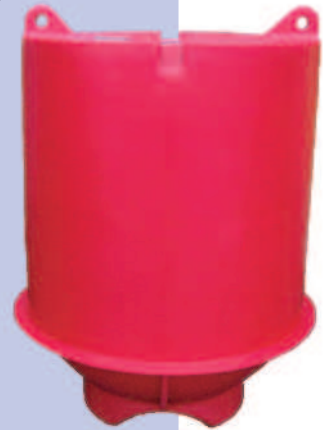
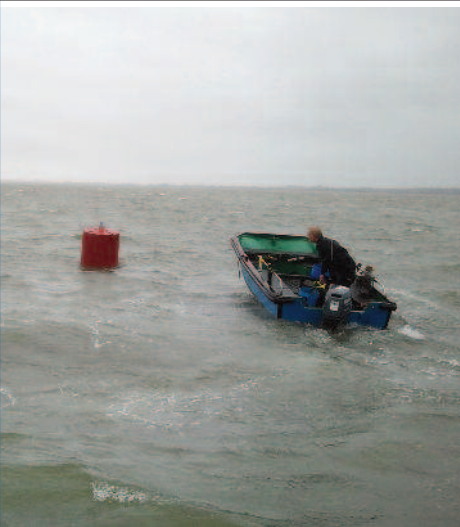
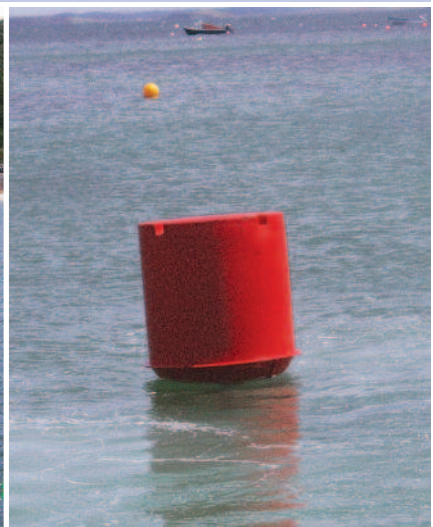
Mould in graphics  
Monitoring Systems (RF-Com Sync, GPS Sync)  
Radar Reflector,  
Top Marks

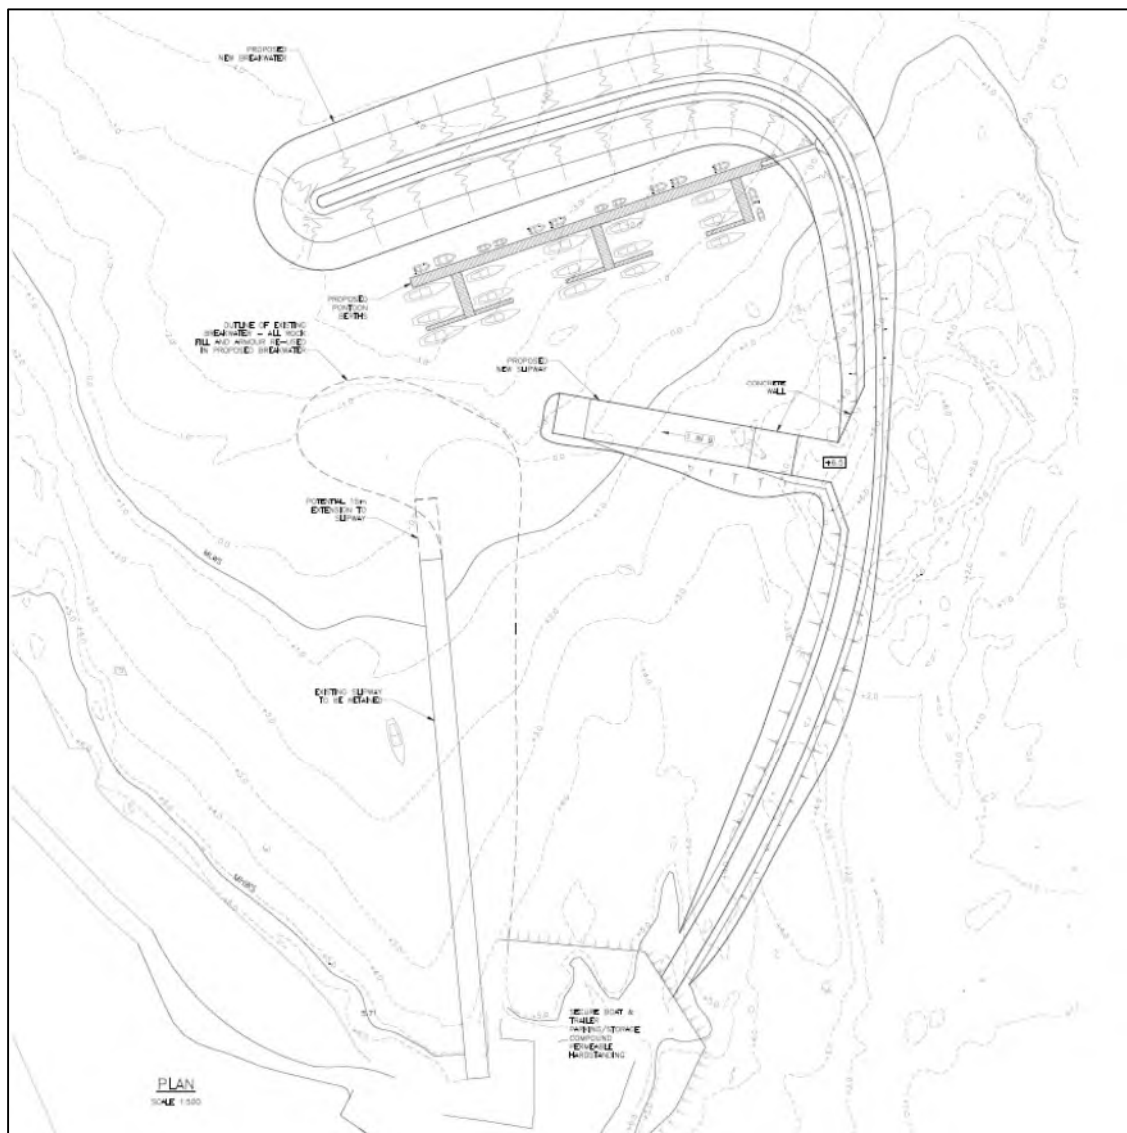
**Figure 1** Radical East Option for Staffin Harbour with marina berths and slipway

A revised layout for the Radical East Option (REO) harbour layout and marina has been proposed as shown on the Wallace Stone drawing in Figure 1. RPS were requested to undertake hydraulic modelling for this layout to predict the wave climate around the proposed marina berths and slipway to be located behind this revised breakwater arrangement and to examine the impact on the sediment transport regime.

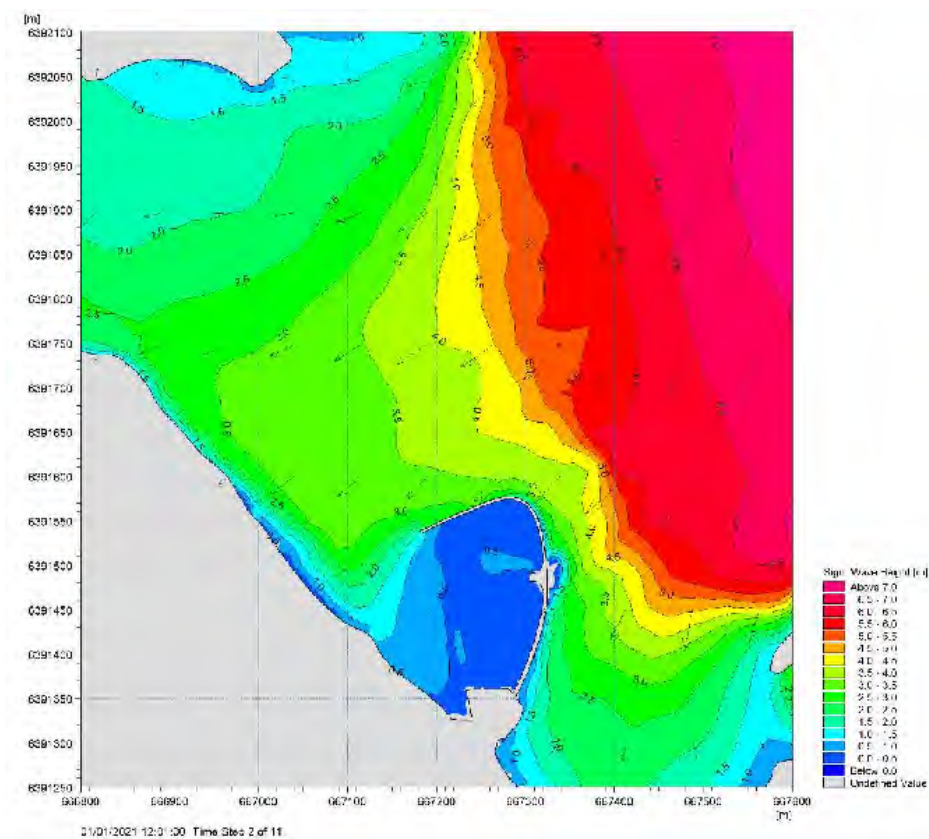
**Figure 3** 1 in 50 year storm from 000°N in North Minch – Hm0 and MWD at Staffin

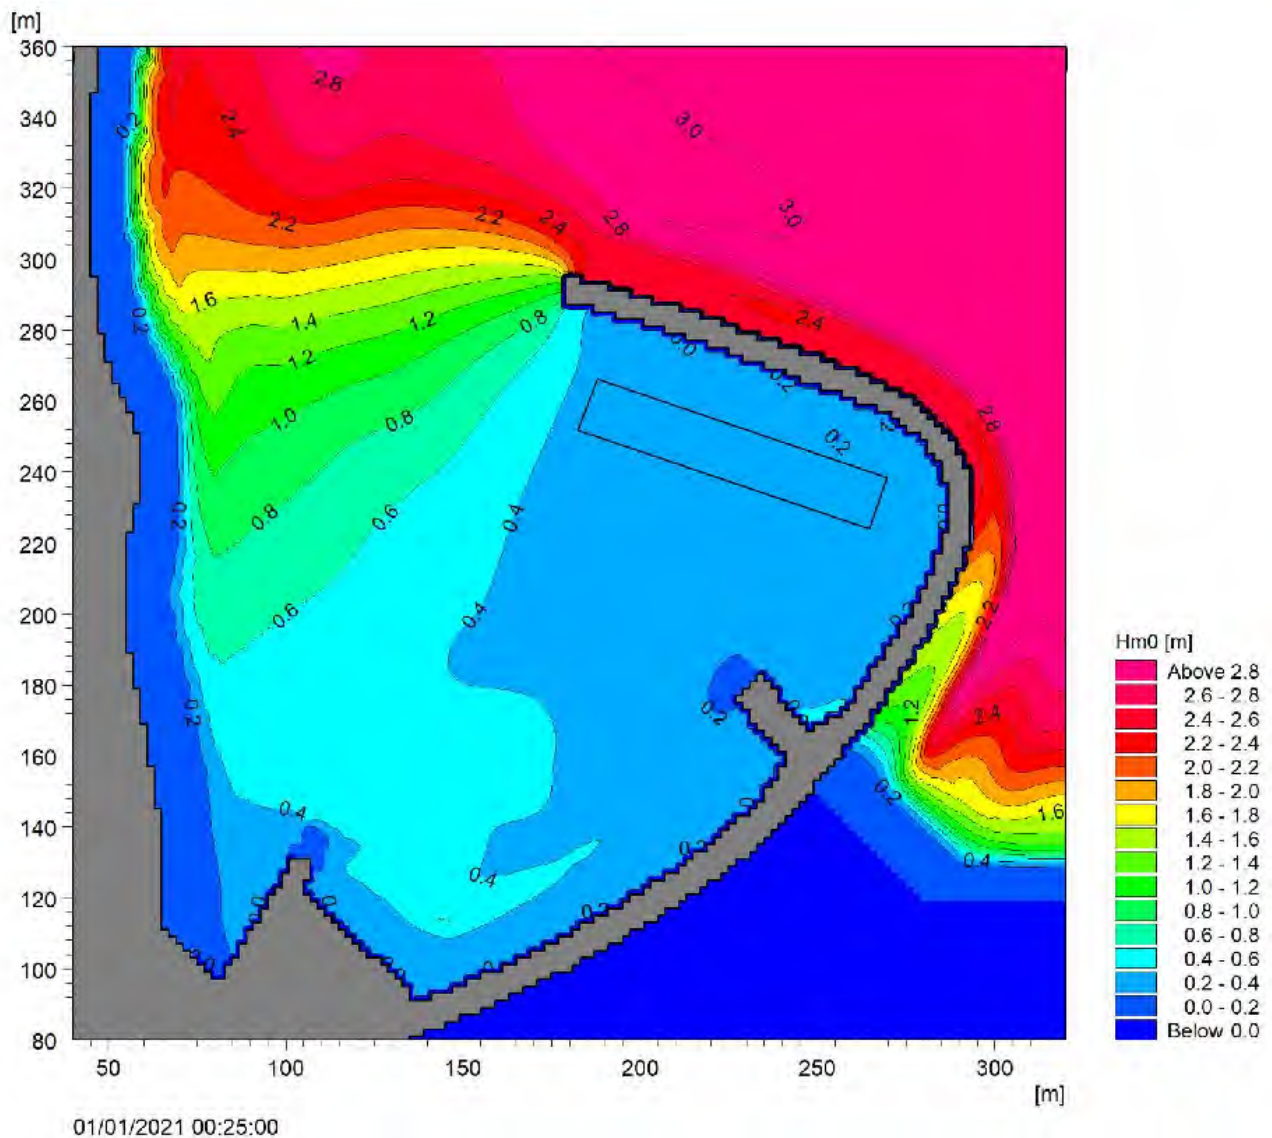
Figure 7 Significant wave heights – 1 in 50 year return period storm from the north with swell

The significant wave heights behind the breakwater during this 1 in 50 year return period storm at HW are shown in Figure 7. The extent of the marina area is shown by the black rectangular line. It will be seen that the significant wave heights over the entire marina area are predicted to be below 0.4m with the wave heights ranging from 0.34m to 0.21m. The significant wave height at the existing slipway will be about 0.47m, but only 0.28m at the new slipway. The wave period will be relatively long at about 15.73 seconds
