**Staffin Community Harbour Development  
Environmental Impact Assessment Report  
Volume 3: Appendices  
September 2021**

# **Appendix A1: The Environmental Impact Assessment Team**

## **Staffin Community Harbour Development**

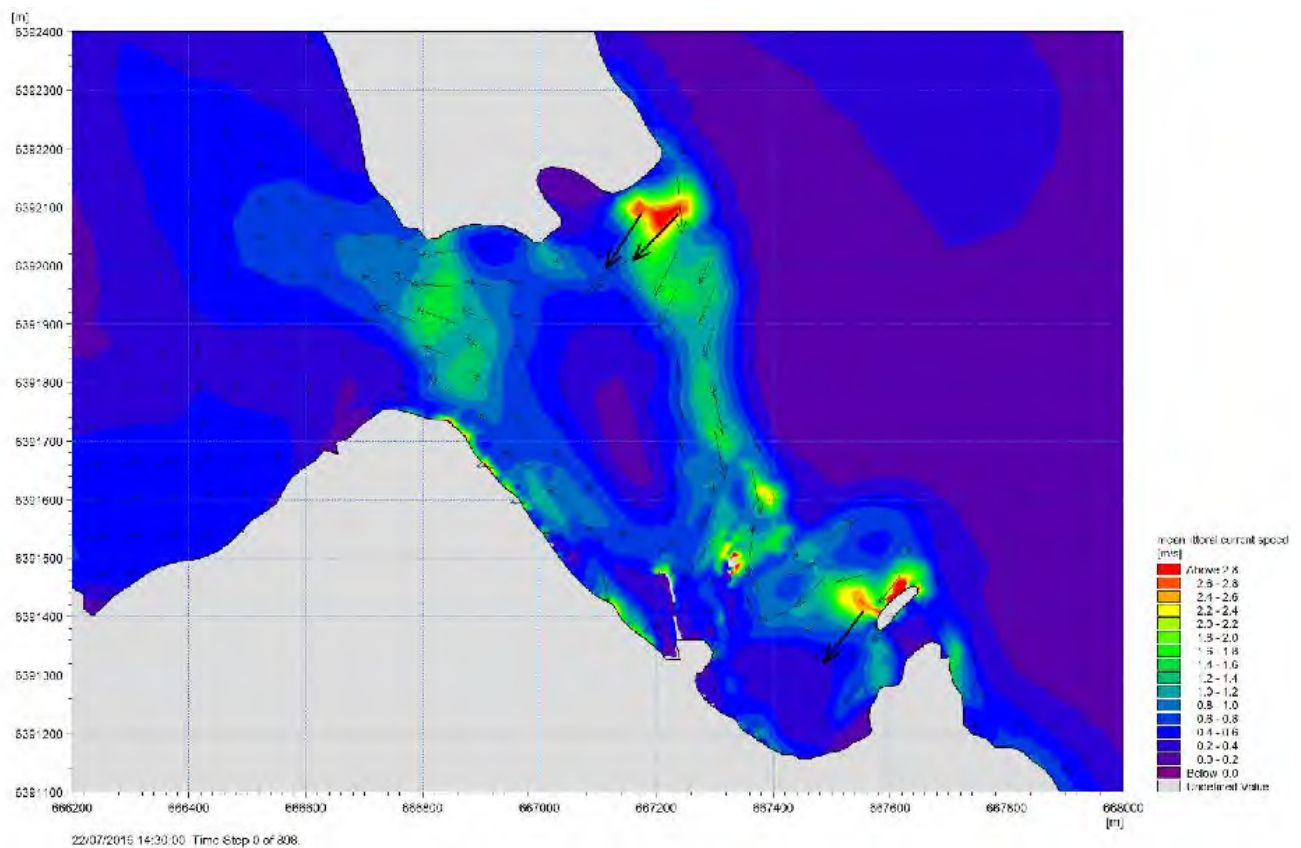
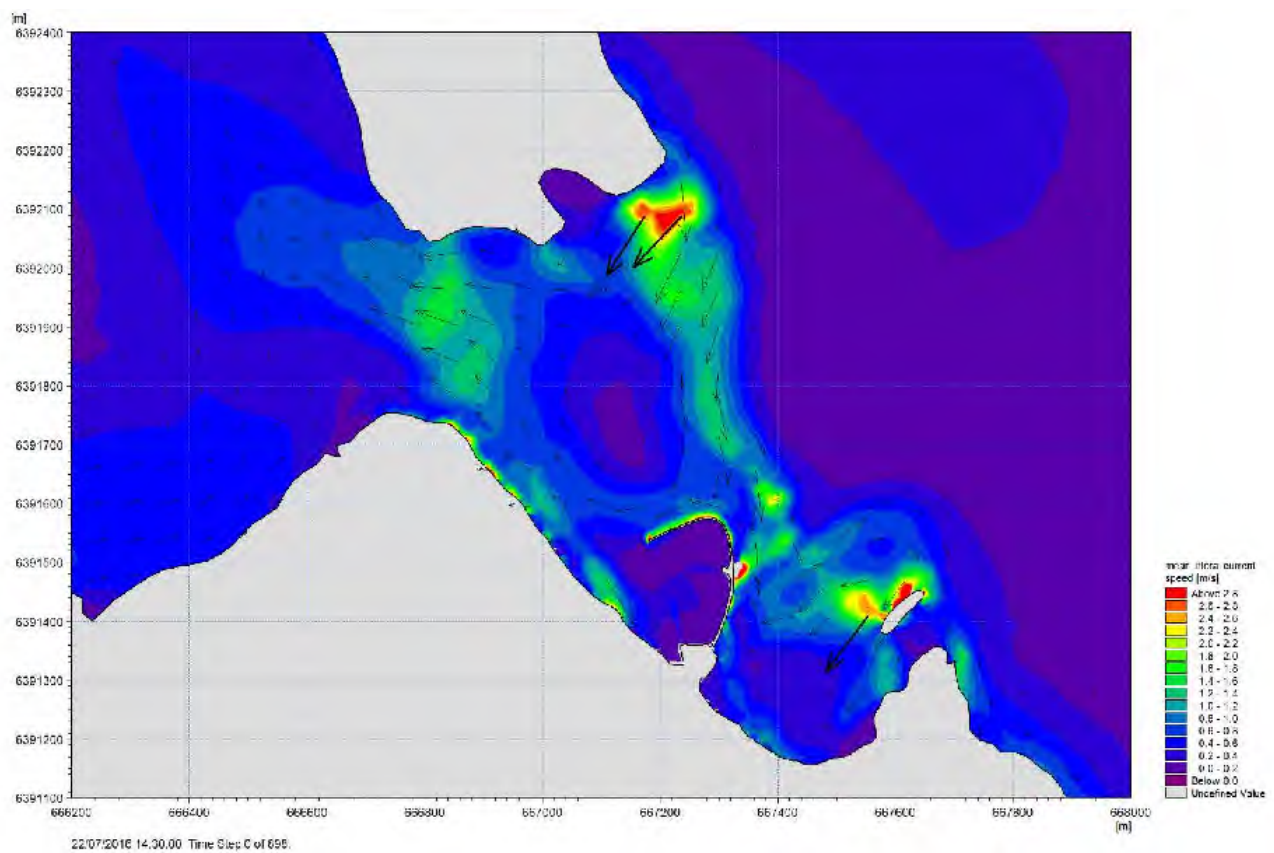
**Figure 13 Mean littoral current spring tide flows for 1 in 1 year storm from 15° – Existing breakwater/slipway (top) and REO harbour (bottom)**

It will be noted from Figure 12 and 13 that the pattern of the littoral currents during the neap and spring tides is similar and also that there is only a small difference in the overall current patterns between the existing and the REO harbour layouts. The main difference is that the southern end of the clockwise gyre is a little further north with the REO harbour due to the location of the breakwater.

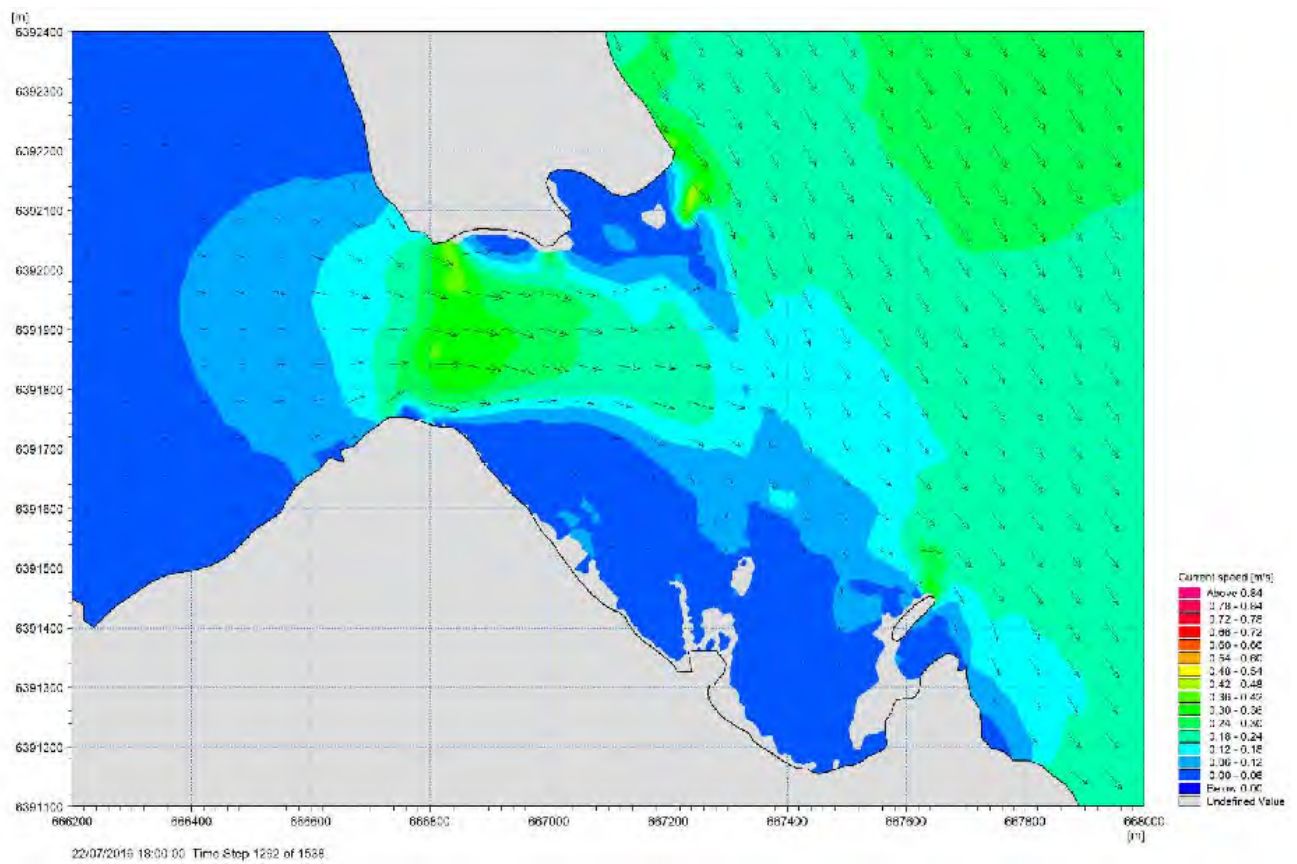
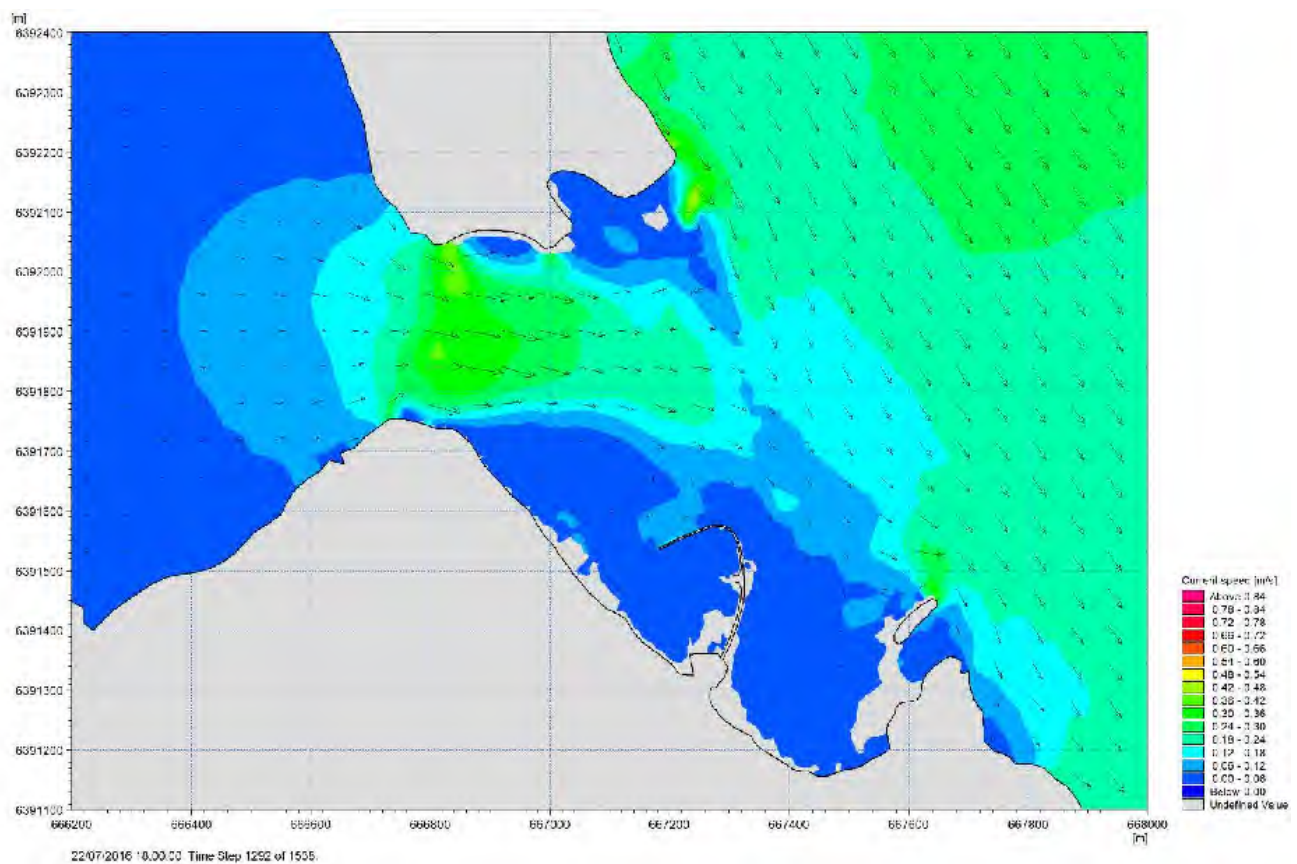
**Figure 20 Mean spring tide flood flows with average wave climate - Existing breakwater/slipway (top) and REO harbour (bottom)**
