Serious incident – CT Operator fell from height

- **BA/BU:** Well Intervention Services
- **Site/Country/Date:** UKCS, 21st July 2012
- **Description:** Coil tubing Operator fell approx. 30ft and impacted drill floor. IP sustained a dislocated shoulder, cracked ribs, fractures of the pelvis, cartilage damage to the knee.
- **Actual Consequence:** Serious Injury
- **Risk Potential:** High/D1
- **Synergi case no.:** 279725

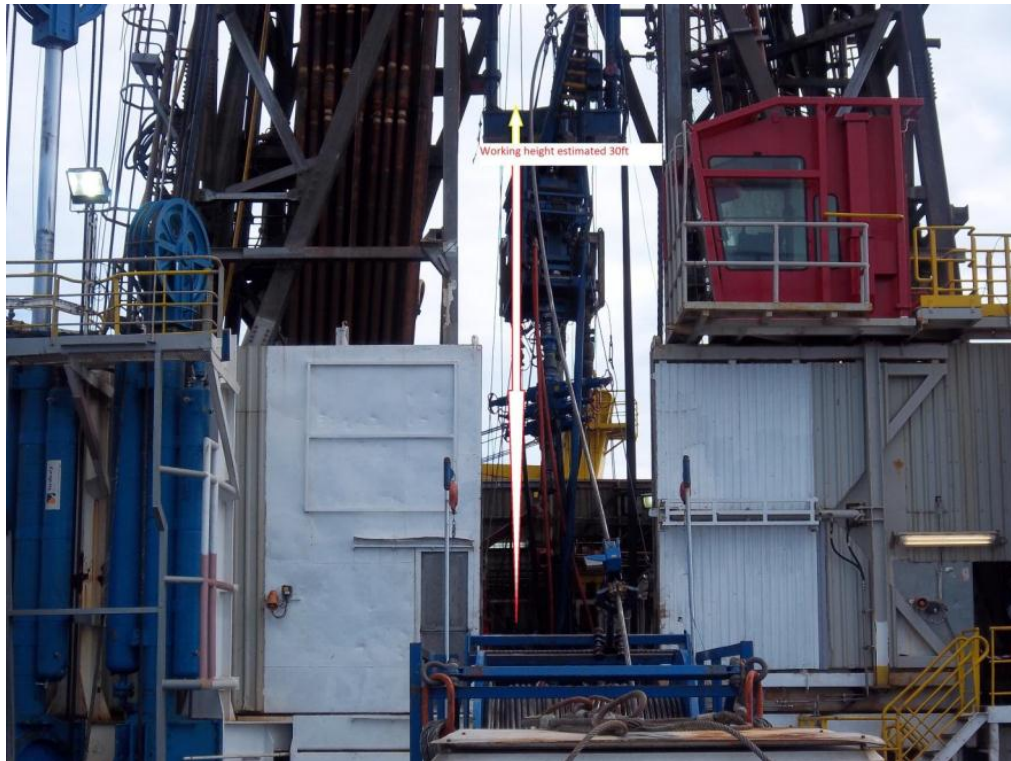
- Uncontrolled descent of CT injector and BOP's within the CT lift frame.
- Suspected CTLF main winch Failure.
- IP was man riding on lower part of CTLF to guide BOP stabbing operations.
- IP man riding winch wire became entangled in descending CT BOP, which pulled the IP off the lift frame.
- Man riding winch overloaded and wire unspooled due to winch cable snagging on BOP's and injector head.
- Worksite was made safe, Senior Onshore Management team mobilised to site to commence investigation.

- Investigation a collaboration between Aker Qserv, rig owner/duty holder and client and remains on-going. S.I slide will be fully updated to reflect conclusions and lessons learned on completion of investigation.
- Winch was returned onshore for testing and strip down to determine failure. Tests conducted and reviewed with winch provider and third party independent.
- Initial findings point to failure of primary failsafe brake
- Secondary method of load control failed due to hydraulic system pressure inadequate to provide continual replenishment of hydraulic oil to the motor and counterbalance valves thus starving the motor/counter balance of oil. This allows the load to drop at a high rate causing cavitation within the motor while the system is in neutral.
