Safety Alert

ALERT 09 – 15

NEAR MISS – DROPPED CASING WHEN ELEVATORS NOT LATCHED CORRECTLY

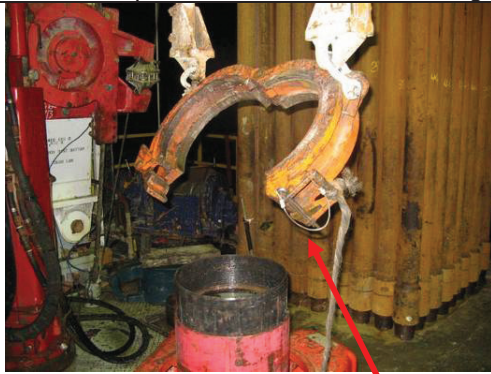
Elevators after the incident. Note the safety pin still in the elevators.

- It is not possible for the latch to open on the SJE if latched and pinned correctly. It is possible to not fully latch the SJE allowing sufficient room to insert the retainer pin behind the latch.

- Single Joint Elevators were changed out for a type considered to have a better latching device (i.e. pin inserted through latch).
- Procedures to be reviewed and amended so that
 - o A second person is assigned to double check the elevator is latched correctly and the pin is inserted correctly.
 - o Driller must have a clear view to the v-door at all times. Where racking pipe in the fingers will prevent this the pipe should be racked differently to allow a clear view or they should be laid out sideways when this is not achievable.
- A rig specific JSA is to be developed which outlines all the potential hazards identified in the investigation report.
- A stopper device design is to be agreed by Management which, when fabricated and fitted, will prevent pipe or casing travelling down the catwalk uncontrollably if there was any future elevator failure or human error.

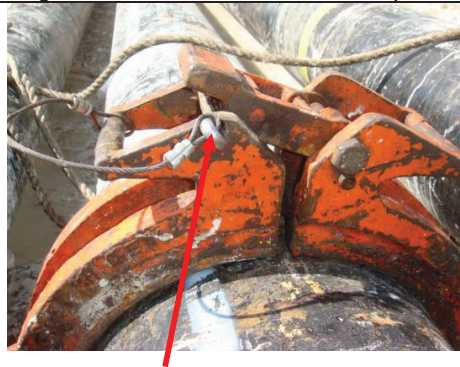
Recreation: Note the latch partially closed with pin incorrectly inserted.

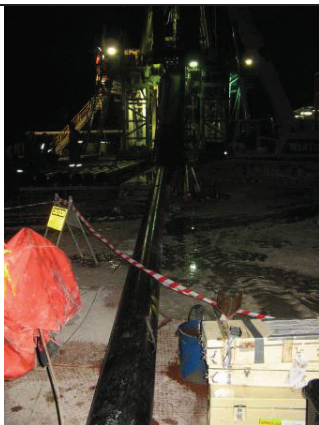
With the winch line and sling removed from the joint of casing the driller was signaled to pick up the casing. When the weight was taken up on the SJE under the collar of the casing the SJE opened and the casing fell out and eventually came to rest against the wire line unit off the catwalk.

Location of the casing after the incident.

- The rig was not equipped with any form of secondary safety device (i.e. stopper bar at the base of the v-door) to prevent casing etc. from sliding down the v-door through the catwalk as it did in this case.

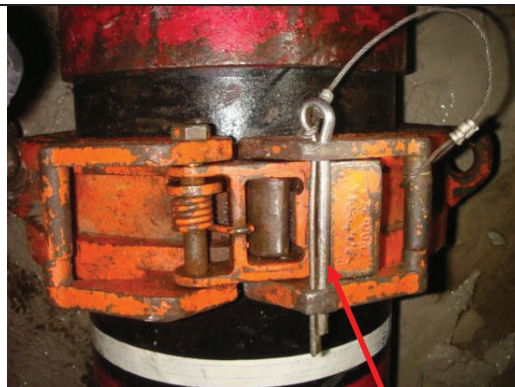
Correct latching and pinning of elevators. Note pin outside elevator latch.
