# Dropped scaffold tube Story Line

0530hrs 20/09/2009 Vessel 1405  
RV Deck

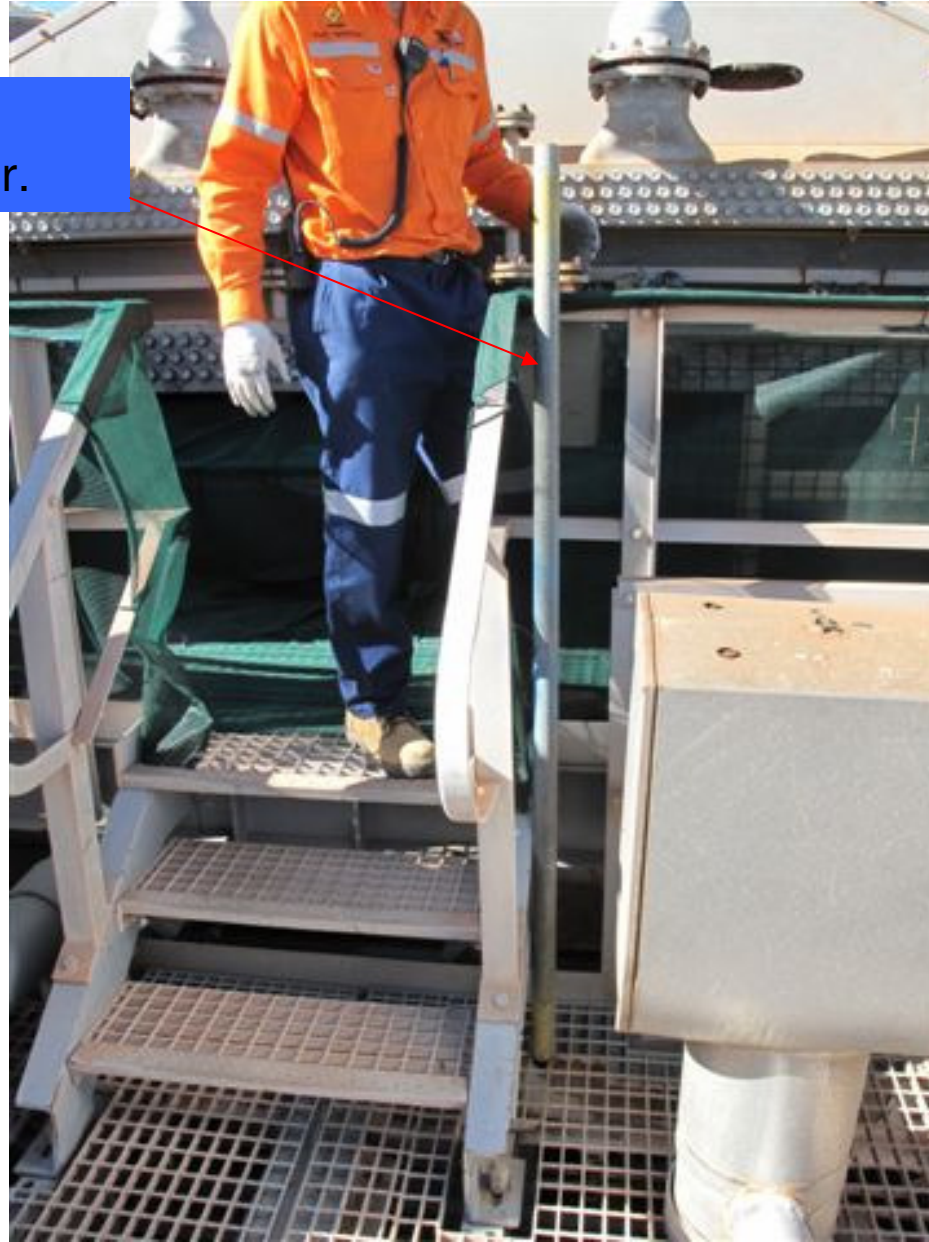
Two 1.8 mt tubes leaning in this corner.

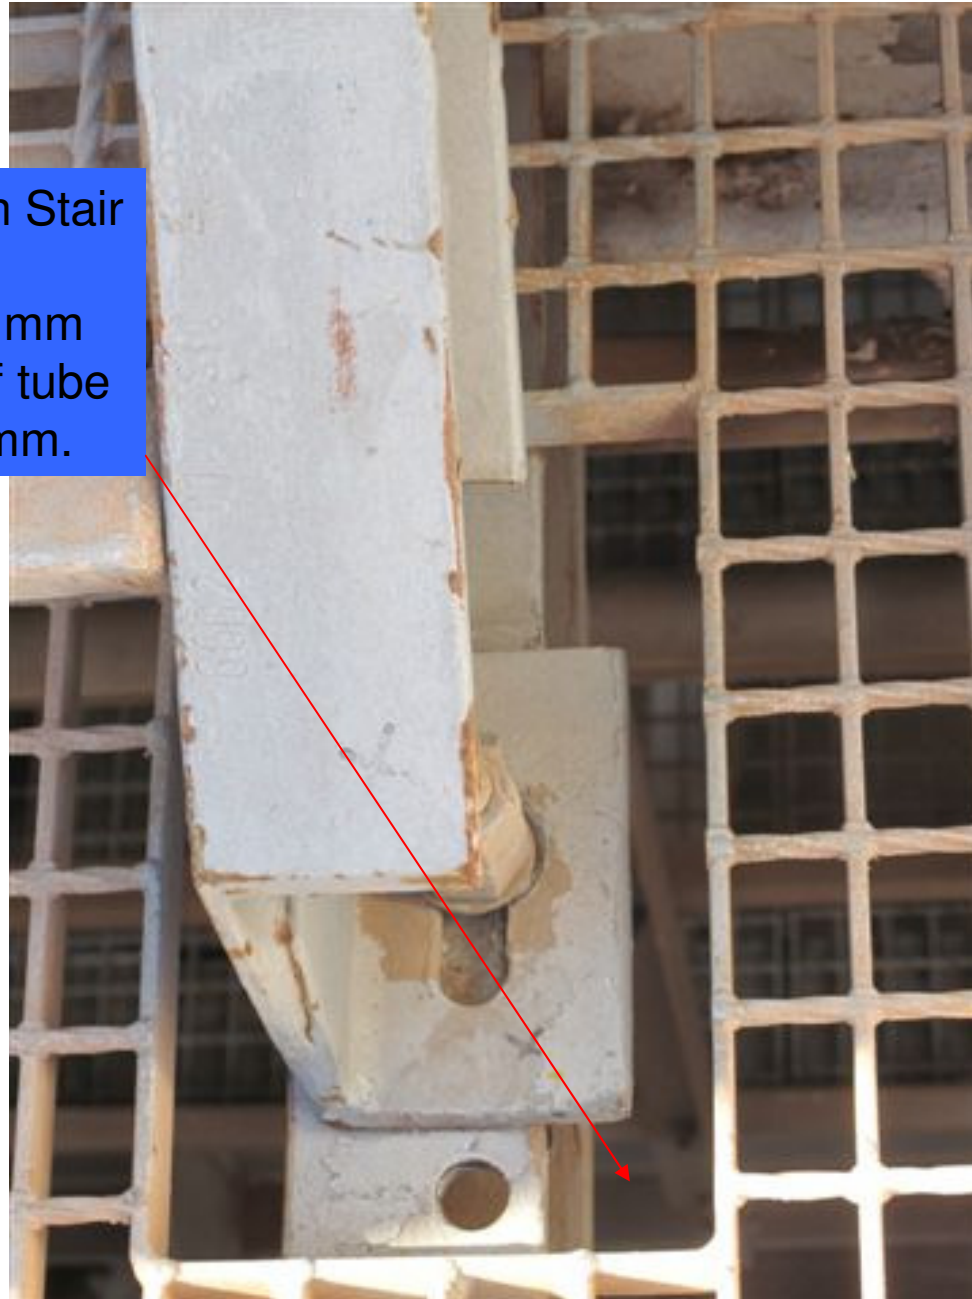
Gap between Stair stringer and gridmesh.53 mm Square.Scaff tube diameter 50mm.

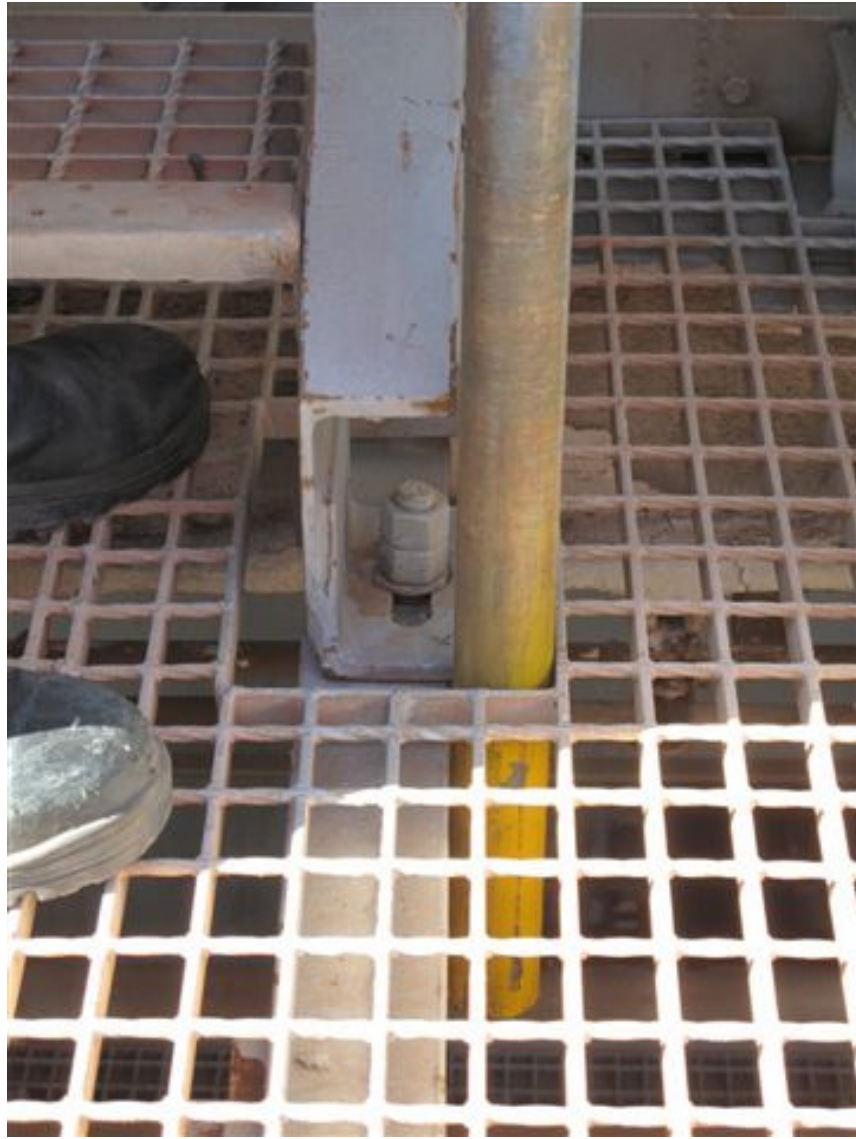
Tube fell through gridmesh above this spool.

Tube definitely deflected of this spool. Fresh Mark of impact.)

Uncertain of specific path through further spools and structures.

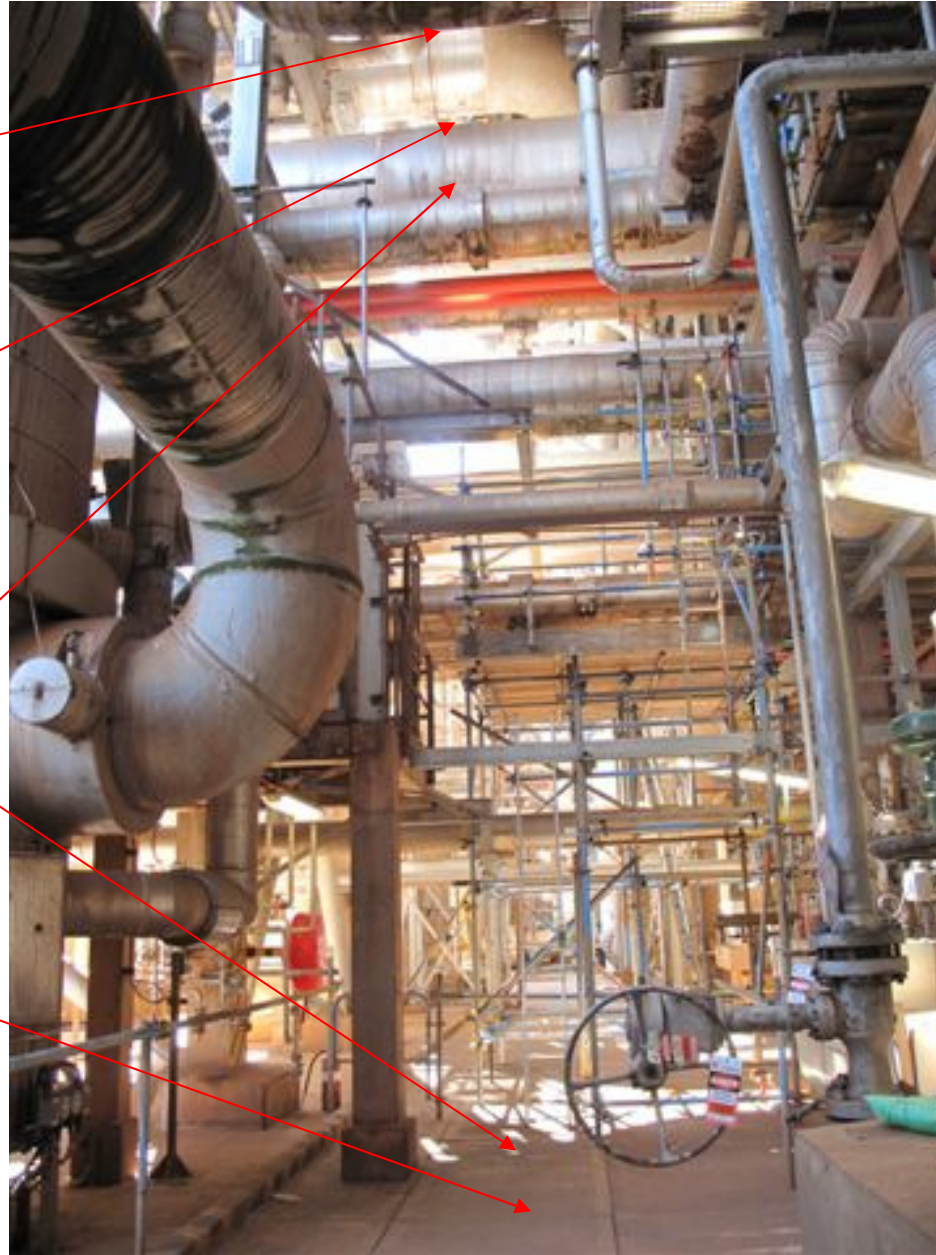
Tube landed here.
