SAFETY ALERT

Lifesaving Equipment

DAMAGE TO BRAKE RELEASE CABLE SHEAVE

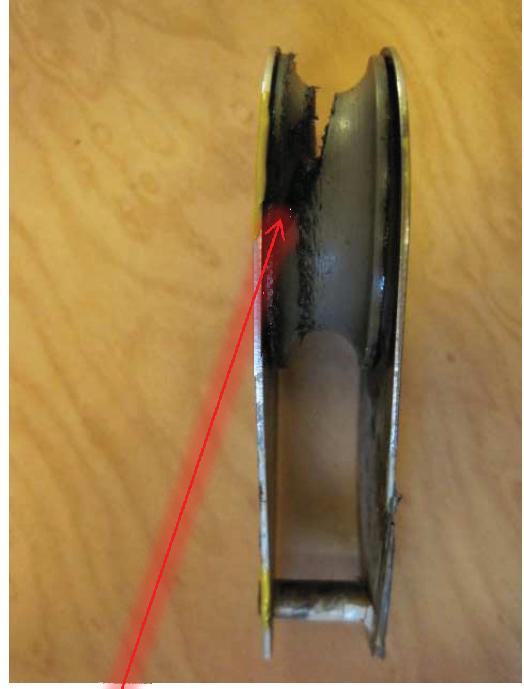
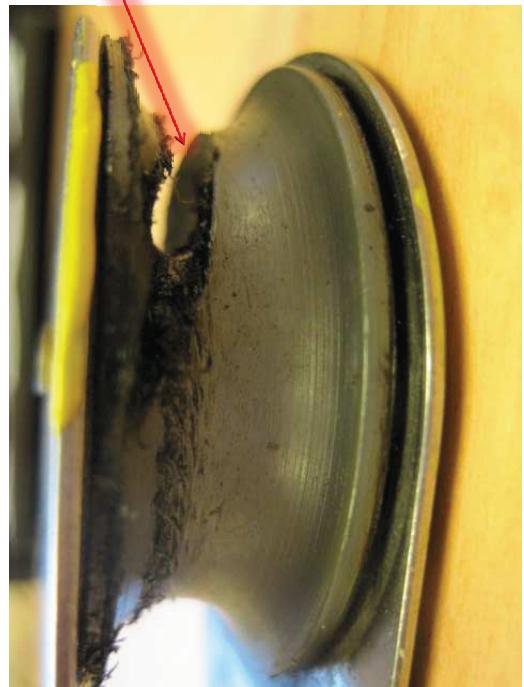
Problem : During planned maintenance routine to Lifeboat Davit, it was found that one of the plastic brake release cable sheaves had been cut through by the cable, due to the sheave wheel not turning freely.

Cause: Poor quality plastic sheaves installed from rig build. Sheave not rotating freely, and hence wire cutting through sheave roller. No lubrication points on sheave. Sheave roller not designed for small 5mm diameter cable.

Damage to sheave from
Small diameter cable
cutting through plastic

Action: Inspect all sheaves installed on davits. If similar poor quality sheaves are installed replace with better quality, stainless steel , low maintenance brake cable guide sheaves. Ensure sheave roller is designed for small diameter cable.
