# Safety Alert

ALERT 11 – 18

## DROPPED OBJECT - PIN FALLS FROM TOP DRIVE RESULTS IN A NEAR MISS

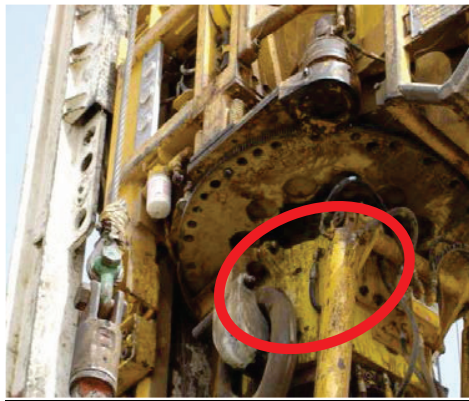
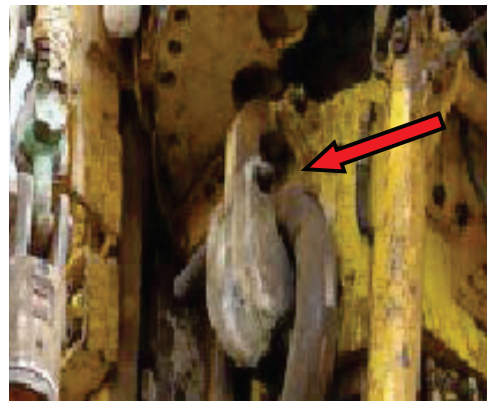
While laying down 5" Drill Pipe, the upper pin of the top drive link support assembly came loose and fell approximately 15-18 feet to the rig floor near the driller's side. No injury was reported.

- The safety pin was sheared off allowing the upper pin to work its way loose and drop to the rig floor.

- Conduct routine scheduled inspection of all equipment that has a potential to drop from the derrick. Utilize the company "DROPS Prevention Scheme" checklist and complete a Dropped Object Management System (DOMS) Rig Inventory List. Attach pictures to the inventory list and retain in the rig file.
- Use safety pin with spring latch instead of using nuts similar to the ones used in 350 ton top drive.
- Develop a JSA to be used when conducting the top drive routine inspection check.
- Reference the following internal documents
  - Dropped Object Management System (DOMS)
  - Job Safety Analysis
  - Top drive manufacture's (OEM) operating manual
  - Perform monthly inspections
