Safety Alert

ALERT 11 – 20

DRILL LINE PULLS THROUGH WIRE ROPE SNAKE WHILE STRINGING BLOCKS

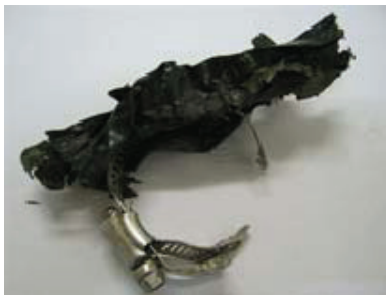
The snake grip was in good condition and was the correct type for the line. The drill line had been fully inserted into the 1 inch - 1-1/2 inch snake grip right to the rubber boot and then 3 x hose clamps were used to secure the snake grip. The clamps were then covered with tape for about 6 inches on each. The snake grip was then attached to a 3/8 inch wire rope line by back splicing the line's dead end through the snake grip's soft eye. The 3/8 inch wire rope is used to pull the drill line through the crown and travelling block sheaves.

Tape and Clamp

- **Hose clamp failure:** When the tape covering the hose clamps was removed after the incident two of the hose clamps had broken bands. While guiding the line through the travelling block sheaves, it is likely the larger diameter clamp got caught up passing through the smaller diameter sheaves. The snake grip manufacturer recommends using banding or tape to secure the snake grip. They also mention the option of using a nail through the end of the snake and bending the ends back to secure.

- Rig personnel were instructed to follow the snake grip manufacture's recommended "Band It® Clamp" so that the preferred method of securing the snake is used.
- Distributed an internal safety alert to all rigs so that everyone is aware of the hazards of using a snake with oily or grease coated drill line.
- Reinforced to all rigs to follow standard operating procedures so that all of the agreed and necessary steps of the job are known and communicated.

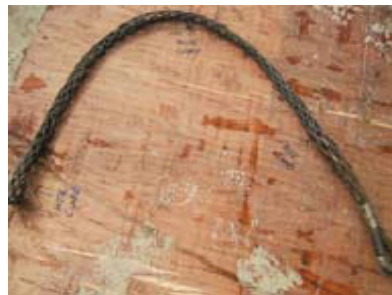
Snake

- **Not following procedure:** A procedure is in place for the "Installation and use of a Lewis Snake". One step in the procedure is to "make sure the cable is clean and free of grease and oil in the areas that will be loaded into the snake grip". The manufacture procedure says: "The grips cannot grip an oily line no matter how hard they are compressing or squeezed. A high grade degreaser and heavy duty disposable towels are recommended for this task."
