## Finger injury caused by opening of jetting door unit

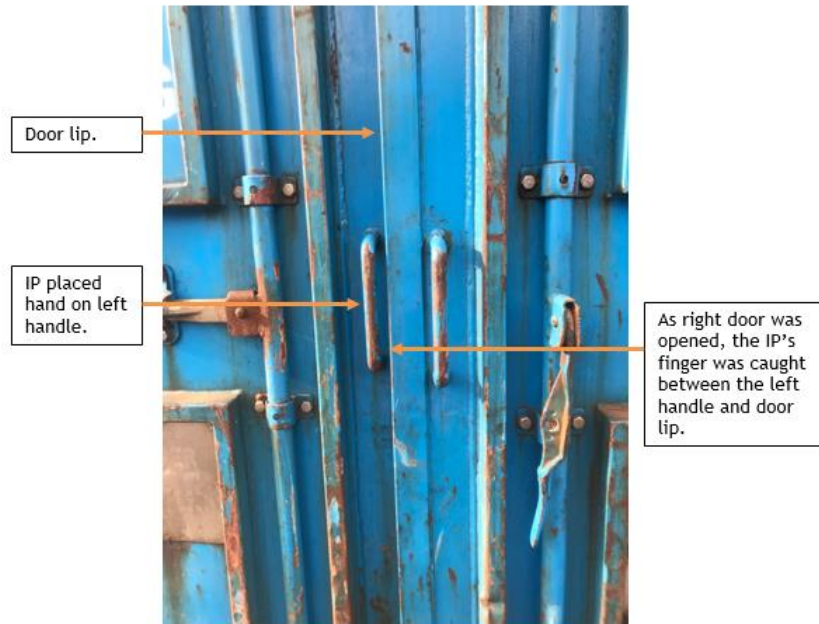
The employee suffered an injury to the third finger on his left hand when opening the double doors on an ultra high pressure jetting unit. As the IP opened the right hand door of the unit, his left hand was caught between the left hand door handle and the door lip, resulting in a laceration to his finger. The IP was subsequently medivaced and received 14 stitches to his finger.

- All access points to must be kept clear of obstruction so the doors can be easily accessed and fully opened.
- Always take extra care when opening any container or unit door and remain conscious of hand placement.
