Dropped object during lifting operations

SAFETY ALERT

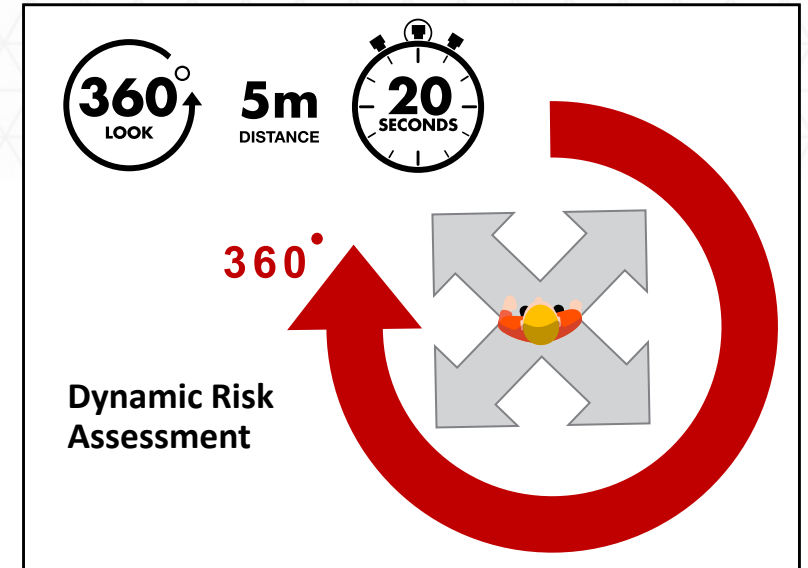
During deck lifting operations, as the banksman was providing final instructions to the crane operator, the load handler looked up and observed the hoist rope very close to an antenna which was fixed to a handrail on the Heli-deck access platform.

The load handler alerted the banksman of the hoist rope proximity to the antenna. Immediately after this communication the antenna weighing 13.3Kg fell 21 meters to the deck landing 4.5 meters from where the banksman was positioned. No injuries were sustained.

Outcome Calculator		
Height	21	m
Mass	13.3	kg
Outcome	Fatality	2738.98 Joules

- Ensure lifting teams are fully aware of the potential overhead hazards for their site and that suitable controls are in place
- Ensure a lifting operations risk assessment is carried out - specific to each lifting operation
- Continuously dynamically risk assess the worksite
